Profile/Photo Observation Report

Date:	04/10/2018	Weather:		Coding:	PACP 6.0
Pipe Length (ft):	229.2	Owner:	NA	Pre Clean:	Not Known
P.O.#:		Surveyor:	Mark Ruby	PSR:	P-707-027-029
Customer:		Clean Date:	01/01/1900	Shape:	C

Street:	Capitol	Flow Control:	Not Controlled
City:	Hobart, IN	Year Renewed:	
Location:	Light Highway	Tape/Media #:	
Purpose:	Maintenance Related	Dia/Height:	8"
Use:	Sanitary	Material:	PVC
Drain Area:	NA	Lining:	Cured in Place
Category:	NA		
Comment:	heavy silt/underwater at 94'.-flow incorrect.		
Location Details:		Direction of Survey:	Downstream
US MH:	M-707-029	DS MH:	M-707-027
		Total Length Surveyed (ft):	96.0

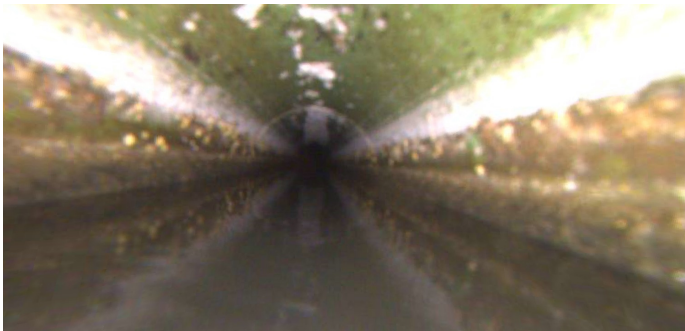
Code: **DAGS**
Description: **Deposits Attached Grease**

Distance (ft): **.0**
Structural Grade: **0**
O&M Grade: **2**
Clock Start/From: **8**
Clock To: **4**
1st Value:
2nd Value:
Value Percent: **5.000**
Continuous Index: **S01**
Within 8" of Joint: **NO**
Remarks:

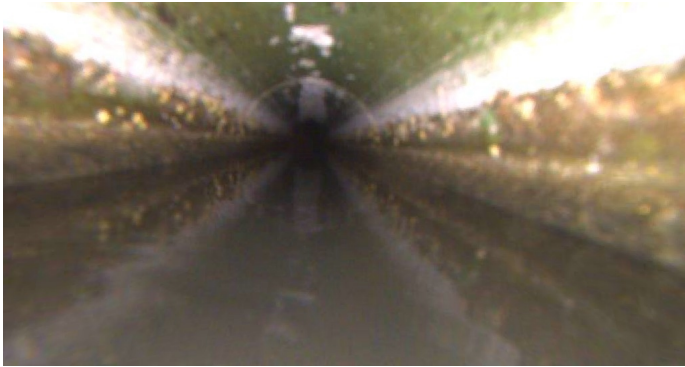
Code:	AMH
Description:	Manhole

Distance (ft):	.0
Structural Grade:	0
O&M Grade:	0
Clock Start/From:	
Clock To:	
1st Value:	
2nd Value:	
Value Percent:	
Continuous Index:	
Within 8" of Joint:	NO
Remarks:	M-707-029

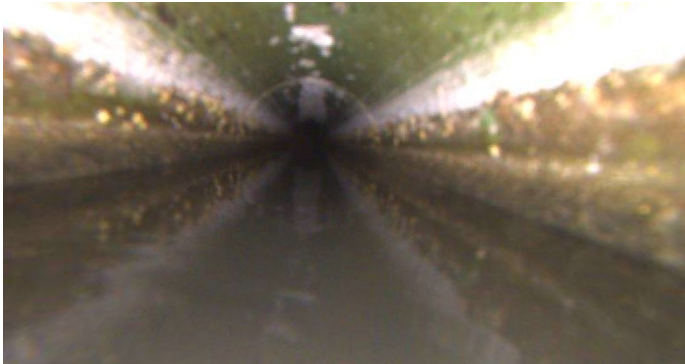
Code:	MWL
Description:	Water Level

Distance (ft):	.0
Structural Grade:	0
O&M Grade:	0
Clock Start/From:	
Clock To:	
1st Value:	
2nd Value:	
Value Percent:	10.000
Continuous Index:	
Within 8" of Joint:	NO
Remarks:

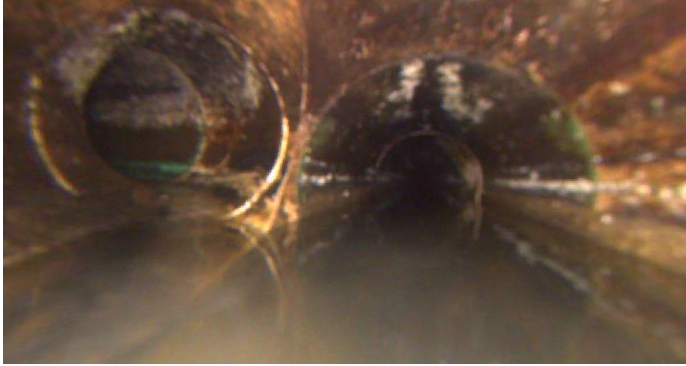
Code: **TF**
Description: **Tap Factory**

Distance (ft): **35.1**
Structural Grade: **0**
O&M Grade: **0**
Clock Start/From: **8**
Clock To:
1st Value: **4.000**
2nd Value:
Value Percent:
Continuous Index:
Within 8" of Joint:
Remarks:

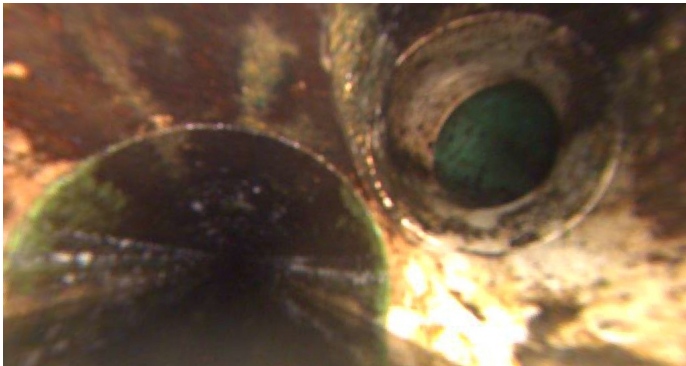
Code: **TF**
Description: **Tap Factory**

Distance (ft): **37.2**
Structural Grade: **0**
O&M Grade: **0**
Clock Start/From: **2**
Clock To:
1st Value: **4.000**
2nd Value:
Value Percent:
Continuous Index:
Within 8" of Joint:
Remarks:

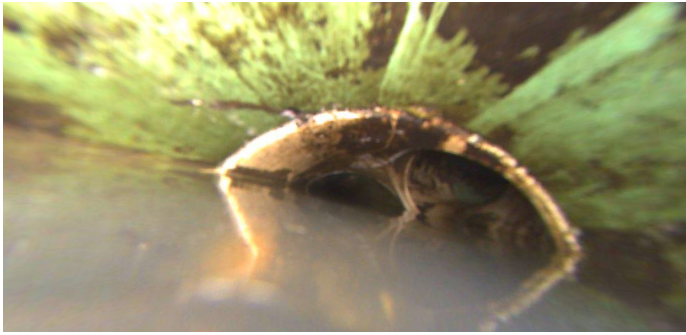
Code: **DAGS**
Description: **Deposits Attached Grease**

Distance (ft): **94.4**
Structural Grade: **0**
O&M Grade: **2**
Clock Start/From: **8**
Clock To: **4**
1st Value:
2nd Value:
Value Percent: **5.000**
Continuous Index: **F01**
Within 8" of Joint: **NO**
Remarks:
