Profile/Photo Observation Report

Date:	02/10/2022	Weather:		Coding:	PACP 7.0
Pipe Length (ft):	229.5	Owner:	City of Hobart	Pre Clean:	Heavy Cleaning
P.O.#:	YES502259	Surveyor:	S. Bucklin	PSR:	P-707-027-029
Customer:	City of Hobart	Clean Date:	02/09/2022	Shape:	C

Street:	South Lincoln Street	Flow Control:	Not Controlled
City:	Hobart, IN	Year Renewed:	
Location:	Local rural streets with light traffic, t	Tape/Media #:	
Purpose:	Routine Assessment	Dia/Height:	8"
Use:	Sanitary Sewage Pipe	Material:	PVC
Drain Area:		Lining:	None
Category:	NA		
Comment:			
Location Details:		Direction of Survey:	Downstream
US MH:	M-707-029	DS MH:	M-707-027
		Total Length Surveyed (ft):	229.5

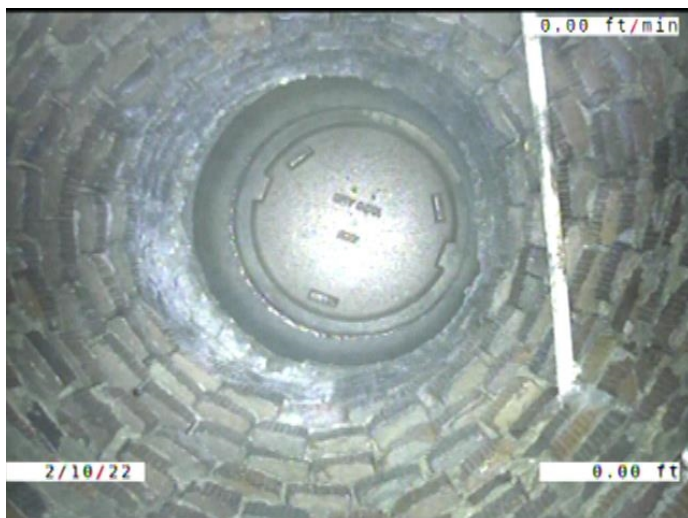
Code: **AMH**
Description: **Manhole**

Distance (ft): **.0**
Structural Grade: **0**
O&M Grade: **0**
Clock Start/From:
Clock To:
1st Value:
2nd Value:
Value Percent:
Continuous Index:
Within 8" of Joint: **NO**
Remarks: **M-707-029**

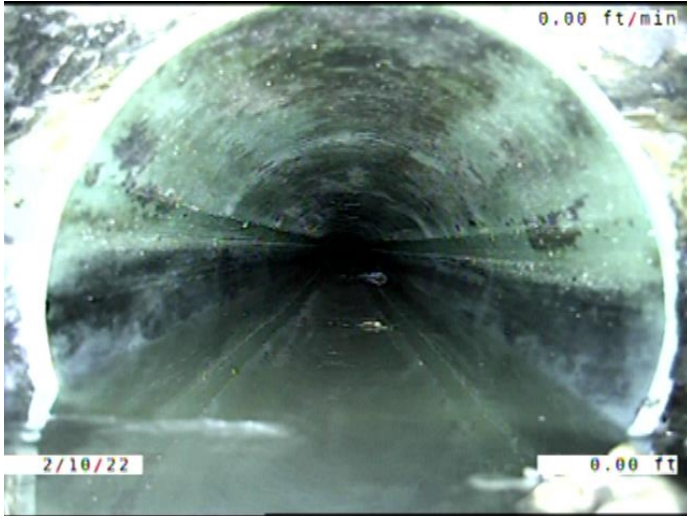
Code: **MWL**
 Description: **Miscellaneous Water Level**

Distance (ft): **.0**
 Structural Grade: **0**
 O&M Grade: **0**
 Clock Start/From:
 Clock To:
 1st Value:
 2nd Value:
 Value Percent: **15.000**
 Continuous Index:
 Within 8" of Joint: **NO**
 Remarks:

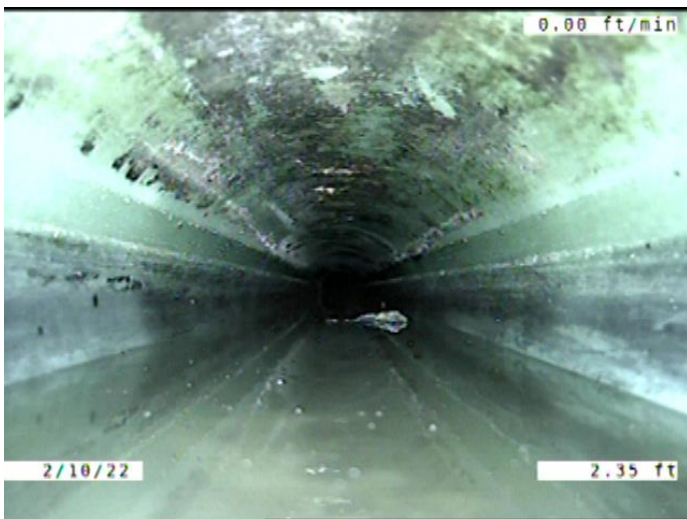
Code: **DSF**
 Description: **Deposits Settled Fine**

Distance (ft): **2.4**
 Structural Grade: **0**
 O&M Grade: **2**
 Clock Start/From: **5**
 Clock To: **7**
 1st Value:
 2nd Value:
 Value Percent: **5.000**
 Continuous Index: **S01**
 Within 8" of Joint: **YES**
 Remarks: **ROOTS THAT HAVE BEEN CUT. ALSO RAGS**

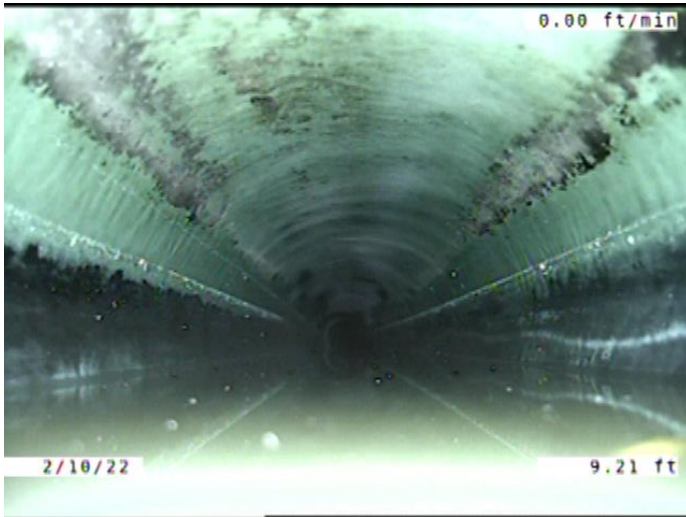
Code: **MWL**
 Description: **Miscellaneous Water Level**

Distance (ft): **9.2**
 Structural Grade: **0**
 O&M Grade: **0**
 Clock Start/From:
 Clock To:
 1st Value:
 2nd Value:
 Value Percent: **25.000**
 Continuous Index:
 Within 8" of Joint: **NO**
 Remarks:

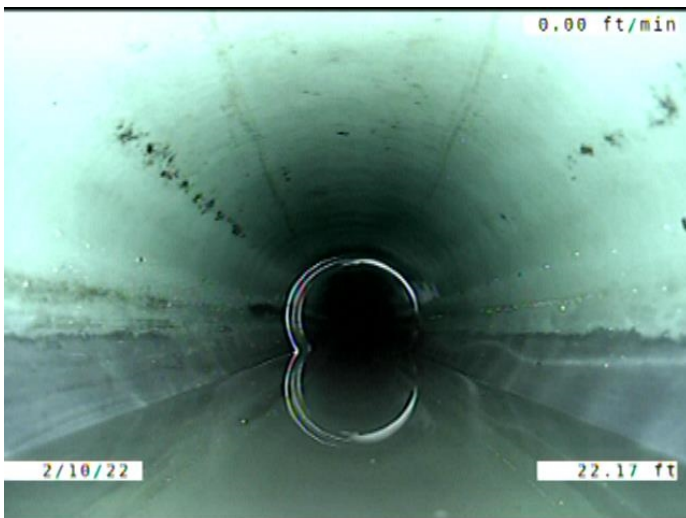
Code: **MWL**
 Description: **Miscellaneous Water Level**

Distance (ft): **22.2**
 Structural Grade: **0**
 O&M Grade: **0**
 Clock Start/From:
 Clock To:
 1st Value:
 2nd Value:
 Value Percent: **15.000**
 Continuous Index:
 Within 8" of Joint: **NO**
 Remarks:

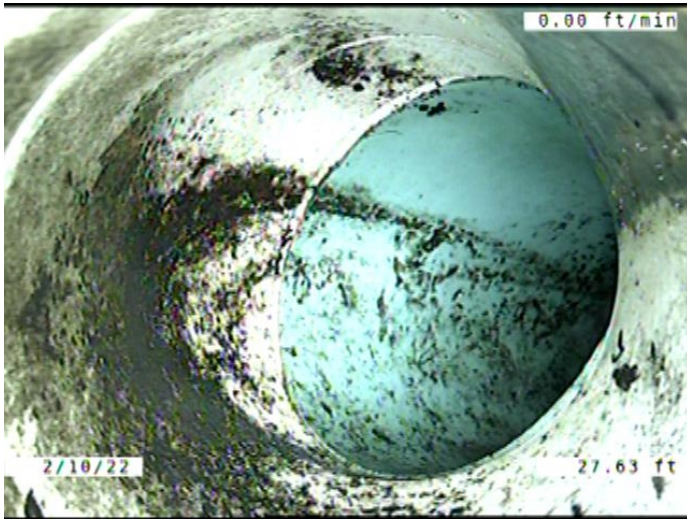
Code: **TF**
Description: **Tap Factory**

Distance (ft): **27.6**
Structural Grade: **0**
O&M Grade: **0**
Clock Start/From: **2**
Clock To:
1st Value: **4.000**
2nd Value:
Value Percent:
Continuous Index:
Within 8" of Joint: **YES**
Remarks:

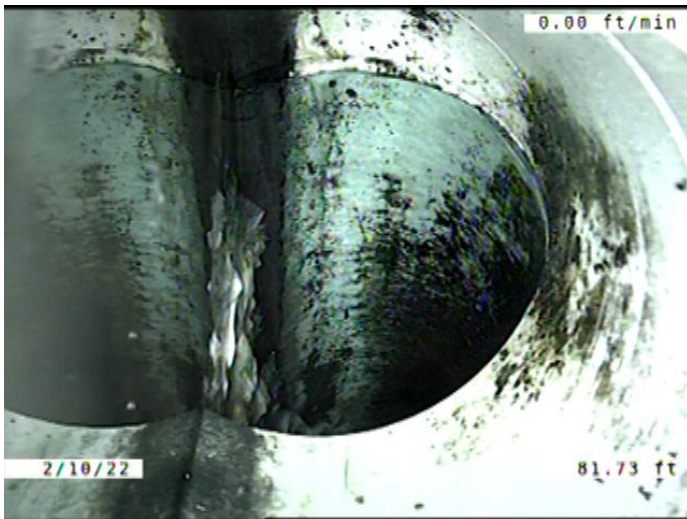
Code: **TF**
Description: **Tap Factory**

Distance (ft): **81.7**
Structural Grade: **0**
O&M Grade: **0**
Clock Start/From: **9**
Clock To:
1st Value: **4.000**
2nd Value:
Value Percent:
Continuous Index:
Within 8" of Joint: **YES**
Remarks:

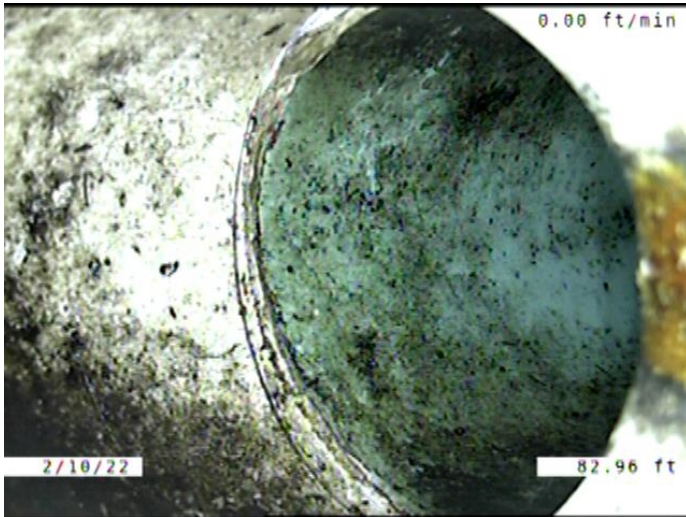
Code: **TB**
 Description: **Tap Break-in/Hammer**

Distance (ft): **83.0**
 Structural Grade: **0**
 O&M Grade: **0**
 Clock Start/From: **1**
 Clock To:
 1st Value: **4.000**
 2nd Value:
 Value Percent:
 Continuous Index:
 Within 8" of Joint: **YES**
 Remarks: **CONSTANTLY RUNNING WATER.**

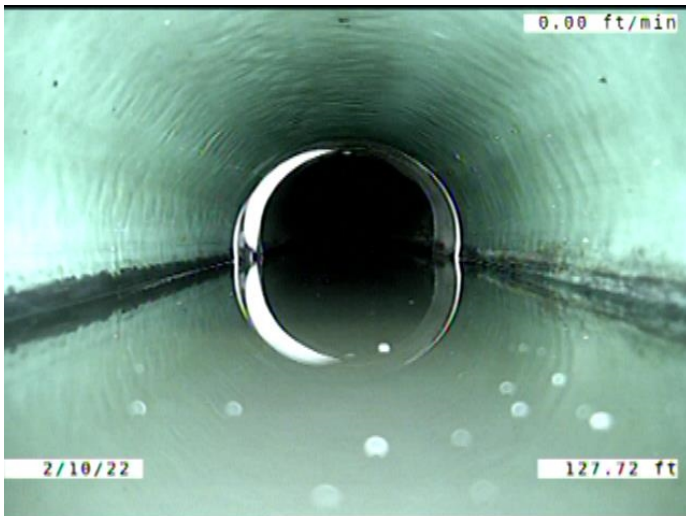
Code: **MWL**
 Description: **Miscellaneous Water Level**

Distance (ft): **127.7**
 Structural Grade: **0**
 O&M Grade: **0**
 Clock Start/From:
 Clock To:
 1st Value:
 2nd Value:
 Value Percent: **25.000**
 Continuous Index:
 Within 8" of Joint: **NO**
 Remarks:

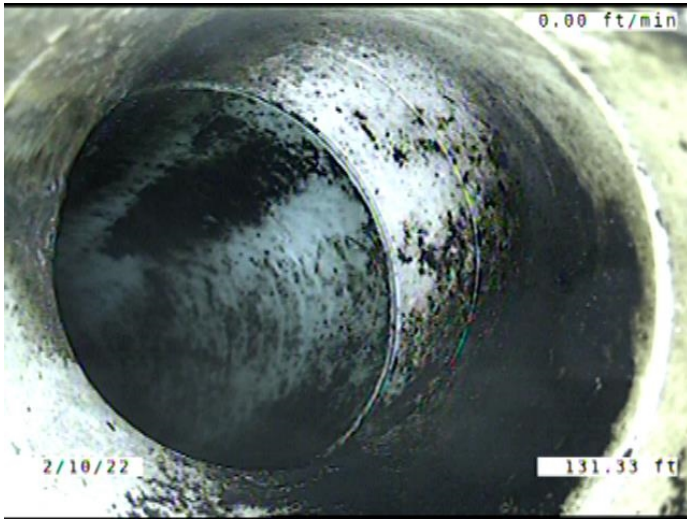
Code: **TF**
Description: **Tap Factory**

Distance (ft): **131.3**
Structural Grade: **0**
O&M Grade: **0**
Clock Start/From: **11**
Clock To:
1st Value: **4.000**
2nd Value:
Value Percent:
Continuous Index:
Within 8" of Joint: **YES**
Remarks:

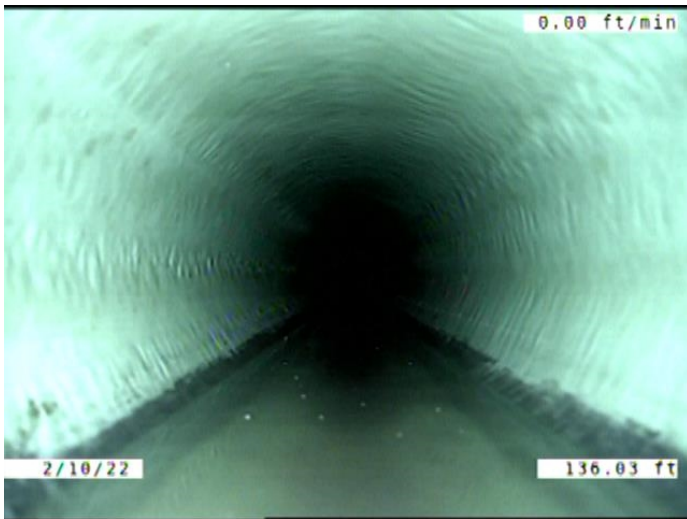
Code: **MWL**
Description: **Miscellaneous Water Level**

Distance (ft): **136.0**
Structural Grade: **0**
O&M Grade: **0**
Clock Start/From:
Clock To:
1st Value:
2nd Value:
Value Percent: **10.000**
Continuous Index:
Within 8" of Joint: **NO**
Remarks:

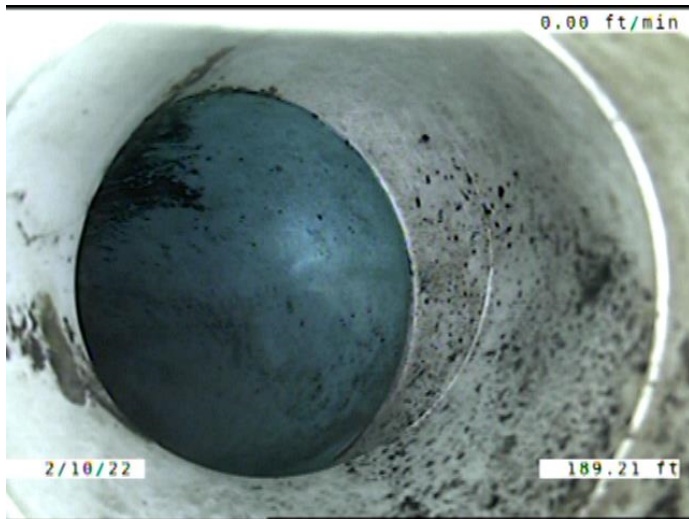
Code: **TF**
Description: **Tap Factory**

Distance (ft): **189.2**
Structural Grade: **0**
O&M Grade: **0**
Clock Start/From: **10**
Clock To:
1st Value: **4.000**
2nd Value:
Value Percent:
Continuous Index:
Within 8" of Joint: **YES**
Remarks:

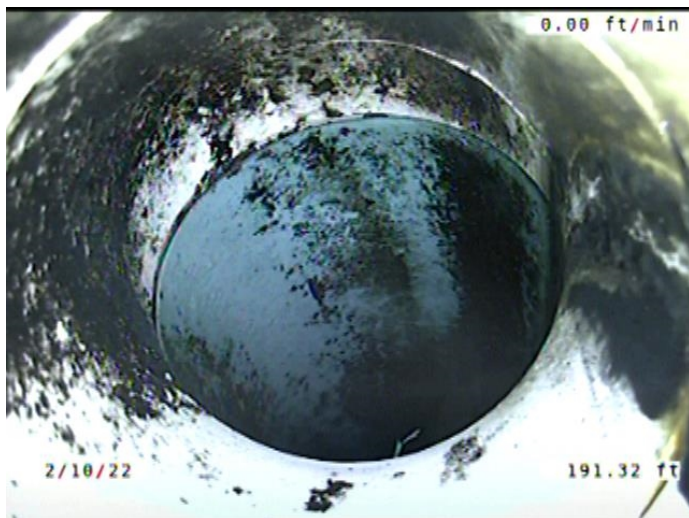
Code: **TF**
Description: **Tap Factory**

Distance (ft): **191.3**
Structural Grade: **0**
O&M Grade: **0**
Clock Start/From: **3**
Clock To:
1st Value: **4.000**
2nd Value:
Value Percent:
Continuous Index:
Within 8" of Joint: **YES**
Remarks:

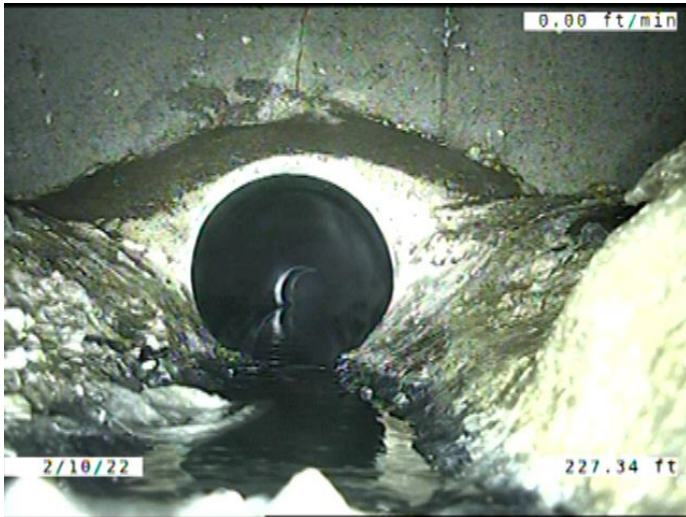
Code:	DSF
Description:	Deposits Settled Fine
Distance (ft):	227.3
Structural Grade:	0
O&M Grade:	2
Clock Start/From:	5
Clock To:	7
1st Value:	
2nd Value:	
Value Percent:	5.000
Continuous Index:	F01
Within 8" of Joint:	YES
Remarks:	ROOTS THAT HAVE BEEN CUT. ALSO RAGS

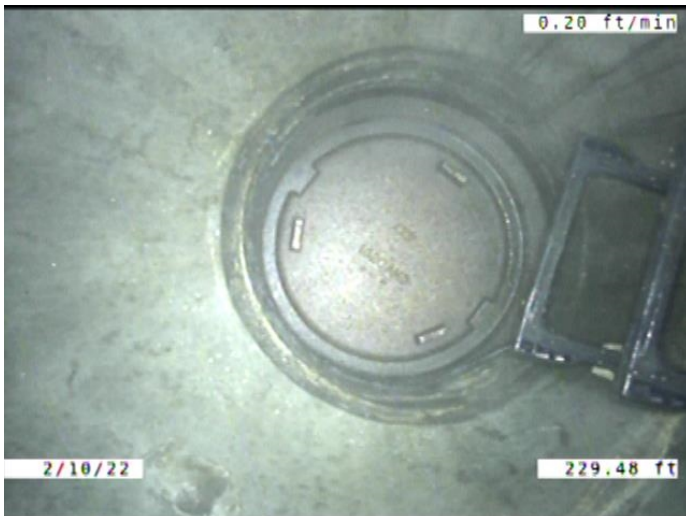
Code:	AMH
Description:	Manhole
Distance (ft):	229.5
Structural Grade:	0
O&M Grade:	0
Clock Start/From:	
Clock To:	
1st Value:	
2nd Value:	
Value Percent:	
Continuous Index:	
Within 8" of Joint:	NO
Remarks:	M-707-027
