## Profile/Photo Observation Report

Street:	<b>LINCOLN ST</b>	Flow Control:	<b>Not Controlled</b>
City:	<b>Hobart, IN</b>	Year Renewed:	
Location:	<b>Light Highway</b>	Tape/Media #:	
Purpose:	<b>Maintenance Related</b>	Dia/Height:	<b>8"</b>
Use:	<b>Sanitary</b>	Material:	<b>VCP</b>
Drain Area:	<b>NA</b>	Lining:	<b>Cured in Place</b>
Category:	<b>NA</b>		
Comment:	<b>flow incorrect.</b>

Location Details:		Direction of Survey:	<b>Upstream</b>
US MH:	<b>M-707-030</b>	DS MH:	<b>M-707-029</b>
		Total Length Surveyed (ft):	<b>240.6</b>

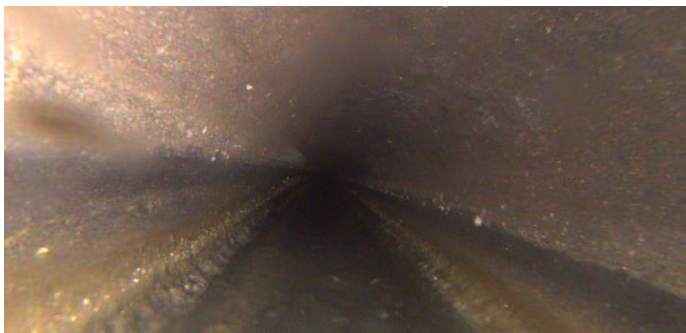
Code: **DAGS**  
Description: **Deposits Attached Grease**

Distance (ft): **.0**  
Structural Grade: **0**  
O&M Grade: **2**  
Clock Start/From: **8**  
Clock To: **4**  
1st Value:  
2nd Value:  
Value Percent: **5.000**  
Continuous Index: **S01**  
Within 8" of Joint: **NO**  
Remarks:

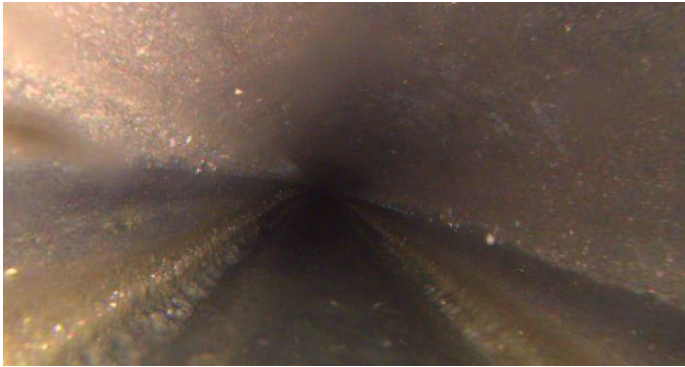
Code:	<b>AMH</b>
Description:	<b>Manhole</b>

Distance (ft):	<b>.0</b>
Structural Grade:	<b>0</b>
O&M Grade:	<b>0</b>
Clock Start/From:	
Clock To:	
1st Value:	
2nd Value:	
Value Percent:	
Continuous Index:	
Within 8" of Joint:	<b>NO</b>
Remarks:	<b>M-707-029</b>

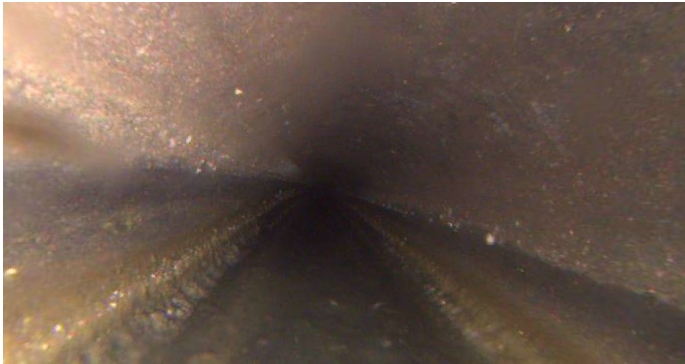
Code:	<b>MWL</b>
Description:	<b>Water Level</b>

Distance (ft):	<b>.0</b>
Structural Grade:	<b>0</b>
O&M Grade:	<b>0</b>
Clock Start/From:	
Clock To:	
1st Value:	
2nd Value:	
Value Percent:	<b>10.000</b>
Continuous Index:	
Within 8" of Joint:	<b>NO</b>
Remarks:

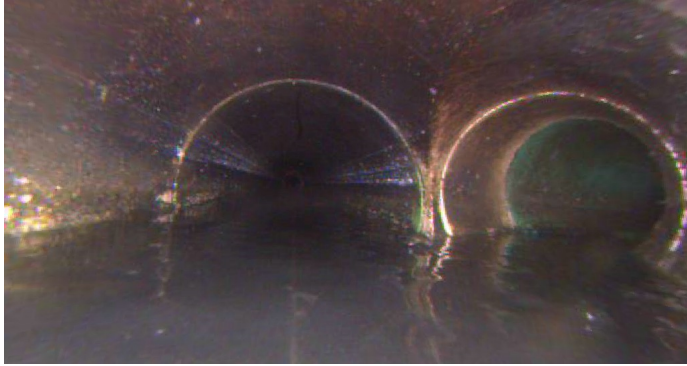
Code: **TF**  
Description: **Tap Factory**

Distance (ft): **10.0**  
Structural Grade: **0**  
O&M Grade: **0**  
Clock Start/From: **8**  
Clock To:  
1st Value: **4.000**  
2nd Value:  
Value Percent:  
Continuous Index:  
Within 8" of Joint:  
Remarks: **Photo taken from rear camera.**

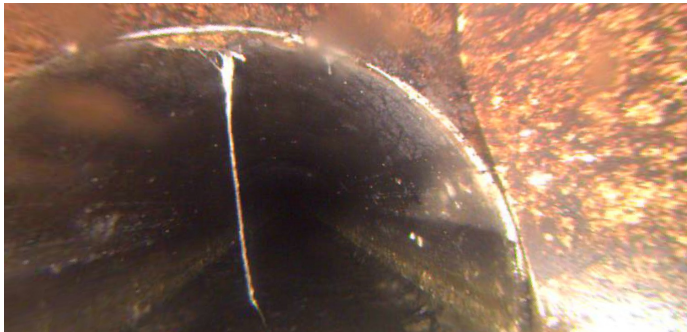
Code: **RFJ**  
Description: **Roots Fine Joint**

Distance (ft): **11.6**  
Structural Grade: **0**  
O&M Grade: **1**  
Clock Start/From: **12**  
Clock To:  
1st Value:  
2nd Value:  
Value Percent:  
Continuous Index:  
Within 8" of Joint: **YES**  
Remarks:

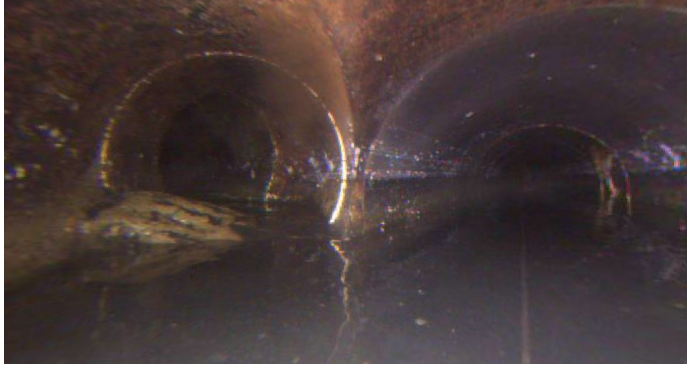
Code: **TF**  
Description: **Tap Factory**

Distance (ft): **11.8**  
Structural Grade: **0**  
O&M Grade: **0**  
Clock Start/From: **4**  
Clock To:  
1st Value: **4.000**  
2nd Value:  
Value Percent:  
Continuous Index:  
Within 8" of Joint:  
Remarks: **Photo taken from rear camera.**

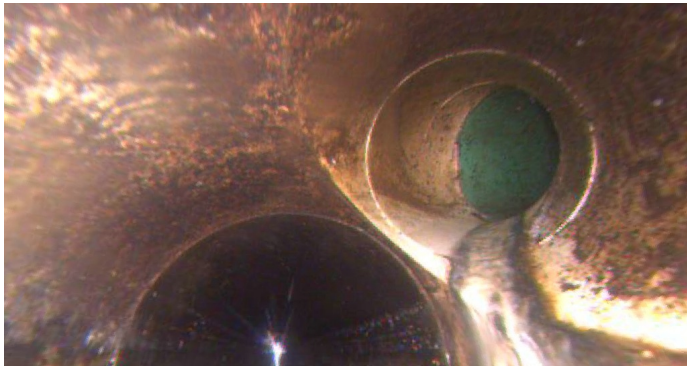
Code: **TF**  
Description: **Tap Factory**

Distance (ft): **63.7**  
Structural Grade: **0**  
O&M Grade: **0**  
Clock Start/From: **10**  
Clock To:  
1st Value: **4.000**  
2nd Value:  
Value Percent:  
Continuous Index:  
Within 8" of Joint:  
Remarks: **Photo taken from rear camera.**

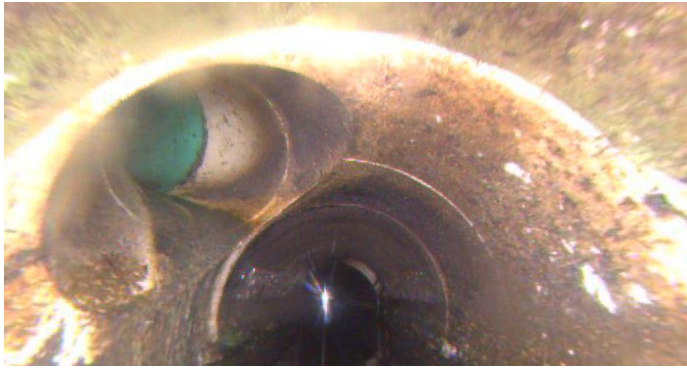
Code: **TF**  
Description: **Tap Factory**

Distance (ft): **66.2**  
Structural Grade: **0**  
O&M Grade: **0**  
Clock Start/From: **2**  
Clock To:  
1st Value: **4.000**  
2nd Value:  
Value Percent:  
Continuous Index:  
Within 8" of Joint:  
Remarks: **Photo taken from rear camera.**

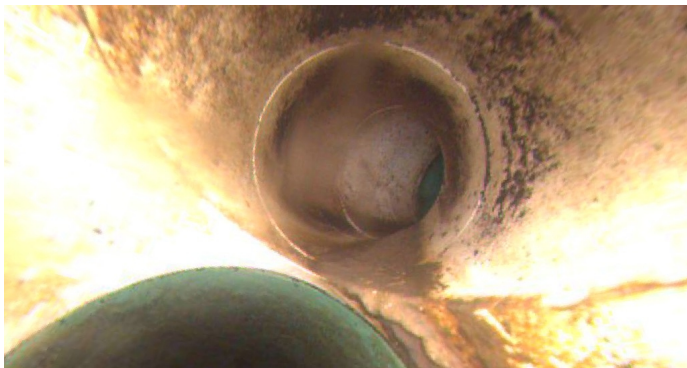
Code: **TF**  
Description: **Tap Factory**

Distance (ft): **115.4**  
Structural Grade: **0**  
O&M Grade: **0**  
Clock Start/From: **2**  
Clock To:  
1st Value: **4.000**  
2nd Value:  
Value Percent:  
Continuous Index:  
Within 8" of Joint:  
Remarks: **Photo taken from rear camera.**

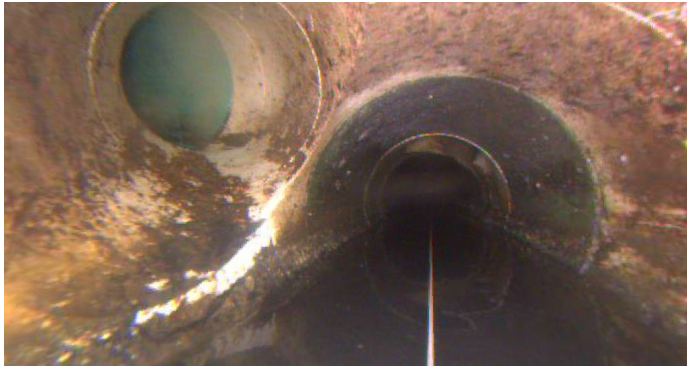
Code: **TF**  
Description: **Tap Factory**

Distance (ft): **117.3**  
Structural Grade: **0**  
O&M Grade: **0**  
Clock Start/From: **2**  
Clock To:  
1st Value: **4.000**  
2nd Value:  
Value Percent:  
Continuous Index:  
Within 8" of Joint:  
Remarks: **Photo taken from rear camera.**

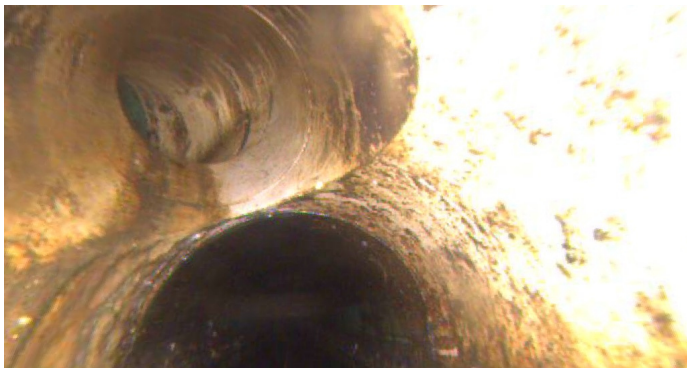
Code: **TF**  
Description: **Tap Factory**

Distance (ft): **171.3**  
Structural Grade: **0**  
O&M Grade: **0**  
Clock Start/From: **1**  
Clock To:  
1st Value: **4.000**  
2nd Value:  
Value Percent:  
Continuous Index:  
Within 8" of Joint:  
Remarks: **Photo taken from rear camera.**

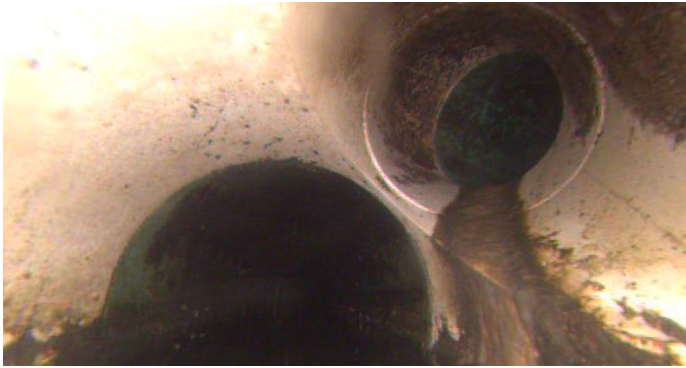
Code: **TF**  
Description: **Tap Factory**

Distance (ft): **223.2**  
Structural Grade: **0**  
O&M Grade: **0**  
Clock Start/From: **10**  
Clock To:  
1st Value: **4.000**  
2nd Value:  
Value Percent:  
Continuous Index:  
Within 8" of Joint:  
Remarks: **Photo taken from rear camera.**

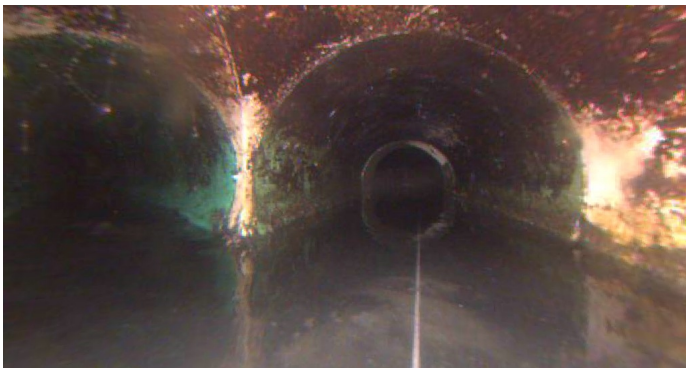
Code: **TF**  
Description: **Tap Factory**

Distance (ft): **225.8**  
Structural Grade: **0**  
O&M Grade: **0**  
Clock Start/From: **4**  
Clock To:  
1st Value: **4.000**  
2nd Value:  
Value Percent:  
Continuous Index:  
Within 8" of Joint:  
Remarks:

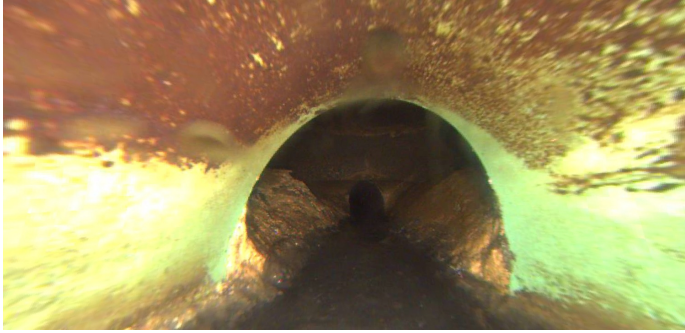
Code: **DAGS**  
Description: **Deposits Attached Grease**

Distance (ft): **238.3**  
Structural Grade: **0**  
O&M Grade: **2**  
Clock Start/From: **8**  
Clock To: **4**  
1st Value:  
2nd Value:  
Value Percent: **5.000**  
Continuous Index: **F01**  
Within 8" of Joint: **NO**  
Remarks:

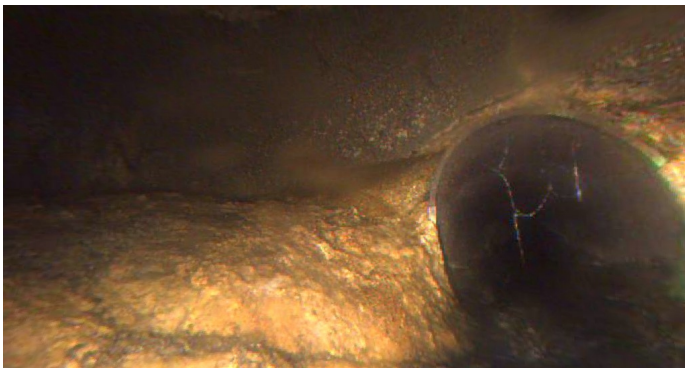
Code: **AMH**  
Description: **Manhole**

Distance (ft): **240.6**  
Structural Grade: **0**  
O&M Grade: **0**  
Clock Start/From:  
Clock To:  
1st Value:  
2nd Value:  
Value Percent:  
Continuous Index:  
Within 8" of Joint: **NO**  
Remarks: **M-707-030**
