Profile/Photo Observation Report

Date:	04/10/2018	Weather:		Coding:	PACP 6.0
Pipe Length (ft):	240.5	Owner:	NA	Pre Clean:	Not Known
P.O.#:		Surveyor:	Mark Ruby	PSR:	P-707-029-030
Customer:		Clean Date:	01/01/1900	Shape:	C

Street:	Capitol	Flow Control:	Not Controlled
City:	Hobart, IN	Year Renewed:	
Location:	Light Highway	Tape/Media #:	
Purpose:	Maintenance Related	Dia/Height:	8"
Use:	Sanitary	Material:	VCP
Drain Area:	NA	Lining:	Cured in Place
Category:	NA		
Comment:	flow incorrect.

Location Details:		Direction of Survey:	Upstream
US MH:	M-707-030	DS MH:	M-707-029
		Total Length Surveyed (ft):	240.6

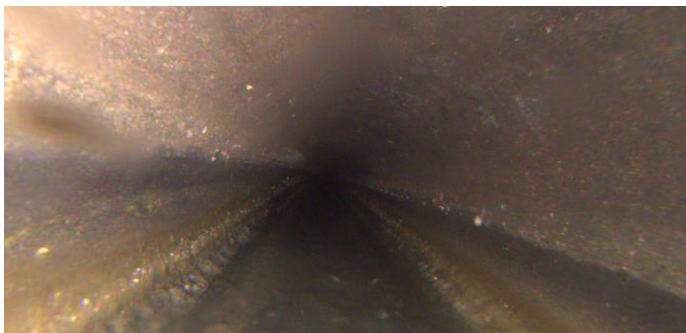
Code: **DAGS**
Description: **Deposits Attached Grease**

Distance (ft): **.0**
Structural Grade: **0**
O&M Grade: **2**
Clock Start/From: **8**
Clock To: **4**
1st Value:
2nd Value:
Value Percent: **5.000**
Continuous Index: **S01**
Within 8" of Joint: **NO**
Remarks:

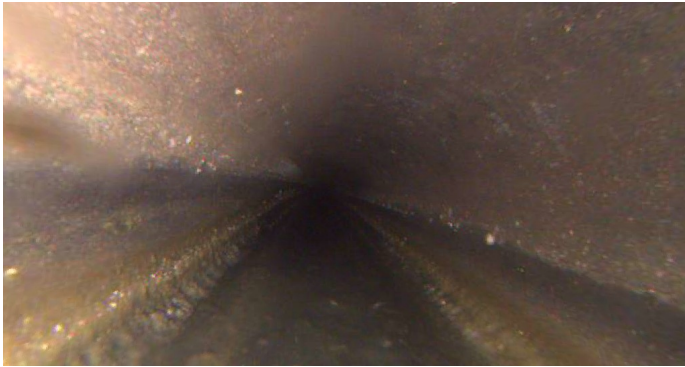
Code:	AMH
Description:	Manhole

Distance (ft):	.0
Structural Grade:	0
O&M Grade:	0
Clock Start/From:	
Clock To:	
1st Value:	
2nd Value:	
Value Percent:	
Continuous Index:	
Within 8" of Joint:	NO
Remarks:	M-707-029

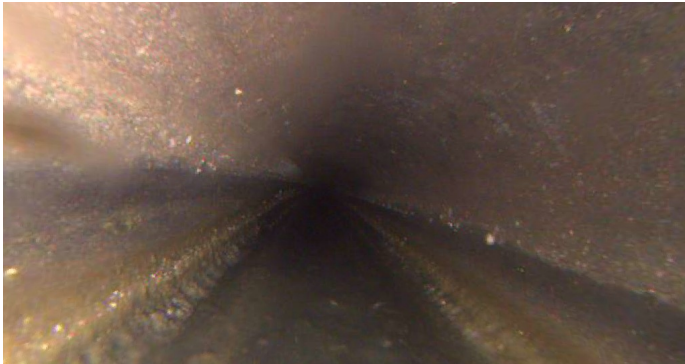
Code:	MWL
Description:	Water Level

Distance (ft):	.0
Structural Grade:	0
O&M Grade:	0
Clock Start/From:	
Clock To:	
1st Value:	
2nd Value:	
Value Percent:	10.000
Continuous Index:	
Within 8" of Joint:	NO
Remarks:

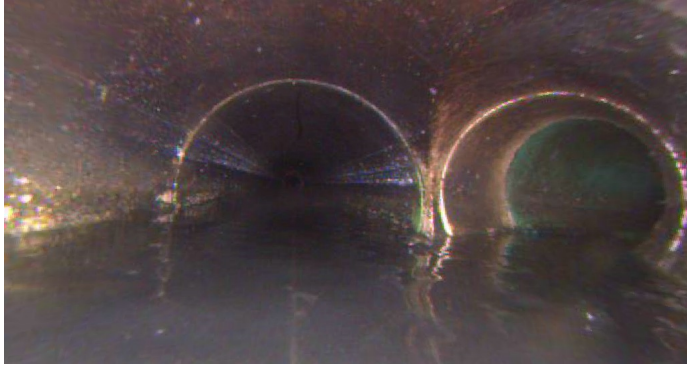
Code: **TF**
 Description: **Tap Factory**

Distance (ft): **10.0**
 Structural Grade: **0**
 O&M Grade: **0**
 Clock Start/From: **8**
 Clock To:
 1st Value: **4.000**
 2nd Value:
 Value Percent:
 Continuous Index:
 Within 8" of Joint:
 Remarks: **Photo taken from rear camera.**

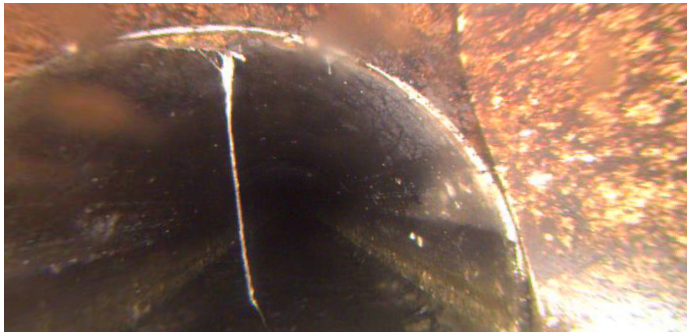
Code: **RFJ**
 Description: **Roots Fine Joint**

Distance (ft): **11.6**
 Structural Grade: **0**
 O&M Grade: **1**
 Clock Start/From: **12**
 Clock To:
 1st Value:
 2nd Value:
 Value Percent:
 Continuous Index:
 Within 8" of Joint: **YES**
 Remarks:

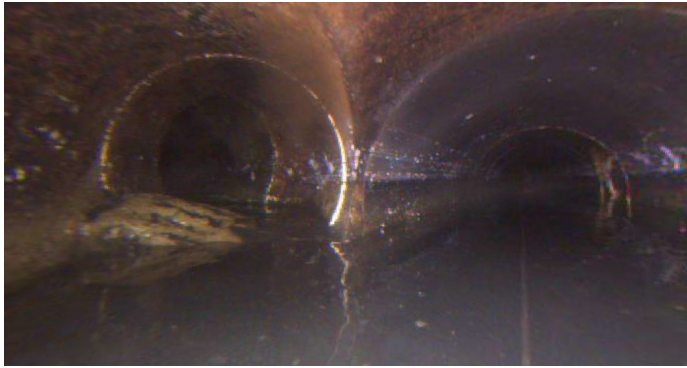
Code: **TF**
Description: **Tap Factory**

Distance (ft): **11.8**
Structural Grade: **0**
O&M Grade: **0**
Clock Start/From: **4**
Clock To:
1st Value: **4.000**
2nd Value:
Value Percent:
Continuous Index:
Within 8" of Joint:
Remarks: **Photo taken from rear camera.**

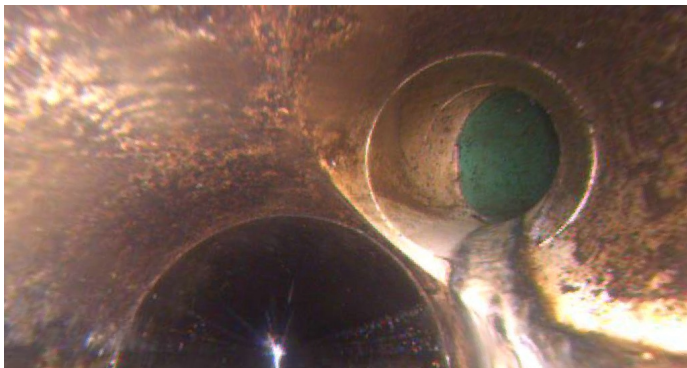
Code: **TF**
Description: **Tap Factory**

Distance (ft): **63.7**
Structural Grade: **0**
O&M Grade: **0**
Clock Start/From: **10**
Clock To:
1st Value: **4.000**
2nd Value:
Value Percent:
Continuous Index:
Within 8" of Joint:
Remarks: **Photo taken from rear camera.**

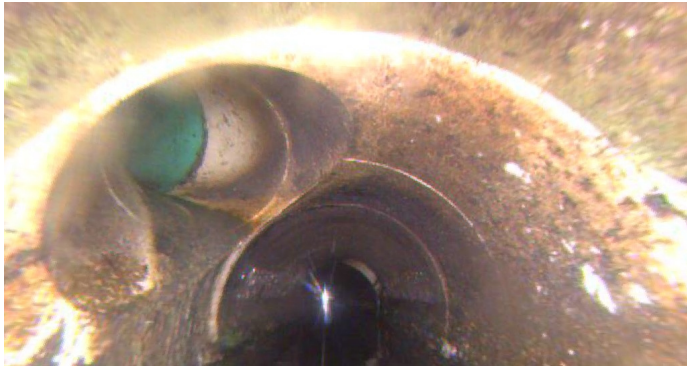
Code: **TF**
Description: **Tap Factory**

Distance (ft): **66.2**
Structural Grade: **0**
O&M Grade: **0**
Clock Start/From: **2**
Clock To:
1st Value: **4.000**
2nd Value:
Value Percent:
Continuous Index:
Within 8" of Joint:
Remarks: **Photo taken from rear camera.**

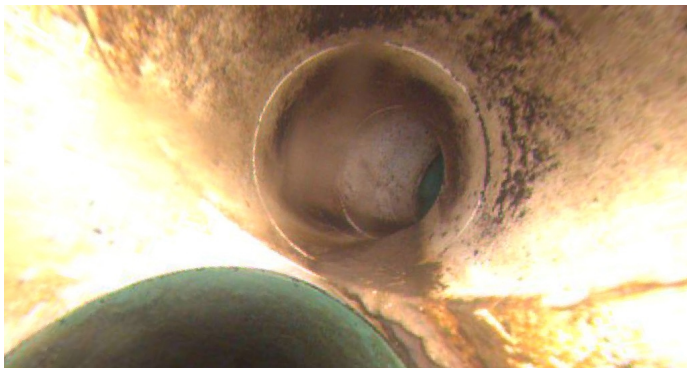
Code: **TF**
Description: **Tap Factory**

Distance (ft): **115.4**
Structural Grade: **0**
O&M Grade: **0**
Clock Start/From: **2**
Clock To:
1st Value: **4.000**
2nd Value:
Value Percent:
Continuous Index:
Within 8" of Joint:
Remarks: **Photo taken from rear camera.**

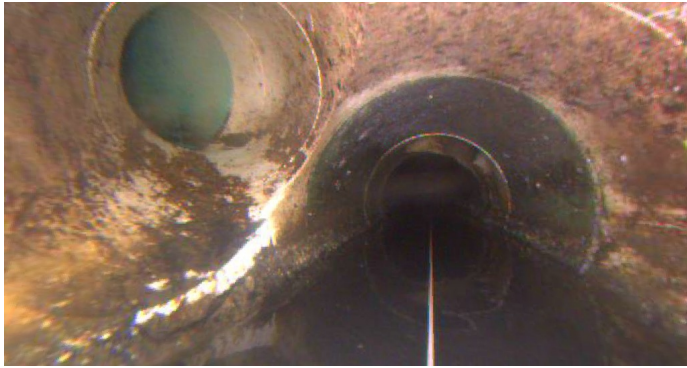
Code: **TF**
Description: **Tap Factory**

Distance (ft): **117.3**
Structural Grade: **0**
O&M Grade: **0**
Clock Start/From: **2**
Clock To:
1st Value: **4.000**
2nd Value:
Value Percent:
Continuous Index:
Within 8" of Joint:
Remarks: **Photo taken from rear camera.**

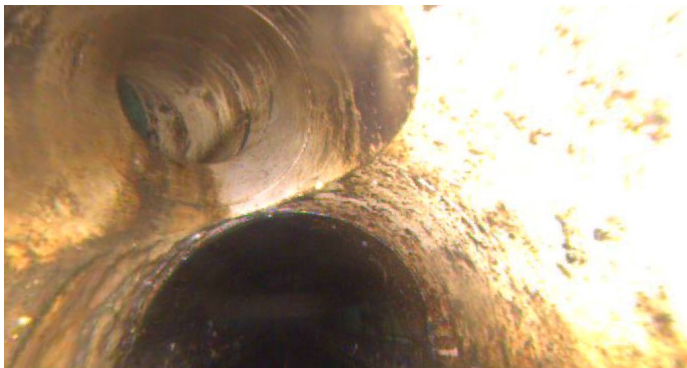
Code: **TF**
Description: **Tap Factory**

Distance (ft): **171.3**
Structural Grade: **0**
O&M Grade: **0**
Clock Start/From: **1**
Clock To:
1st Value: **4.000**
2nd Value:
Value Percent:
Continuous Index:
Within 8" of Joint:
Remarks: **Photo taken from rear camera.**

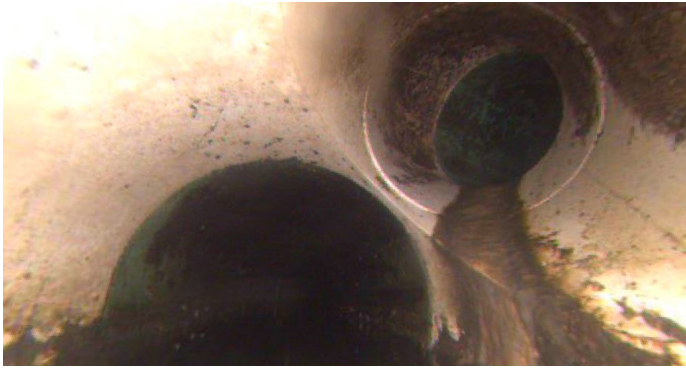
Code: **TF**
Description: **Tap Factory**

Distance (ft): **223.2**
Structural Grade: **0**
O&M Grade: **0**
Clock Start/From: **10**
Clock To:
1st Value: **4.000**
2nd Value:
Value Percent:
Continuous Index:
Within 8" of Joint:
Remarks: **Photo taken from rear camera.**

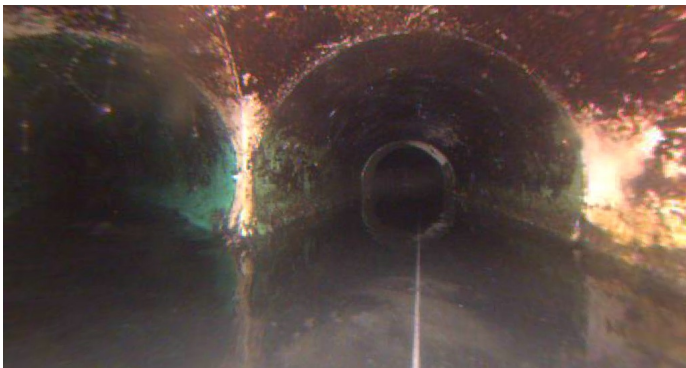
Code: **TF**
Description: **Tap Factory**

Distance (ft): **225.8**
Structural Grade: **0**
O&M Grade: **0**
Clock Start/From: **4**
Clock To:
1st Value: **4.000**
2nd Value:
Value Percent:
Continuous Index:
Within 8" of Joint:
Remarks:

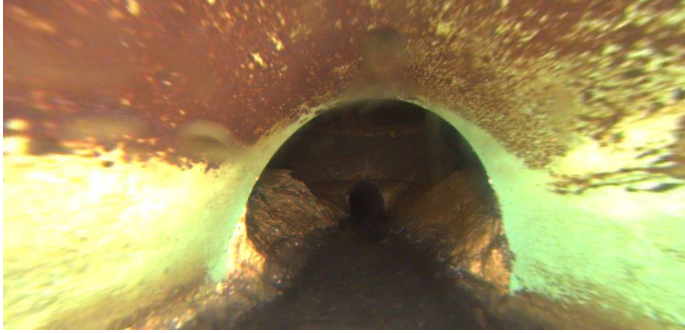
Code: **DAGS**
Description: **Deposits Attached Grease**

Distance (ft): **238.3**
Structural Grade: **0**
O&M Grade: **2**
Clock Start/From: **8**
Clock To: **4**
1st Value:
2nd Value:
Value Percent: **5.000**
Continuous Index: **F01**
Within 8" of Joint: **NO**
Remarks:

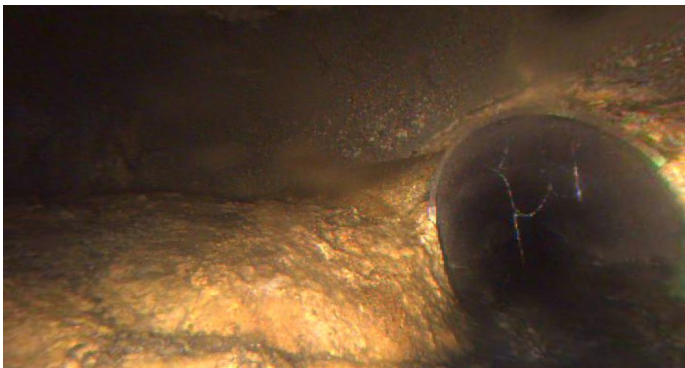
Code: **AMH**
Description: **Manhole**

Distance (ft): **240.6**
Structural Grade: **0**
O&M Grade: **0**
Clock Start/From:
Clock To:
1st Value:
2nd Value:
Value Percent:
Continuous Index:
Within 8" of Joint: **NO**
Remarks: **M-707-030**
