Profile/Photo Observation Report

Street:	LINCOLN ST & E 11TH ST	Flow Control:	Not Controlled
City:	Hobart, IN	Year Renewed:	
Location:	Light Highway	Tape/Media #:	
Purpose:	Maintenance Related	Dia/Height:	10"
Use:	Sanitary	Material:	VCP
Drain Area:	NA	Lining:	Cured in Place
Category:	NA		
Comment:	sediment at 176'.

Location Details:		Direction of Survey:	Downstream
US MH:	M-707-031	DS MH:	M-707-013
		Total Length Surveyed (ft):	177.7

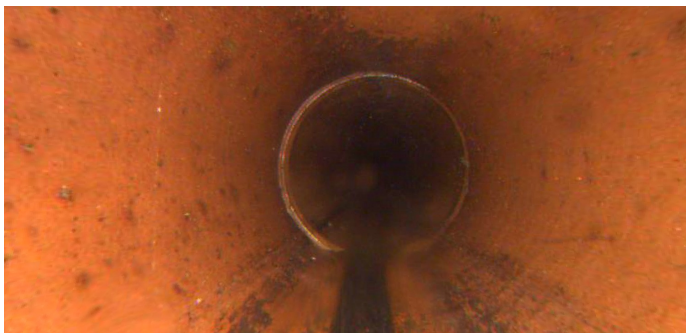
Code: **AMH**
Description: **Manhole**

Distance (ft): **.0**
Structural Grade: **0**
O&M Grade: **0**
Clock Start/From:
Clock To:
1st Value:
2nd Value:
Value Percent:
Continuous Index:
Within 8" of Joint: **NO**
Remarks: **M-707-031**

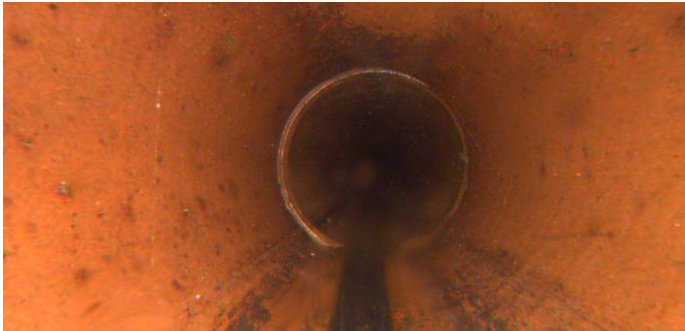
Code:	MWL
Description:	Water Level

Distance (ft):	.0
Structural Grade:	0
O&M Grade:	0
Clock Start/From:	
Clock To:	
1st Value:	
2nd Value:	
Value Percent:	5.000
Continuous Index:	
Within 8" of Joint:	NO
Remarks:

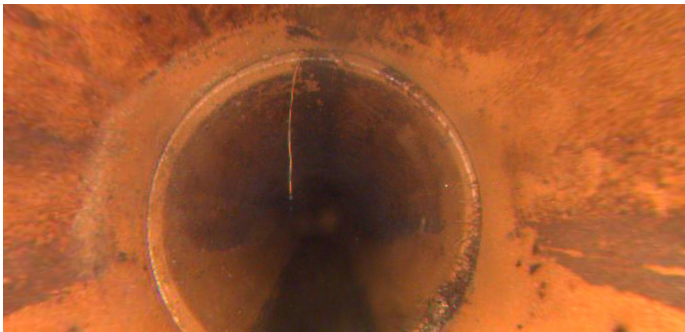
Code:	RFJ
Description:	Roots Fine Joint

Distance (ft):	26.6
Structural Grade:	0
O&M Grade:	1
Clock Start/From:	12
Clock To:	
1st Value:	
2nd Value:	
Value Percent:	
Continuous Index:	
Within 8" of Joint:	YES
Remarks:

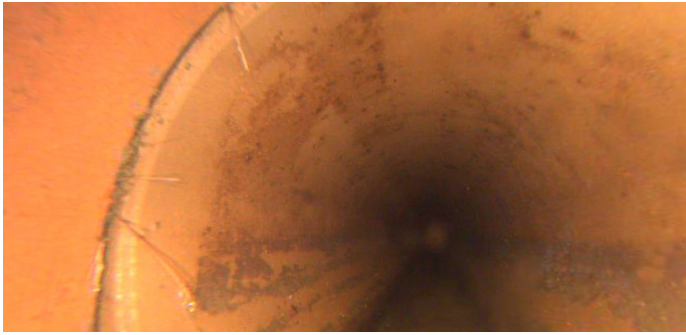
Code: **RFJ**
Description: **Roots Fine Joint**

Distance (ft): **37.0**
Structural Grade: **0**
O&M Grade: **1**
Clock Start/From: **9**
Clock To: **11**
1st Value:
2nd Value:
Value Percent:
Continuous Index:
Within 8" of Joint: **YES**
Remarks:

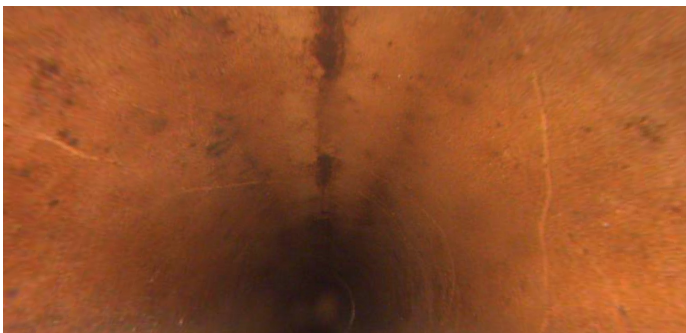
Code: **CM**
Description: **Crack Multiple**

Distance (ft): **78.4**
Structural Grade: **3**
O&M Grade: **0**
Clock Start/From: **8**
Clock To: **4**
1st Value:
2nd Value:
Value Percent:
Continuous Index: **S01**
Within 8" of Joint:
Remarks:

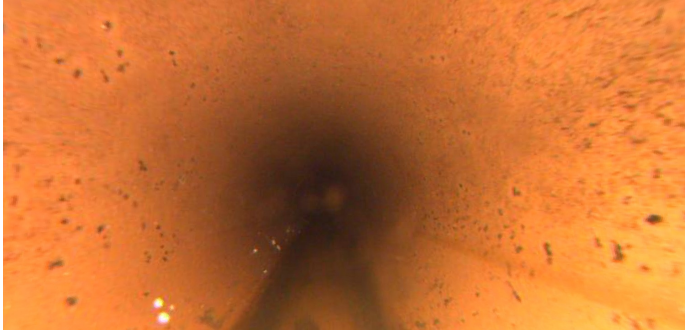
Code: **CM**
Description: **Crack Multiple**

Distance (ft): **117.7**
Structural Grade: **3**
O&M Grade: **0**
Clock Start/From: **8**
Clock To: **4**
1st Value:
2nd Value:
Value Percent:
Continuous Index: **F01**
Within 8" of Joint:
Remarks:

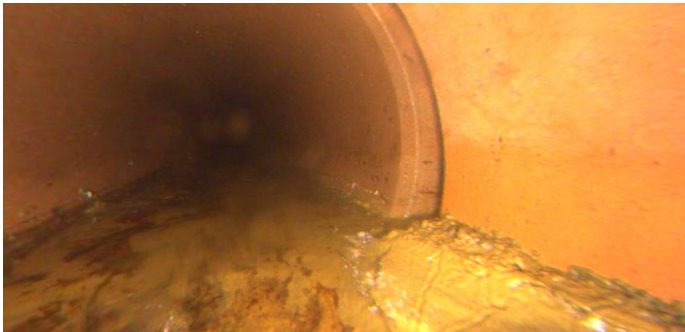
Code: **DSF**
Description: **Deposits Settled Fine**

Distance (ft): **152.0**
Structural Grade: **0**
O&M Grade: **2**
Clock Start/From: **3**
Clock To: **5**
1st Value:
2nd Value:
Value Percent: **5.000**
Continuous Index:
Within 8" of Joint: **YES**
Remarks:

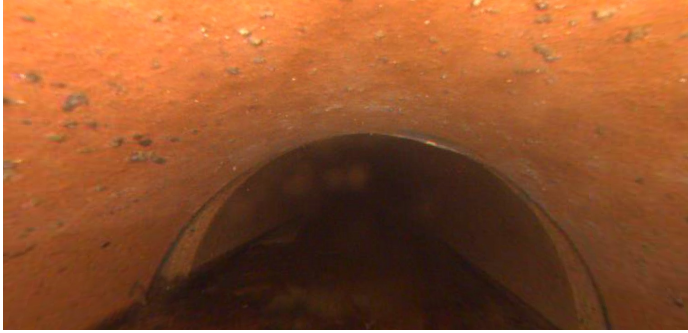
Code:	MSA
Description:	Abandoned Survey
Distance (ft):	177.7
Structural Grade:	0
O&M Grade:	0
Clock Start/From:	
Clock To:	
1st Value:	
2nd Value:	
Value Percent:	
Continuous Index:	
Within 8" of Joint:	NO
Remarks:	debris under water
