## Profile/Photo Observation Report

Street:	<b>Capitol</b>	Flow Control:	<b>Not Controlled</b>
City:	<b>Hobart, IN</b>	Year Renewed:	
Location:	<b>Light Highway</b>	Tape/Media #:	
Purpose:	<b>Maintenance Related</b>	Dia/Height:	<b>10"</b>
Use:	<b>Sanitary</b>	Material:	<b>VCP</b>
Drain Area:	<b>NA</b>	Lining:	<b>Cured in Place</b>
Category:	<b>NA</b>		
Comment:	<b>sediment at 176'.</b>

Location Details:		Direction of Survey:	<b>Downstream</b>
US MH:	<b>M-707-031</b>	DS MH:	<b>M-707-013</b>
		Total Length Surveyed (ft):	<b>177.7</b>

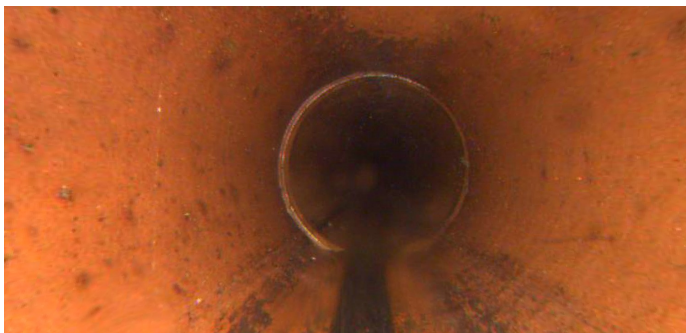
Code: **AMH**  
Description: **Manhole**

Distance (ft): **.0**  
Structural Grade: **0**  
O&M Grade: **0**  
Clock Start/From:  
Clock To:  
1st Value:  
2nd Value:  
Value Percent:  
Continuous Index:  
Within 8" of Joint: **NO**  
Remarks: **M-707-031**

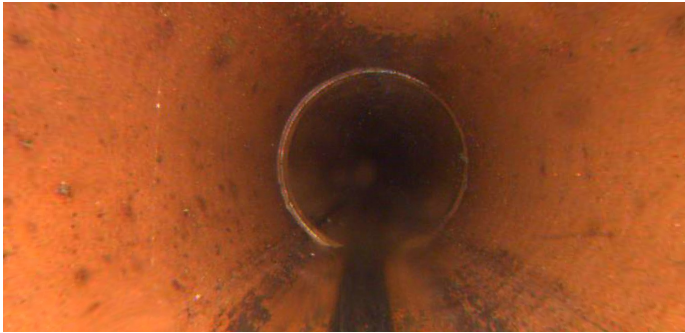
Code:	<b>MWL</b>
Description:	<b>Water Level</b>

Distance (ft):	<b>.0</b>
Structural Grade:	<b>0</b>
O&M Grade:	<b>0</b>
Clock Start/From:	
Clock To:	
1st Value:	
2nd Value:	
Value Percent:	<b>5.000</b>
Continuous Index:	
Within 8" of Joint:	<b>NO</b>
Remarks:

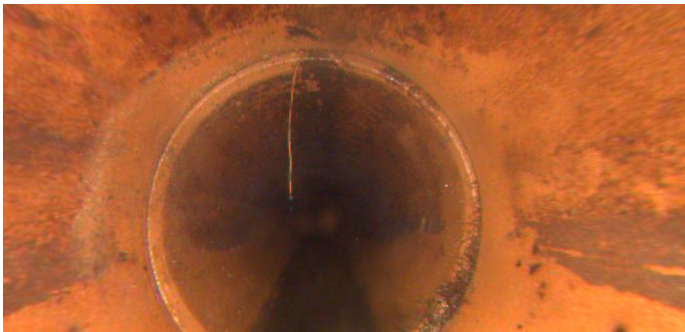
Code:	<b>RFJ</b>
Description:	<b>Roots Fine Joint</b>

Distance (ft):	<b>26.6</b>
Structural Grade:	<b>0</b>
O&M Grade:	<b>1</b>
Clock Start/From:	<b>12</b>
Clock To:	
1st Value:	
2nd Value:	
Value Percent:	
Continuous Index:	
Within 8" of Joint:	<b>YES</b>
Remarks:

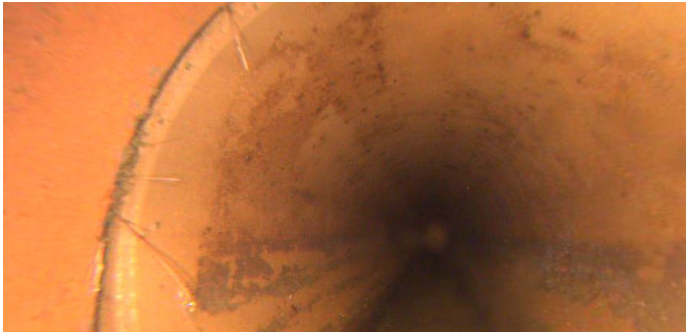
Code: **RFJ**  
Description: **Roots Fine Joint**

Distance (ft): **37.0**  
Structural Grade: **0**  
O&M Grade: **1**  
Clock Start/From: **9**  
Clock To: **11**  
1st Value:  
2nd Value:  
Value Percent:  
Continuous Index:  
Within 8" of Joint: **YES**  
Remarks:

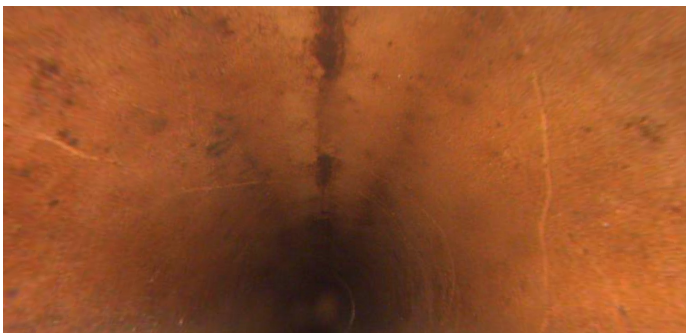
Code: **CM**  
Description: **Crack Multiple**

Distance (ft): **78.4**  
Structural Grade: **3**  
O&M Grade: **0**  
Clock Start/From: **8**  
Clock To: **4**  
1st Value:  
2nd Value:  
Value Percent:  
Continuous Index: **S01**  
Within 8" of Joint:  
Remarks:

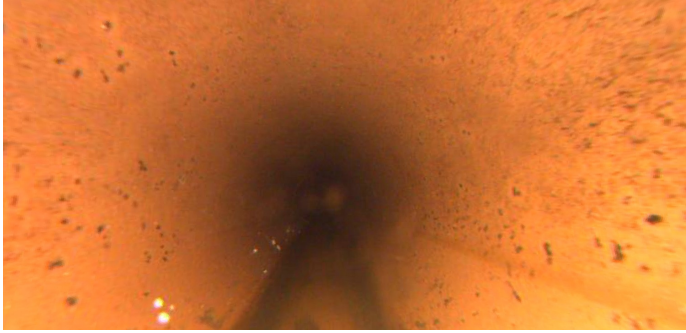
Code: **CM**  
Description: **Crack Multiple**

Distance (ft): **117.7**  
Structural Grade: **3**  
O&M Grade: **0**  
Clock Start/From: **8**  
Clock To: **4**  
1st Value:  
2nd Value:  
Value Percent:  
Continuous Index: **F01**  
Within 8" of Joint:  
Remarks:

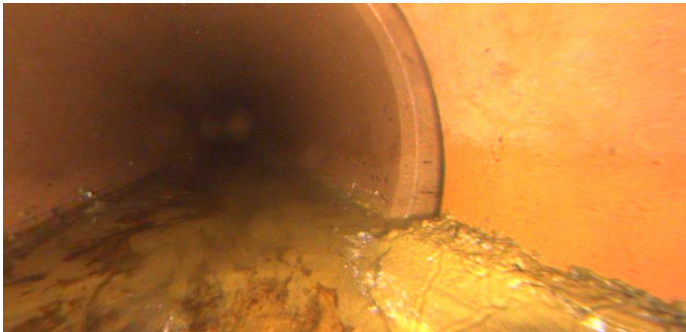
Code: **DSF**  
Description: **Deposits Settled Fine**

Distance (ft): **152.0**  
Structural Grade: **0**  
O&M Grade: **2**  
Clock Start/From: **3**  
Clock To: **5**  
1st Value:  
2nd Value:  
Value Percent: **5.000**  
Continuous Index:  
Within 8" of Joint: **YES**  
Remarks:

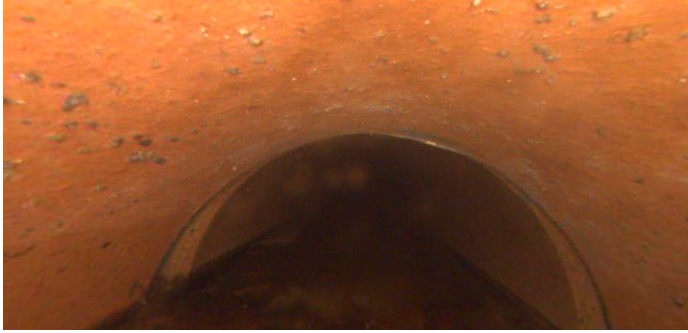
Code:	<b>MSA</b>
Description:	<b>Abandoned Survey</b>
Distance (ft):	<b>177.7</b>
Structural Grade:	<b>0</b>
O&M Grade:	<b>0</b>
Clock Start/From:	
Clock To:	
1st Value:	
2nd Value:	
Value Percent:	
Continuous Index:	
Within 8" of Joint:	<b>NO</b>
Remarks:	<b>debris under water</b>
