## Profile/Photo Observation Report

Date:	<b>02/12/2022</b>	Weather:		Coding:	<b>PACP 7.0</b>
Pipe Length (ft):	<b>329.0</b>	Owner:	<b>City of Hobart</b>	Pre Clean:	<b>Heavy Cleaning</b>
P.O.#:	<b>YES502259</b>	Surveyor:	<b>S. Bucklin</b>	PSR:	<b>P-707-031-013</b>
Customer:	<b>City of Hobart</b>	Clean Date:	<b>02/11/2022</b>	Shape:	<b>C</b>

Street:	<b>East 11th Street</b>	Flow Control:	<b>Not Controlled</b>
City:	<b>Hobart, IN</b>	Year Renewed:	
Location:	<b>Local rural streets with light traffic, t</b>	Tape/Media #:	
Purpose:	<b>Routine Assessment</b>	Dia/Height:	<b>10"</b>
Use:	<b>Sanitary Sewage Pipe</b>	Material:	<b>VCP</b>
Drain Area:		Lining:	<b>None</b>
Category:	<b>NA</b>		
Comment:			
Location Details:		Direction of Survey:	<b>Downstream</b>
US MH:	<b>M-707-031</b>	DS MH:	<b>M-707-013</b>
		Total Length Surveyed (ft):	<b>271.4</b>

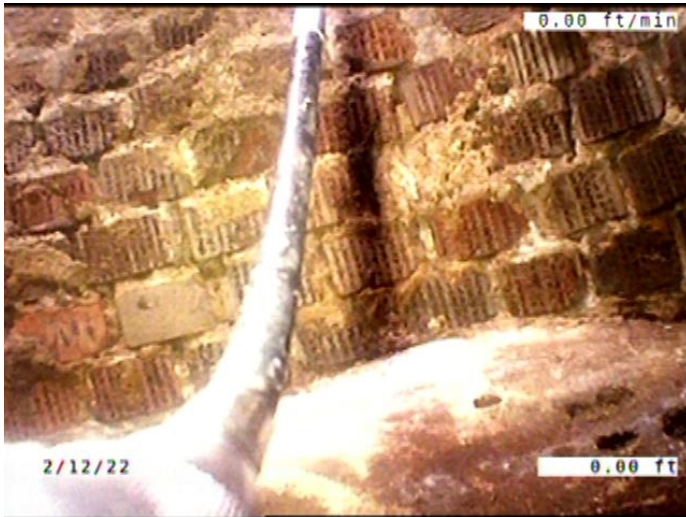
Code: **AMH**  
Description: **Manhole**

Distance (ft): **.0**  
Structural Grade: **0**  
O&M Grade: **0**  
Clock Start/From:  
Clock To:  
1st Value:  
2nd Value:  
Value Percent:  
Continuous Index:  
Within 8" of Joint: **NO**  
Remarks: **M-707-031**

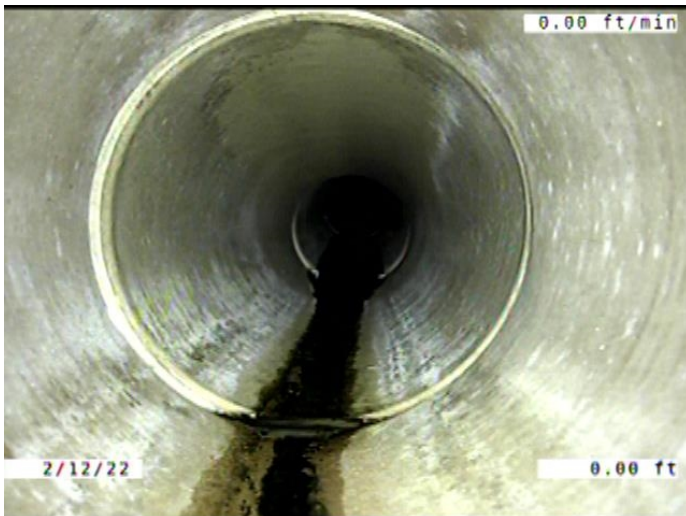
Code: **MWL**  
Description: **Miscellaneous Water Level**

Distance (ft): **.0**  
Structural Grade: **0**  
O&M Grade: **0**  
Clock Start/From:  
Clock To:  
1st Value:  
2nd Value:  
Value Percent: **5.000**  
Continuous Index:  
Within 8" of Joint: **NO**  
Remarks:

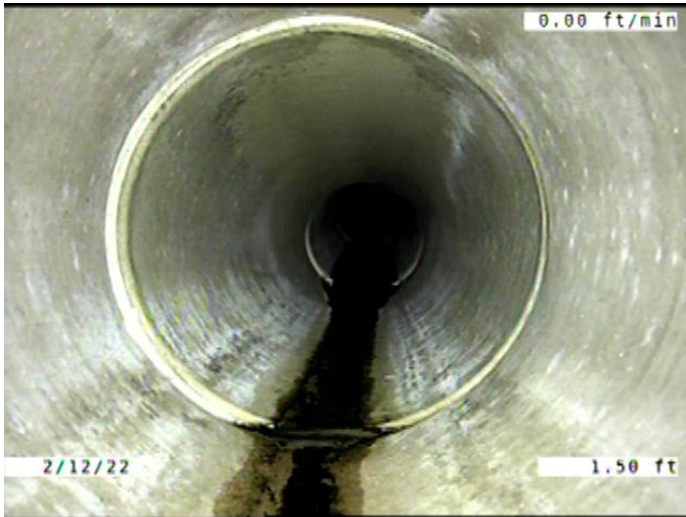
Code: **MGO**  
Description: **Miscellaneous General Observation**

Distance (ft): **1.5**  
Structural Grade: **0**  
O&M Grade: **0**  
Clock Start/From:  
Clock To:  
1st Value:  
2nd Value:  
Value Percent:  
Continuous Index:  
Within 8" of Joint: **NO**  
Remarks: **DROP INTO THE MANHOLE. HAD TO START IN THE PIPE.**

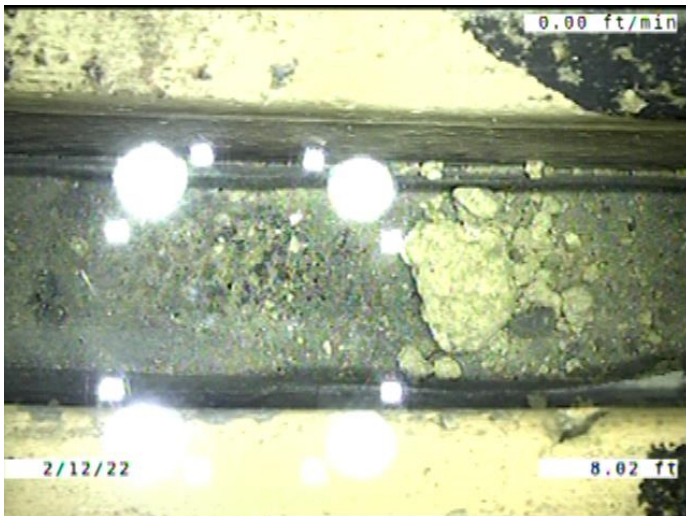
Code: **JAM**  
Description: **Joint Angular Medium**

Distance (ft): **8.0**  
Structural Grade: **3**  
O&M Grade: **0**  
Clock Start/From:  
Clock To:  
1st Value:  
2nd Value:  
Value Percent:  
Continuous Index:  
Within 8" of Joint: **NO**  
Remarks:

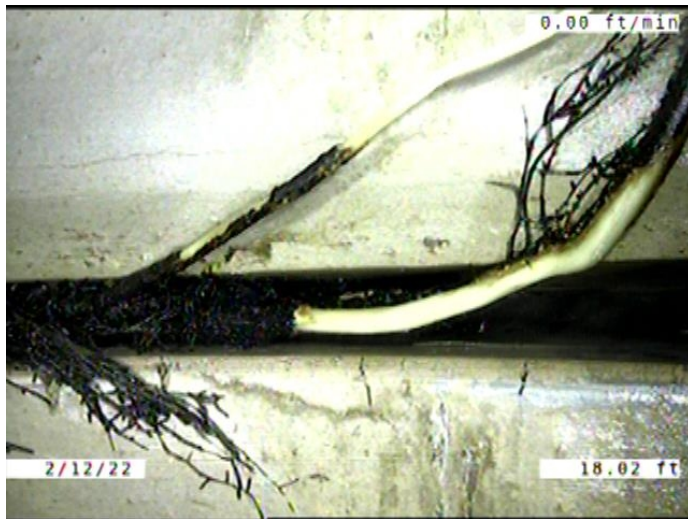
Code: **RFJ**  
 Description: **Roots Fine Joint**

Distance (ft): **18.0**  
 Structural Grade: **0**  
 O&M Grade: **1**  
 Clock Start/From: **7**  
 Clock To: **9**  
 1st Value:  
 2nd Value:  
 Value Percent:  
 Continuous Index:  
 Within 8" of Joint: **YES**  
 Remarks:

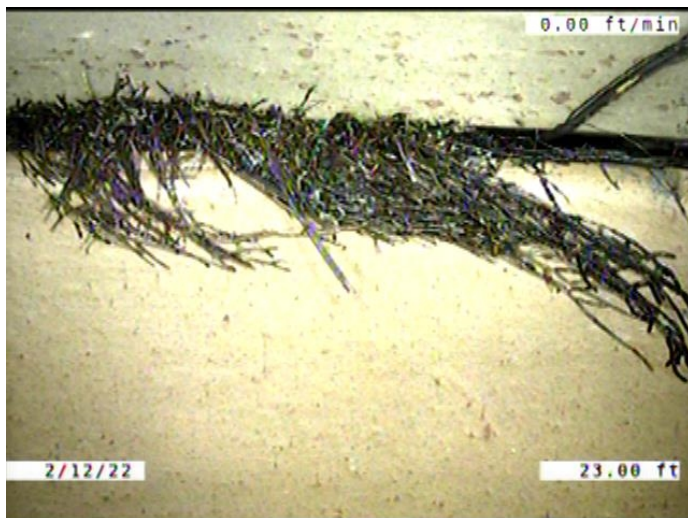
Code: **RFJ**  
 Description: **Roots Fine Joint**

Distance (ft): **23.0**  
 Structural Grade: **0**  
 O&M Grade: **1**  
 Clock Start/From: **7**  
 Clock To: **5**  
 1st Value:  
 2nd Value:  
 Value Percent:  
 Continuous Index: **S01**  
 Within 8" of Joint: **YES**  
 Remarks:

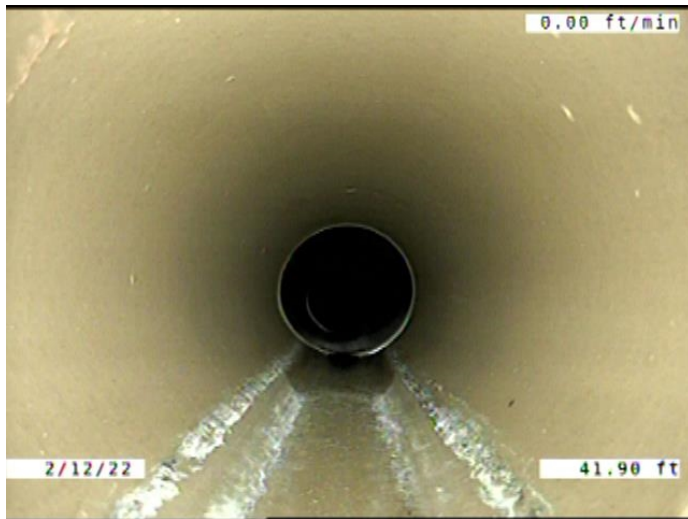
Code: **RFJ**  
 Description: **Roots Fine Joint**

Distance (ft): **41.9**  
 Structural Grade: **0**  
 O&M Grade: **1**  
 Clock Start/From: **7**  
 Clock To: **5**  
 1st Value:  
 2nd Value:  
 Value Percent:  
 Continuous Index: **F01**  
 Within 8" of Joint: **YES**  
 Remarks:

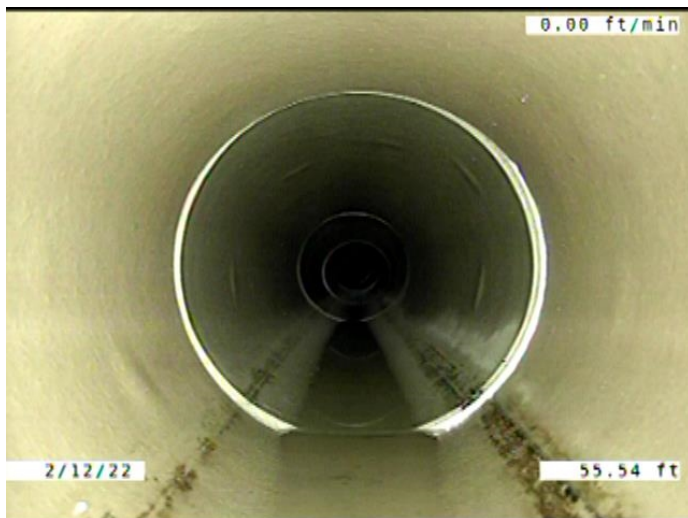
Code: **MWLS**  
 Description: **Miscellaneous Water Level Sag**

Distance (ft): **55.5**  
 Structural Grade: **2**  
 O&M Grade: **0**  
 Clock Start/From:  
 Clock To:  
 1st Value:  
 2nd Value:  
 Value Percent: **5.000**  
 Continuous Index: **S02**  
 Within 8" of Joint: **NO**  
 Remarks:

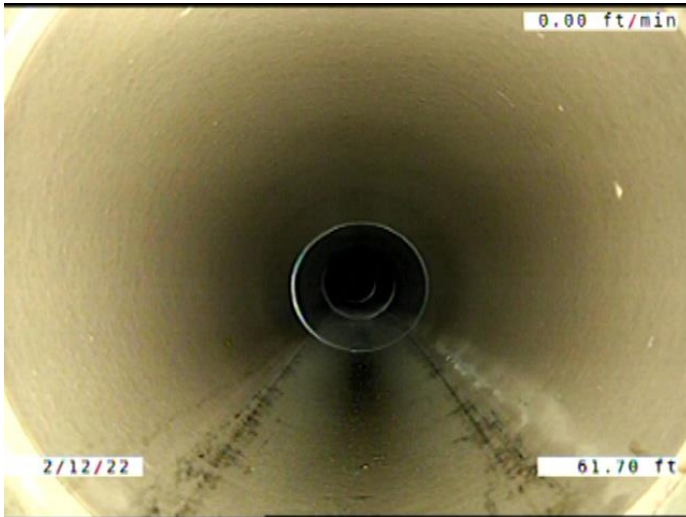
Code: **MWLS**  
Description: **Miscellaneous Water Level Sag**

Distance (ft): **61.7**  
Structural Grade: **2**  
O&M Grade: **0**  
Clock Start/From:  
Clock To:  
1st Value:  
2nd Value:  
Value Percent: **5.000**  
Continuous Index: **F02**  
Within 8" of Joint: **NO**  
Remarks:

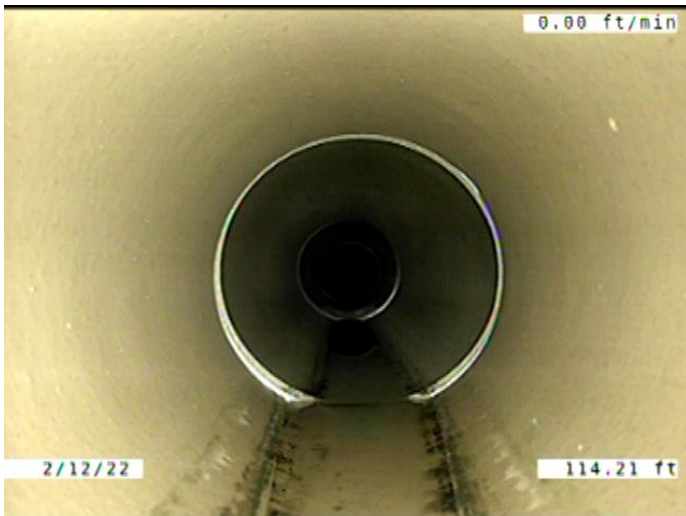
Code: **MWLS**  
Description: **Miscellaneous Water Level Sag**

Distance (ft): **114.2**  
Structural Grade: **2**  
O&M Grade: **0**  
Clock Start/From:  
Clock To:  
1st Value:  
2nd Value:  
Value Percent: **5.000**  
Continuous Index: **S03**  
Within 8" of Joint: **NO**  
Remarks:

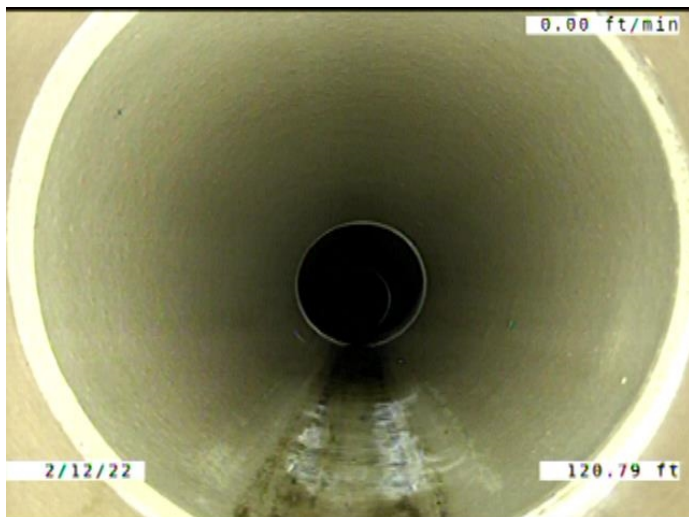
Code: **MWLS**  
Description: **Miscellaneous Water Level Sag**

Distance (ft): **120.8**  
Structural Grade: **2**  
O&M Grade: **0**  
Clock Start/From:  
Clock To:  
1st Value:  
2nd Value:  
Value Percent: **5.000**  
Continuous Index: **F03**  
Within 8" of Joint: **NO**  
Remarks:

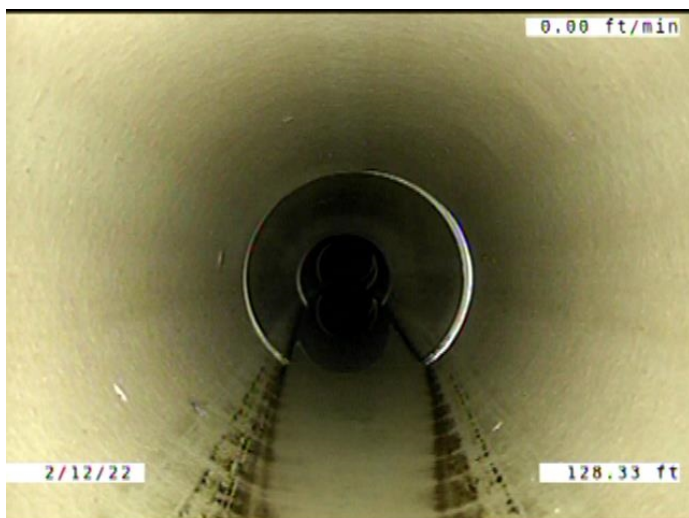
Code: **MWLS**  
Description: **Miscellaneous Water Level Sag**

Distance (ft): **128.3**  
Structural Grade: **2**  
O&M Grade: **0**  
Clock Start/From:  
Clock To:  
1st Value:  
2nd Value:  
Value Percent: **10.000**  
Continuous Index: **S04**  
Within 8" of Joint: **NO**  
Remarks:

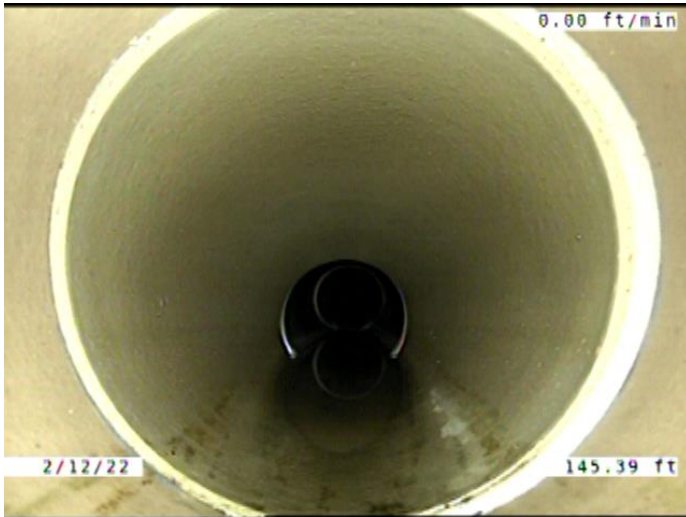
Code: **MWLS**  
Description: **Miscellaneous Water Level Sag**

Distance (ft): **145.4**  
Structural Grade: **2**  
O&M Grade: **0**  
Clock Start/From:  
Clock To:  
1st Value:  
2nd Value:  
Value Percent: **10.000**  
Continuous Index: **F04**  
Within 8" of Joint: **NO**  
Remarks:

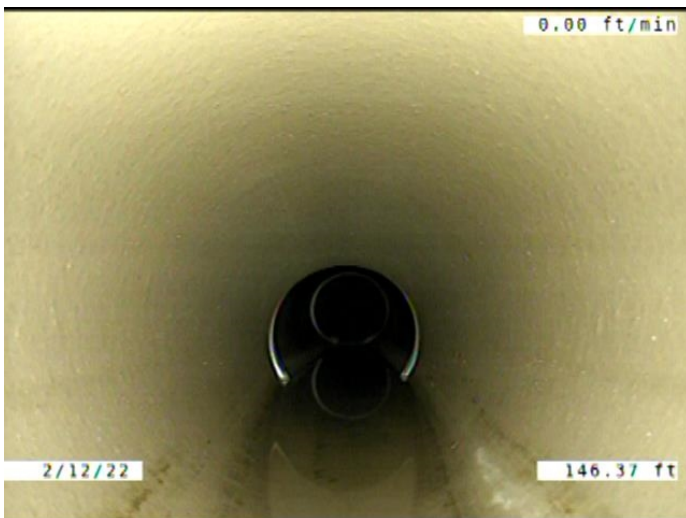
Code: **MWLS**  
Description: **Miscellaneous Water Level Sag**

Distance (ft): **146.4**  
Structural Grade: **2**  
O&M Grade: **0**  
Clock Start/From:  
Clock To:  
1st Value:  
2nd Value:  
Value Percent: **10.000**  
Continuous Index: **S05**  
Within 8" of Joint: **NO**  
Remarks:

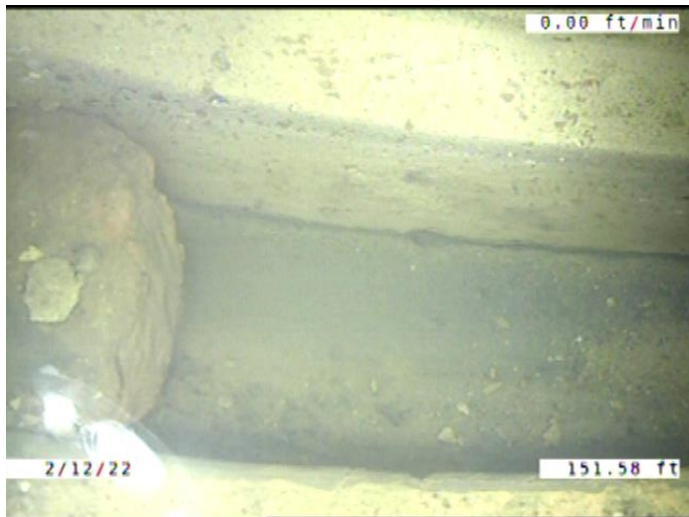
Code: **JAM**  
 Description: **Joint Angular Medium**

Distance (ft): **151.6**  
 Structural Grade: **3**  
 O&M Grade: **0**  
 Clock Start/From:  
 Clock To:  
 1st Value:  
 2nd Value:  
 Value Percent:  
 Continuous Index:  
 Within 8" of Joint: **NO**  
 Remarks:

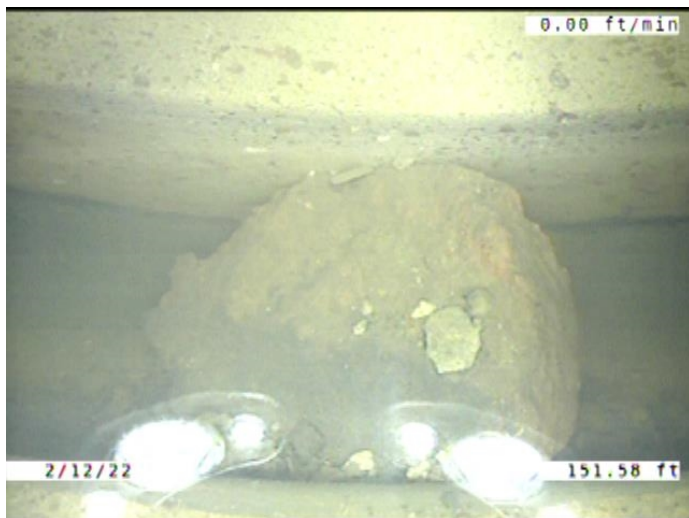
Code: **OBJ**  
 Description: **Obstruction Wedged In The Joint**

Distance (ft): **151.6**  
 Structural Grade: **0**  
 O&M Grade: **2**  
 Clock Start/From: **6**  
 Clock To:  
 1st Value:  
 2nd Value:  
 Value Percent: **5.000**  
 Continuous Index:  
 Within 8" of Joint: **YES**  
 Remarks:

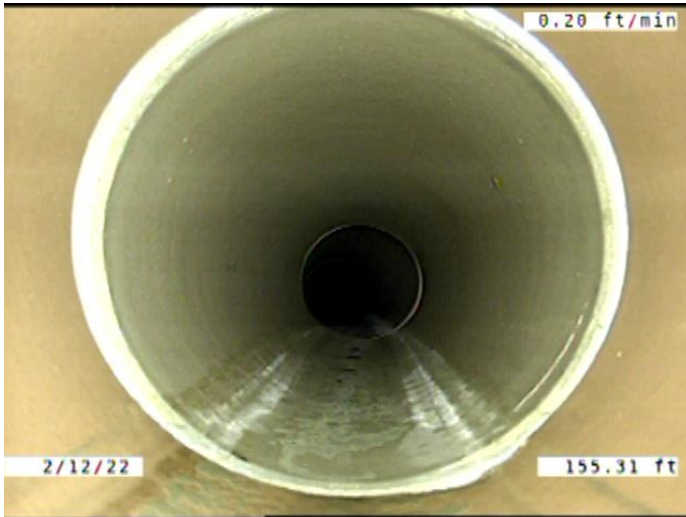
Code: **MWLS**  
Description: **Miscellaneous Water Level Sag**

Distance (ft): **155.3**  
Structural Grade: **2**  
O&M Grade: **0**  
Clock Start/From:  
Clock To:  
1st Value:  
2nd Value:  
Value Percent: **10.000**  
Continuous Index: **F05**  
Within 8" of Joint: **NO**  
Remarks:

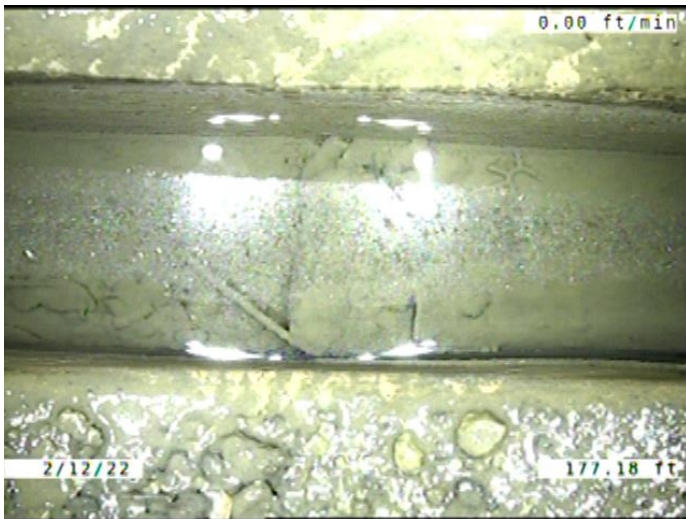
Code: **JAM**  
Description: **Joint Angular Medium**

Distance (ft): **177.2**  
Structural Grade: **3**  
O&M Grade: **0**  
Clock Start/From:  
Clock To:  
1st Value:  
2nd Value:  
Value Percent:  
Continuous Index:  
Within 8" of Joint: **NO**  
Remarks:

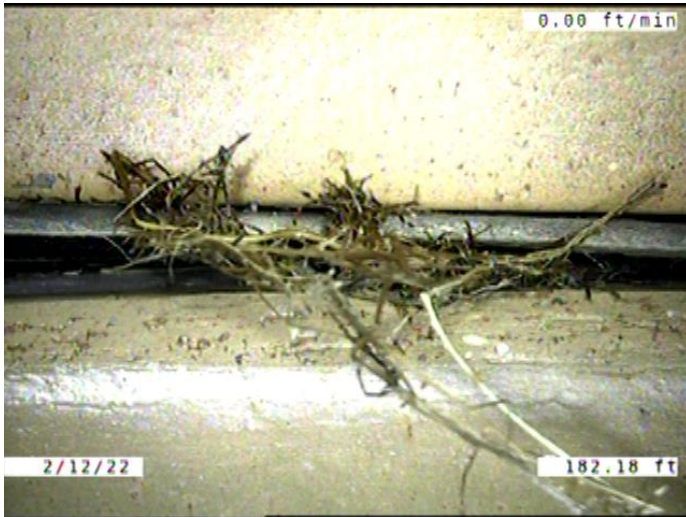
Code: **RFJ**  
Description: **Roots Fine Joint**

Distance (ft): **182.2**  
Structural Grade: **0**  
O&M Grade: **1**  
Clock Start/From: **8**  
Clock To: **4**  
1st Value:  
2nd Value:  
Value Percent:  
Continuous Index:  
Within 8" of Joint: **YES**  
Remarks:

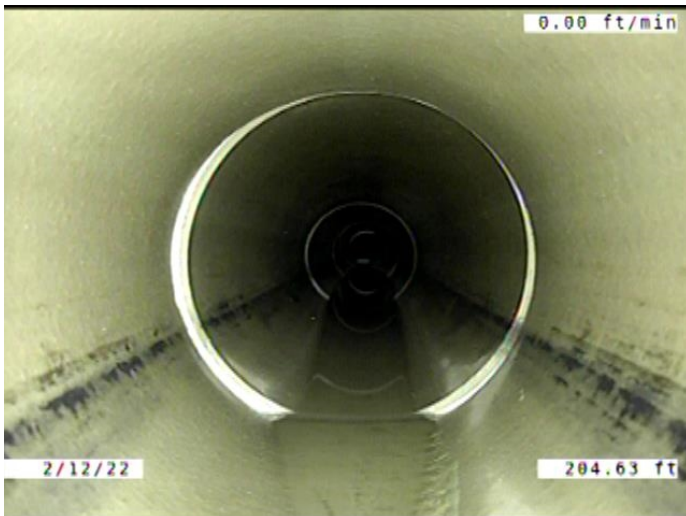
Code: **MWLS**  
Description: **Miscellaneous Water Level Sag**

Distance (ft): **204.6**  
Structural Grade: **2**  
O&M Grade: **0**  
Clock Start/From:  
Clock To:  
1st Value:  
2nd Value:  
Value Percent: **5.000**  
Continuous Index: **S06**  
Within 8" of Joint: **NO**  
Remarks:

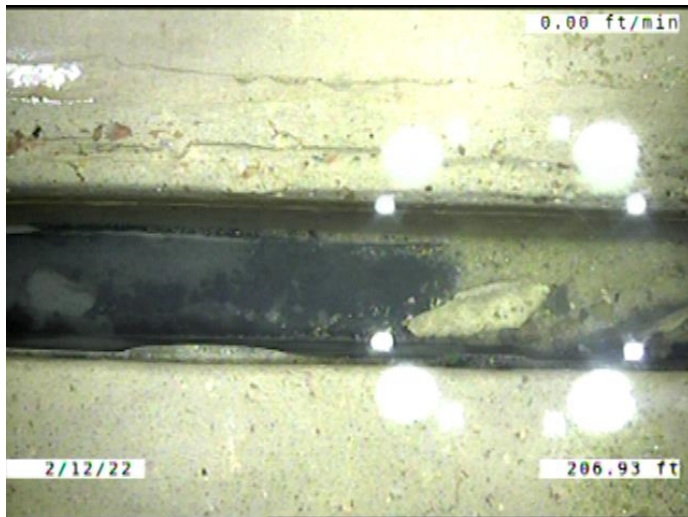
Code: **JAM**  
Description: **Joint Angular Medium**

Distance (ft): **206.9**  
Structural Grade: **3**  
O&M Grade: **0**  
Clock Start/From:  
Clock To:  
1st Value:  
2nd Value:  
Value Percent:  
Continuous Index:  
Within 8" of Joint: **NO**  
Remarks:

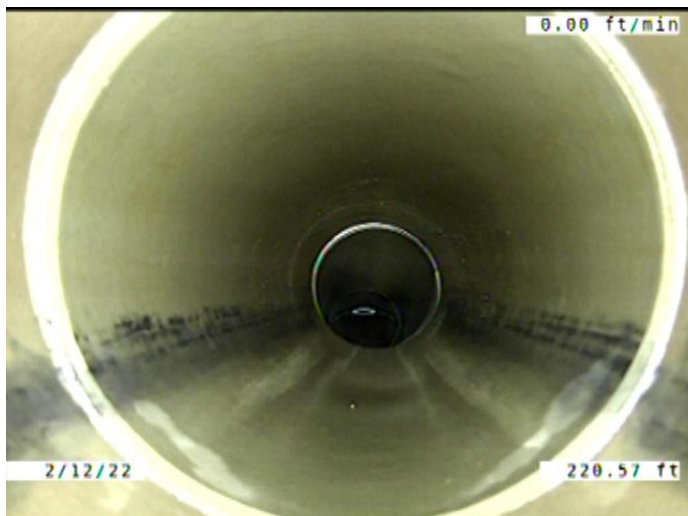
Code: **MWLS**  
Description: **Miscellaneous Water Level Sag**

Distance (ft): **220.6**  
Structural Grade: **2**  
O&M Grade: **0**  
Clock Start/From:  
Clock To:  
1st Value:  
2nd Value:  
Value Percent: **5.000**  
Continuous Index: **F06**  
Within 8" of Joint: **NO**  
Remarks:

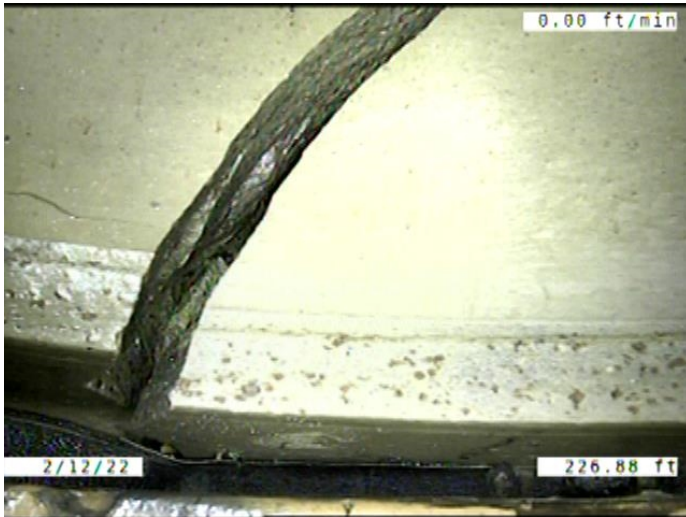
Code: **B**  
Description: **Broken**

Distance (ft): **226.9**  
Structural Grade: **4**  
O&M Grade: **0**  
Clock Start/From: **2**  
Clock To: **9**  
1st Value:  
2nd Value:  
Value Percent:  
Continuous Index:  
Within 8" of Joint: **YES**  
Remarks:

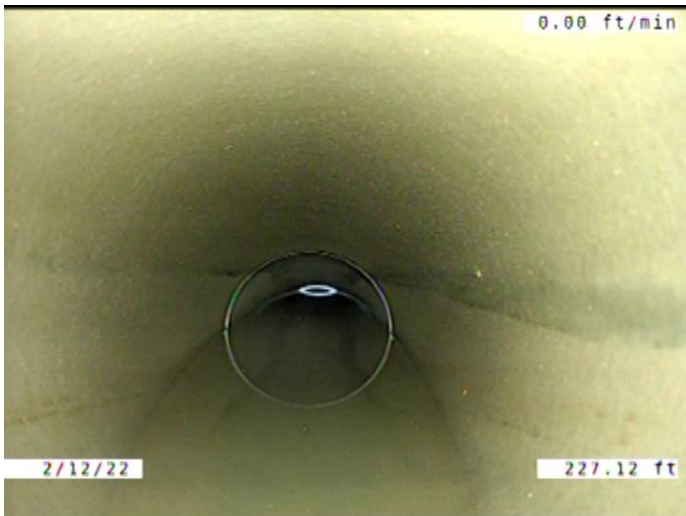
Code: **MWLS**  
Description: **Miscellaneous Water Level Sag**

Distance (ft): **227.1**  
Structural Grade: **5**  
O&M Grade: **0**  
Clock Start/From:  
Clock To:  
1st Value:  
2nd Value:  
Value Percent: **100.000**  
Continuous Index: **S07**  
Within 8" of Joint: **NO**  
Remarks:

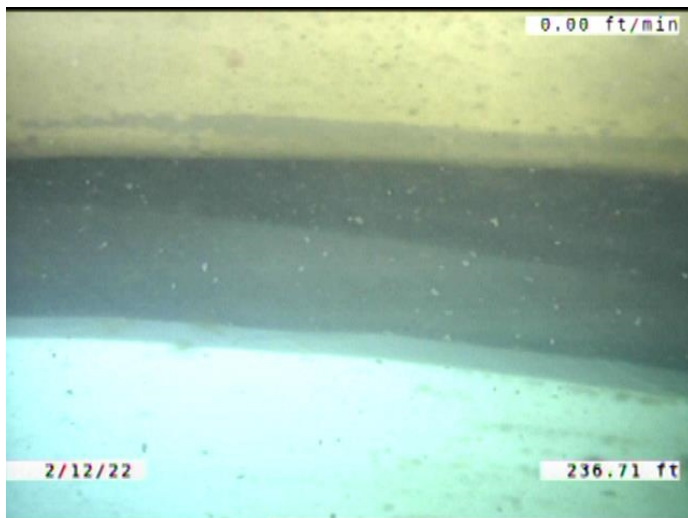
Code: **MMC**  
Description: **Miscellaneous Material Change**

Distance (ft): **236.7**  
Structural Grade: **0**  
O&M Grade: **0**  
Clock Start/From:  
Clock To:  
1st Value:  
2nd Value:  
Value Percent:  
Continuous Index:  
Within 8" of Joint: **NO**  
Remarks: **VCP TO PVC**

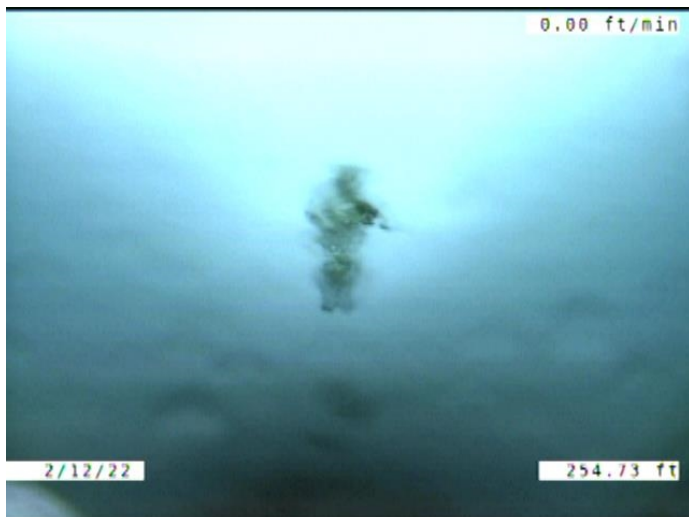
Code: **MCU**  
Description: **Miscellaneous Camera Underwater**

Distance (ft): **254.7**  
Structural Grade: **0**  
O&M Grade: **4**  
Clock Start/From:  
Clock To:  
1st Value:  
2nd Value:  
Value Percent:  
Continuous Index: **F08**  
Within 8" of Joint: **NO**  
Remarks:

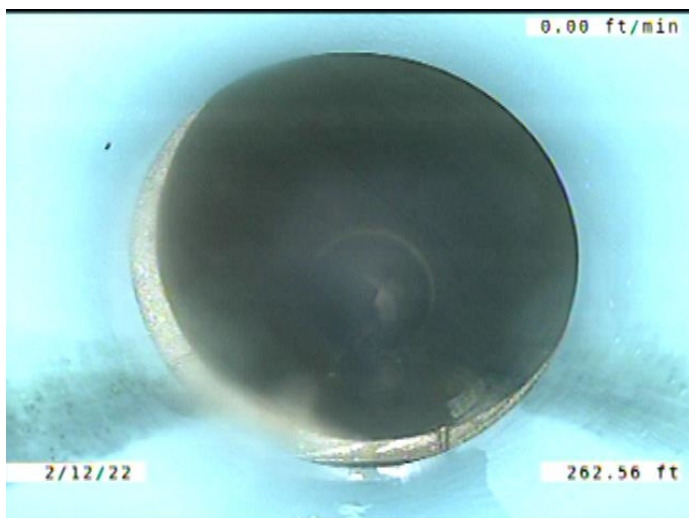
Code: **MWLS**  
Description: **Miscellaneous Water Level Sag**

Distance (ft): **262.6**  
Structural Grade: **5**  
O&M Grade: **0**  
Clock Start/From:  
Clock To:  
1st Value:  
2nd Value:  
Value Percent: **100.000**  
Continuous Index: **F07**  
Within 8" of Joint: **NO**  
Remarks:

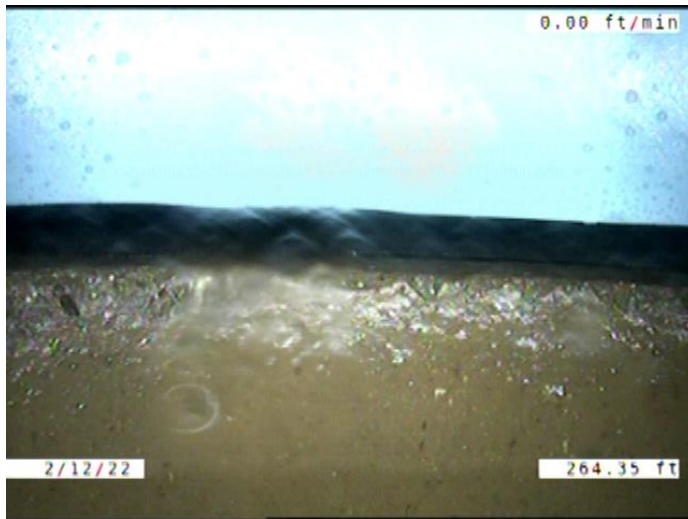
Code: **MMC**  
 Description: **Miscellaneous Material Change**

Distance (ft): **264.4**  
 Structural Grade: **0**  
 O&M Grade: **0**  
 Clock Start/From:  
 Clock To:  
 1st Value:  
 2nd Value:  
 Value Percent:  
 Continuous Index:  
 Within 8" of Joint: **NO**  
 Remarks: **PVC TO VCP**

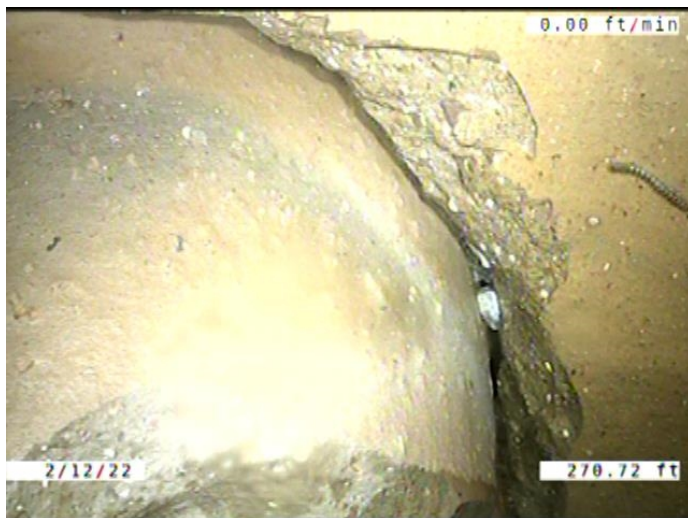
Code: **SSS**  
 Description: **Surface Damage Surface Spalling**

Distance (ft): **270.7**  
 Structural Grade: **2**  
 O&M Grade: **0**  
 Clock Start/From: **1**  
 Clock To: **3**  
 1st Value:  
 2nd Value:  
 Value Percent:  
 Continuous Index:  
 Within 8" of Joint: **YES**  
 Remarks:

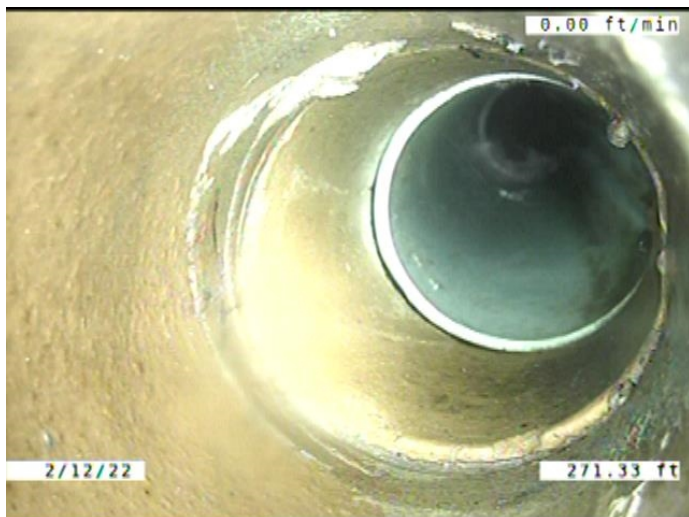
Code: **TBI**  
 Description: **Tap Break-in Intruding**

Distance (ft): **271.3**  
 Structural Grade: **0**  
 O&M Grade: **2**  
 Clock Start/From: **2**  
 Clock To:  
 1st Value: **6.000**  
 2nd Value: **3.000**  
 Value Percent:  
 Continuous Index:  
 Within 8" of Joint: **YES**  
 Remarks: **Active**

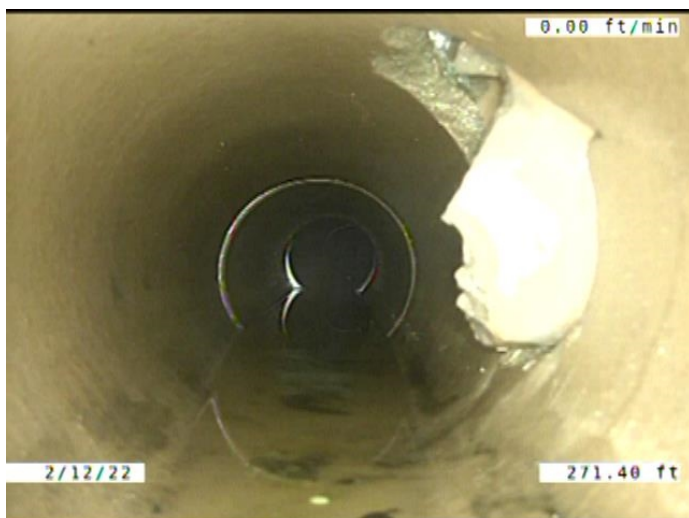
Code: **MSA**  
 Description: **Miscellaneous Survey Abandoned**

Distance (ft): **271.4**  
 Structural Grade: **0**  
 O&M Grade: **0**  
 Clock Start/From:  
 Clock To:  
 1st Value:  
 2nd Value:  
 Value Percent:  
 Continuous Index:  
 Within 8" of Joint: **NO**  
 Remarks: **CAMERA CANT MAKE IT PAST PROTRUDING TAP.**
