Profile/Photo Observation Report

Street:	LINCOLN ST & E 11TH ST	Flow Control:	Not Controlled
City:	Hobart, IN	Year Renewed:	
Location:	Light Highway	Tape/Media #:	
Purpose:	Maintenance Related	Dia/Height:	8"
Use:	Sanitary	Material:	PVC
Drain Area:	NA	Lining:	Cured in Place
Category:	NA		
Comment:	Reverse setup. heavy blk silt at 32'.-flow incorrect.		
Location Details:		Direction of Survey:	Upstream
US MH:	M-707-031	DS MH:	M-707-030
		Total Length Surveyed (ft):	33.6

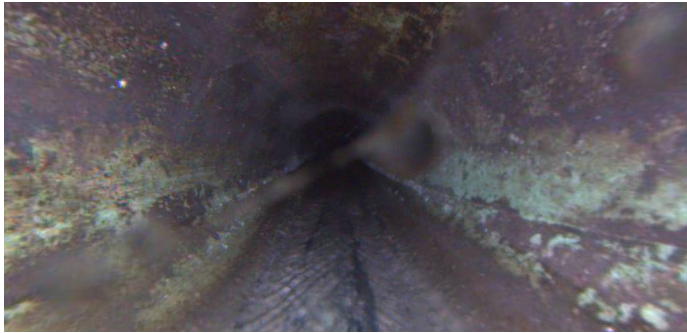
Code: **MWL**
Description: **Water Level**

Distance (ft): **.0**
Structural Grade: **0**
O&M Grade: **0**
Clock Start/From:
Clock To:
1st Value:
2nd Value:
Value Percent: **5.000**
Continuous Index:
Within 8" of Joint: **NO**
Remarks:

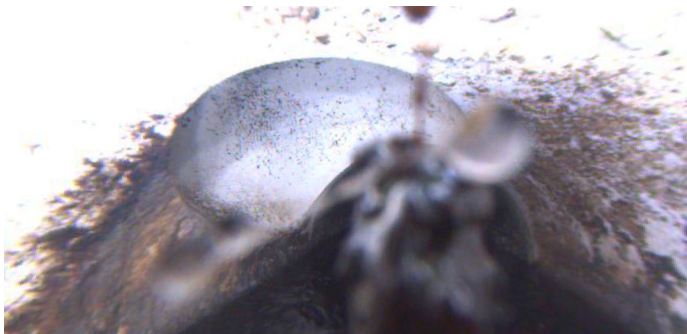
Code: **TF**
Description: **Tap Factory**

Distance (ft): **33.1**
Structural Grade: **0**
O&M Grade: **0**
Clock Start/From: **10**
Clock To:
1st Value: **4.000**
2nd Value:
Value Percent:
Continuous Index:
Within 8" of Joint:
Remarks:

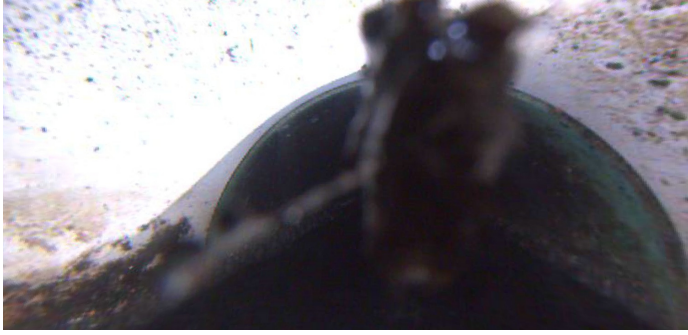
Code:	MSA
Description:	Abandoned Survey
Distance (ft):	33.6
Structural Grade:	0
O&M Grade:	0
Clock Start/From:	
Clock To:	
1st Value:	
2nd Value:	
Value Percent:	
Continuous Index:	
Within 8" of Joint:	NO
Remarks:	debris under water
