Profile/Photo Observation Report

Date:	04/13/2018	Weather:		Coding:	PACP 6.0
Pipe Length (ft):	227.6	Owner:	NA	Pre Clean:	Not Known
P.O.#:		Surveyor:	Jen Costello	PSR:	P-707-030-031
Customer:		Clean Date:	01/01/1900	Shape:	C

Street:	Capitol	Flow Control:	Not Controlled
City:	Hobart, IN	Year Renewed:	
Location:	Light Highway	Tape/Media #:	
Purpose:	Maintenance Related	Dia/Height:	8"
Use:	Sanitary	Material:	PVC
Drain Area:	NA	Lining:	Cured in Place
Category:	NA		
Comment:	Reverse setup. heavy blk silt at 32'. -flow incorrect.		
Location Details:		Direction of Survey:	Upstream
US MH:	M-707-031	DS MH:	M-707-030
		Total Length Surveyed (ft):	33.6

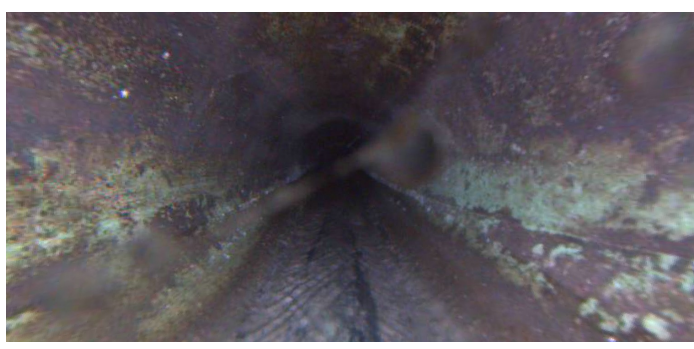
Code: **AMH**
Description: **Manhole**

Distance (ft): **.0**
Structural Grade: **0**
O&M Grade: **0**
Clock Start/From:
Clock To:
1st Value:
2nd Value:
Value Percent:
Continuous Index:
Within 8" of Joint: **NO**
Remarks: **M-707-030**

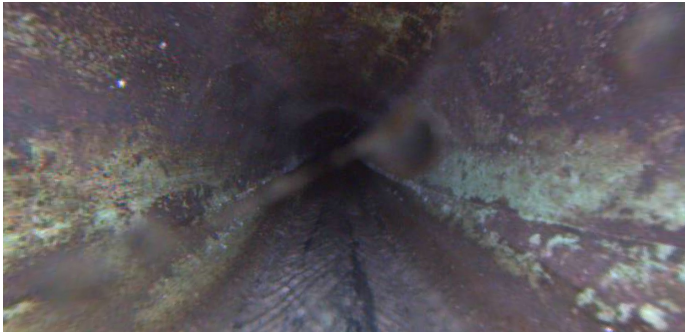
Code:	MWL
Description:	Water Level

Distance (ft):	.0
Structural Grade:	0
O&M Grade:	0
Clock Start/From:	
Clock To:	
1st Value:	
2nd Value:	
Value Percent:	5.000
Continuous Index:	
Within 8" of Joint:	NO
Remarks:

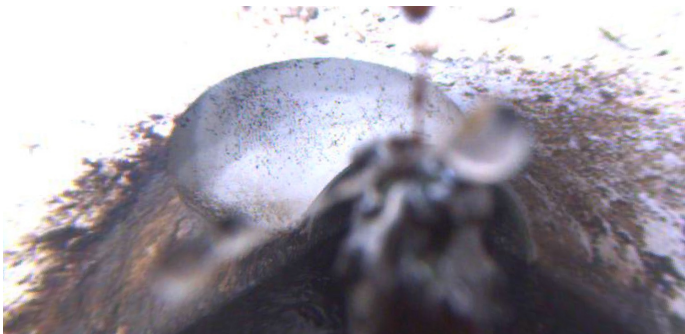
Code:	TF
Description:	Tap Factory

Distance (ft):	33.1
Structural Grade:	0
O&M Grade:	0
Clock Start/From:	10
Clock To:	
1st Value:	4.000
2nd Value:	
Value Percent:	
Continuous Index:	
Within 8" of Joint:	
Remarks:

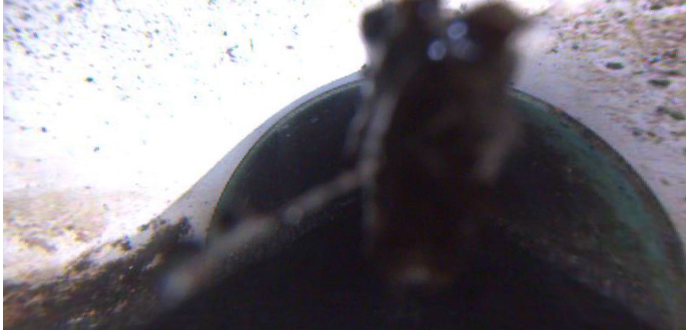
Code:	MSA
Description:	Abandoned Survey
Distance (ft):	33.6
Structural Grade:	0
O&M Grade:	0
Clock Start/From:	
Clock To:	
1st Value:	
2nd Value:	
Value Percent:	
Continuous Index:	
Within 8" of Joint:	NO
Remarks:	debris under water
