Profile/Photo Observation Report

Street:	LINCOLN ST & E 11TH ST	Flow Control:	Not Controlled
City:	Hobart, IN	Year Renewed:	
Location:	Light Highway	Tape/Media #:	
Purpose:	Maintenance Related	Dia/Height:	8"
Use:	Sanitary	Material:	PVC
Drain Area:	NA	Lining:	Cured in Place
Category:	NA		
Comment:	black silt at 161'.-flow incorrect.

Location Details:		Direction of Survey:	Downstream
US MH:	M-707-031	DS MH:	M-707-030
		Total Length Surveyed (ft):	162.8

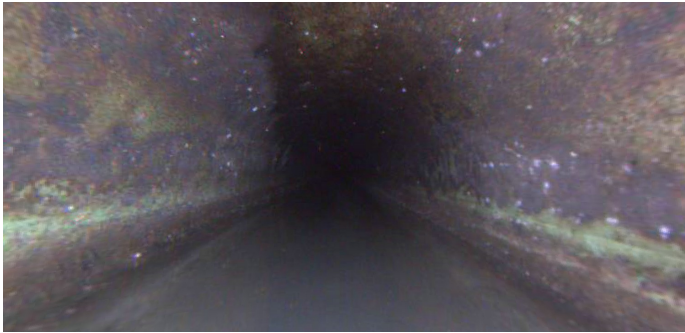
Code:	MWL
Description:	Water Level

Distance (ft):	.0
Structural Grade:	0
O&M Grade:	0
Clock Start/From:	
Clock To:	
1st Value:	
2nd Value:	
Value Percent:	20.000
Continuous Index:	
Within 8" of Joint:	NO
Remarks:

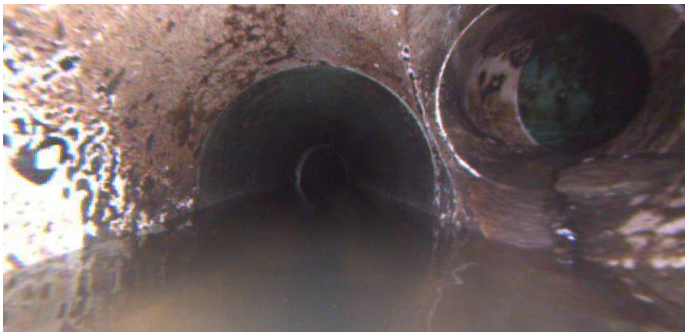
Code:	TF
Description:	Tap Factory

Distance (ft):	33.2
Structural Grade:	0
O&M Grade:	0
Clock Start/From:	3
Clock To:	
1st Value:	4.000
2nd Value:	
Value Percent:	
Continuous Index:	
Within 8" of Joint:	
Remarks:

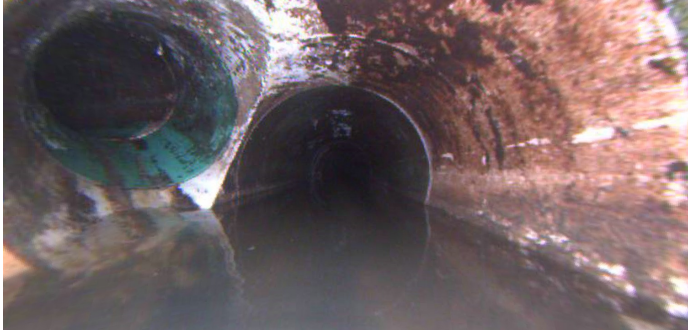
Code: **TF**
Description: **Tap Factory**

Distance (ft): **36.3**
Structural Grade: **0**
O&M Grade: **0**
Clock Start/From: **9**
Clock To:
1st Value: **4.000**
2nd Value:
Value Percent:
Continuous Index:
Within 8" of Joint:
Remarks:

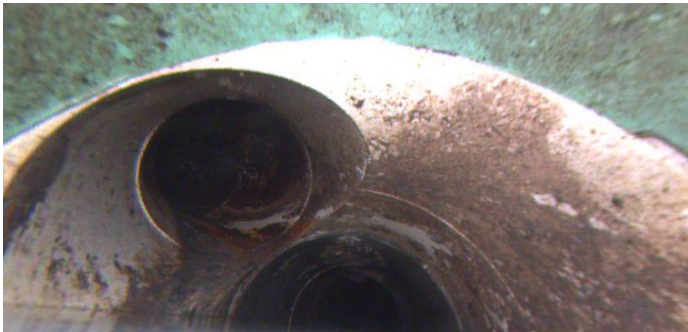
Code: **TF**
Description: **Tap Factory**

Distance (ft): **78.1**
Structural Grade: **0**
O&M Grade: **0**
Clock Start/From: **11**
Clock To:
1st Value: **4.000**
2nd Value:
Value Percent:
Continuous Index:
Within 8" of Joint:
Remarks:

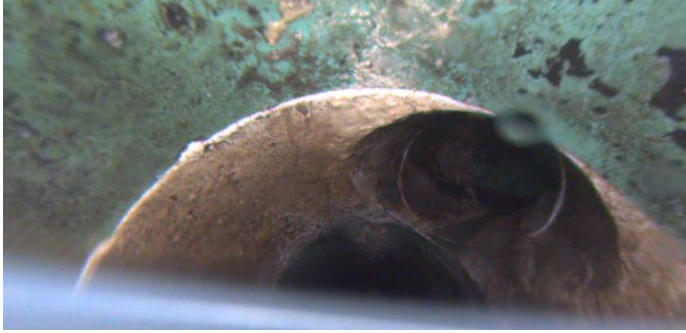
Code: **TF**
Description: **Tap Factory**

Distance (ft): **79.5**
Structural Grade: **0**
O&M Grade: **0**
Clock Start/From: **1**
Clock To:
1st Value: **4.000**
2nd Value:
Value Percent:
Continuous Index:
Within 8" of Joint:
Remarks:

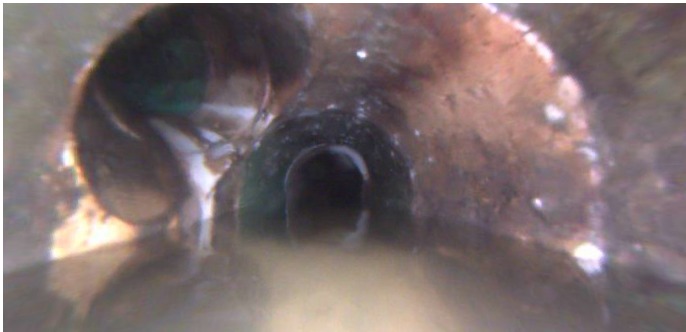
Code: **TFA**
Description: **Tap Factory Active**

Distance (ft): **128.2**
Structural Grade: **0**
O&M Grade: **0**
Clock Start/From: **10**
Clock To:
1st Value: **4.000**
2nd Value:
Value Percent:
Continuous Index:
Within 8" of Joint:
Remarks:

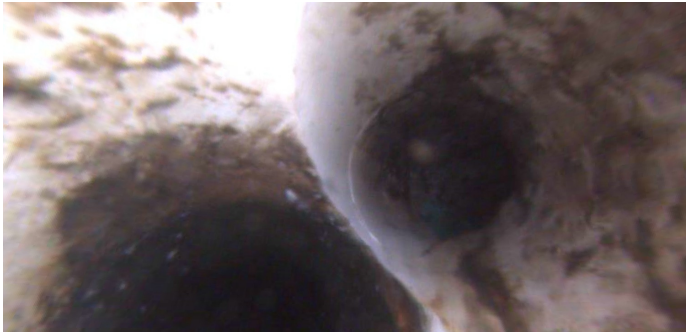
Code: **TF**
Description: **Tap Factory**

Distance (ft): **130.5**
Structural Grade: **0**
O&M Grade: **0**
Clock Start/From: **2**
Clock To:
1st Value: **4.000**
2nd Value:
Value Percent:
Continuous Index:
Within 8" of Joint:
Remarks:

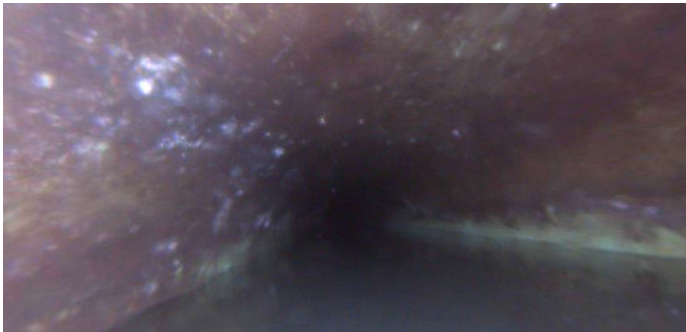
Code: **MSA**
Description: **Abandoned Survey**

Distance (ft): **162.8**
Structural Grade: **0**
O&M Grade: **0**
Clock Start/From:
Clock To:
1st Value:
2nd Value:
Value Percent:
Continuous Index:
Within 8" of Joint: **NO**
Remarks: **debris under water**
