Profile/Photo Observation Report

Date:	04/13/2018	Weather:		Coding:	PACP 6.0
Pipe Length (ft):	227.6	Owner:	NA	Pre Clean:	Not Known
P.O.#:		Surveyor:	Jen Costello	PSR:	P-707-030-031
Customer:		Clean Date:	01/01/1900	Shape:	C

Street:	Capitol	Flow Control:	Not Controlled
City:	Hobart, IN	Year Renewed:	
Location:	Light Highway	Tape/Media #:	
Purpose:	Maintenance Related	Dia/Height:	8"
Use:	Sanitary	Material:	PVC
Drain Area:	NA	Lining:	Cured in Place
Category:	NA		
Comment:	black silt at 161'.-flow incorrect.		
Location Details:		Direction of Survey:	Downstream
US MH:	M-707-031	DS MH:	M-707-030
		Total Length Surveyed (ft):	162.8

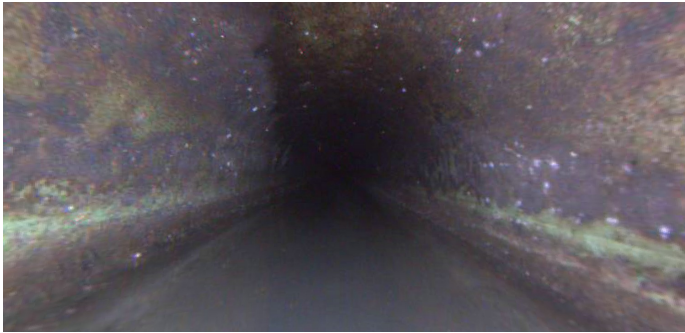
Code:	MWL
Description:	Water Level

Distance (ft):	.0
Structural Grade:	0
O&M Grade:	0
Clock Start/From:	
Clock To:	
1st Value:	
2nd Value:	
Value Percent:	20.000
Continuous Index:	
Within 8" of Joint:	NO
Remarks:

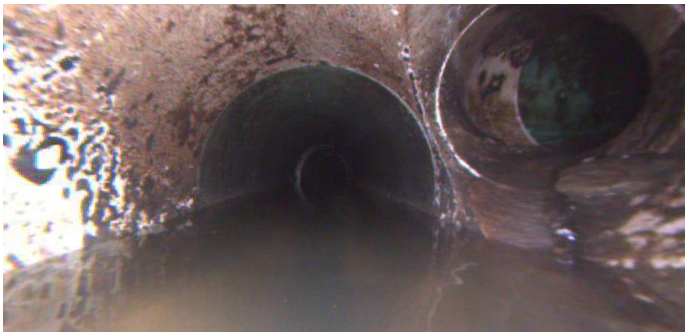
Code:	TF
Description:	Tap Factory

Distance (ft):	33.2
Structural Grade:	0
O&M Grade:	0
Clock Start/From:	3
Clock To:	
1st Value:	4.000
2nd Value:	
Value Percent:	
Continuous Index:	
Within 8" of Joint:	
Remarks:

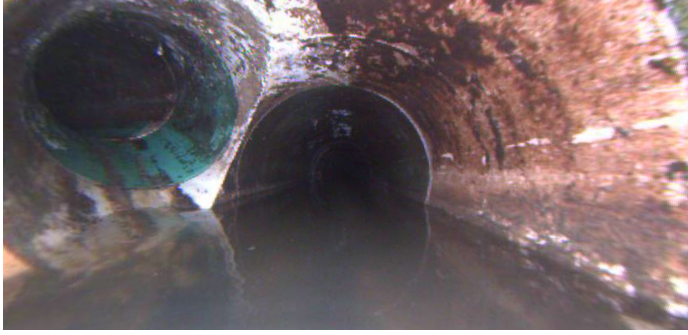
Code: **TF**
Description: **Tap Factory**

Distance (ft): **36.3**
Structural Grade: **0**
O&M Grade: **0**
Clock Start/From: **9**
Clock To:
1st Value: **4.000**
2nd Value:
Value Percent:
Continuous Index:
Within 8" of Joint:
Remarks:

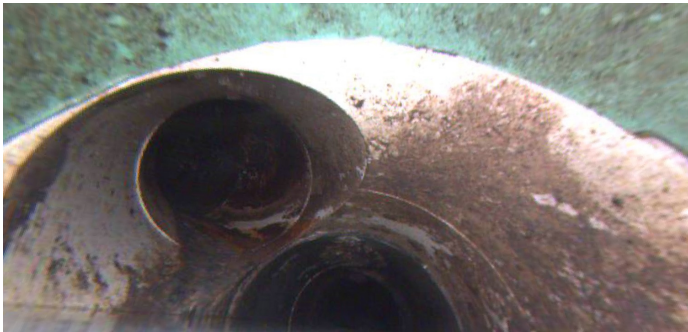
Code: **TF**
Description: **Tap Factory**

Distance (ft): **78.1**
Structural Grade: **0**
O&M Grade: **0**
Clock Start/From: **11**
Clock To:
1st Value: **4.000**
2nd Value:
Value Percent:
Continuous Index:
Within 8" of Joint:
Remarks:

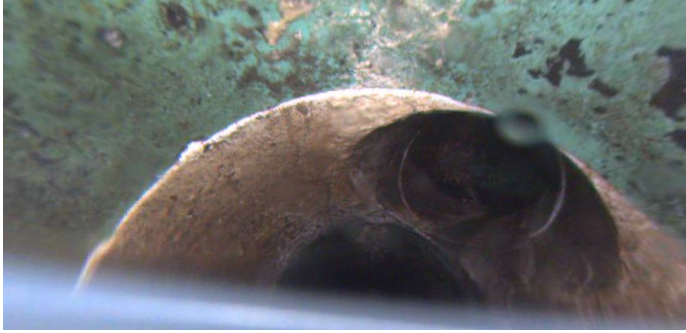
Code: **TF**
Description: **Tap Factory**

Distance (ft): **79.5**
Structural Grade: **0**
O&M Grade: **0**
Clock Start/From: **1**
Clock To:
1st Value: **4.000**
2nd Value:
Value Percent:
Continuous Index:
Within 8" of Joint:
Remarks:

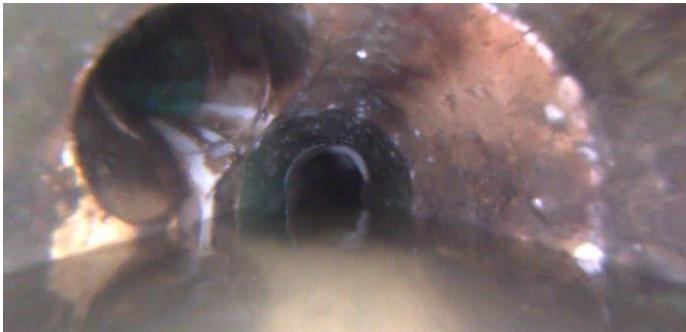
Code: **TFA**
Description: **Tap Factory Active**

Distance (ft): **128.2**
Structural Grade: **0**
O&M Grade: **0**
Clock Start/From: **10**
Clock To:
1st Value: **4.000**
2nd Value:
Value Percent:
Continuous Index:
Within 8" of Joint:
Remarks:

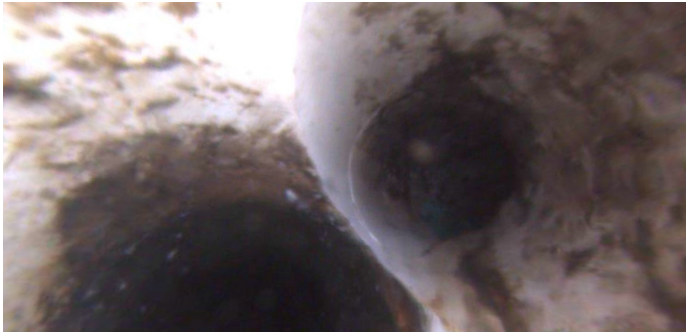
Code: **TF**
Description: **Tap Factory**

Distance (ft): **130.5**
Structural Grade: **0**
O&M Grade: **0**
Clock Start/From: **2**
Clock To:
1st Value: **4.000**
2nd Value:
Value Percent:
Continuous Index:
Within 8" of Joint:
Remarks:

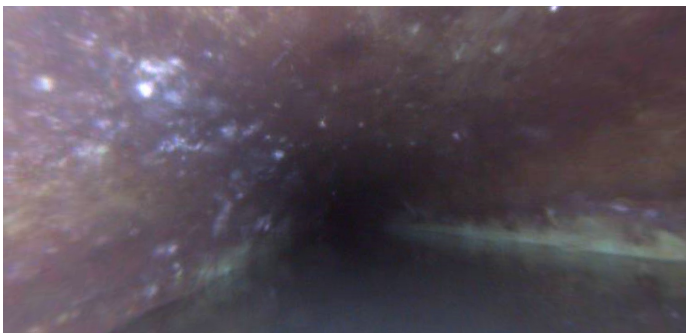
Code: **MSA**
Description: **Abandoned Survey**

Distance (ft): **162.8**
Structural Grade: **0**
O&M Grade: **0**
Clock Start/From:
Clock To:
1st Value:
2nd Value:
Value Percent:
Continuous Index:
Within 8" of Joint: **NO**
Remarks: **debris under water**
