Profile/Photo Observation Report

Date:	04/13/2018	Weather:		Coding:	PACP 6.0
Pipe Length (ft):	230.8	Owner:	NA	Pre Clean:	Not Known
P.O.#:		Surveyor:	Jen Costello	PSR:	P-707-031-032
Customer:		Clean Date:	01/01/1900	Shape:	C

Street:	LINCOLN ST	Flow Control:	Not Controlled
City:	Hobart, IN	Year Renewed:	
Location:	Light Highway	Tape/Media #:	
Purpose:	Maintenance Related	Dia/Height:	8"
Use:	Sanitary	Material:	VCP
Drain Area:	NA	Lining:	Cured in Place
Category:	NA		
Comment:	Reverse setup-heavy silt at 24'.flow incorrect.		
Location Details:		Direction of Survey:	Downstream
US MH:	M-707-032	DS MH:	M-707-031
		Total Length Surveyed (ft):	25.9

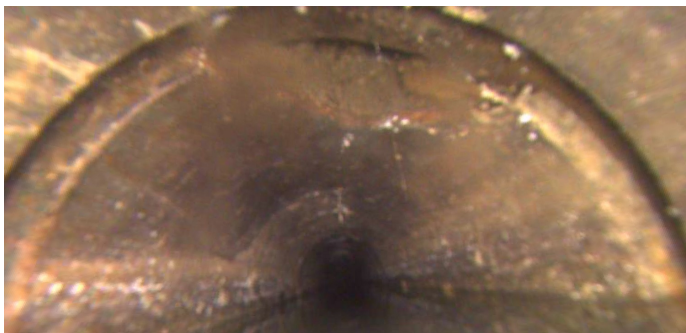
Code: **AMH**
Description: **Manhole**

Distance (ft): **.0**
Structural Grade: **0**
O&M Grade: **0**
Clock Start/From:
Clock To:
1st Value:
2nd Value:
Value Percent:
Continuous Index:
Within 8" of Joint: **NO**
Remarks: **M-707-032**

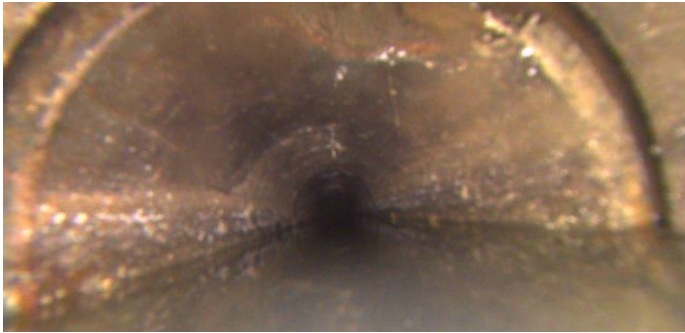
Code:	MWL
Description:	Water Level

Distance (ft):	.0
Structural Grade:	0
O&M Grade:	0
Clock Start/From:	
Clock To:	
1st Value:	
2nd Value:	
Value Percent:	40.000
Continuous Index:	
Within 8" of Joint:	NO
Remarks:

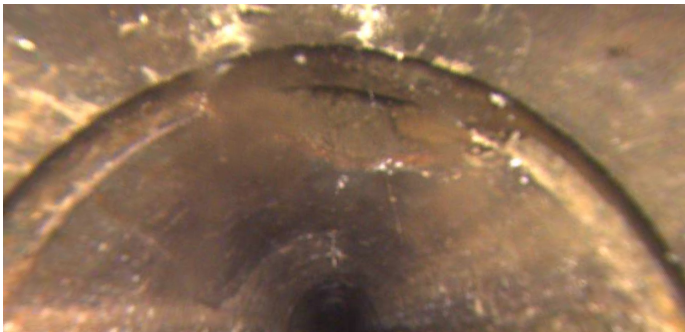
Code:	HSV
Description:	Hole Soil Visible

Distance (ft):	.0
Structural Grade:	5
O&M Grade:	0
Clock Start/From:	12
Clock To:	1
1st Value:	
2nd Value:	
Value Percent:	
Continuous Index:	
Within 8" of Joint:	YES
Remarks:

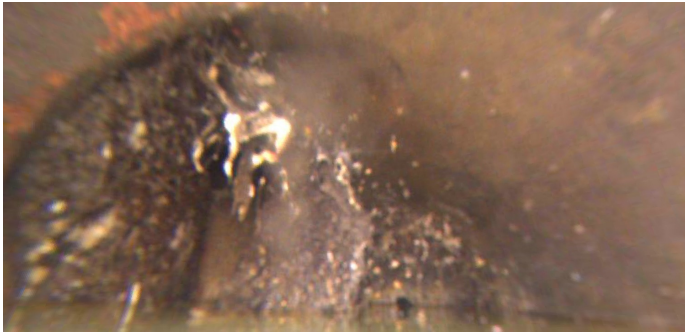
Code: **TFD**
Description: **Tap Factory Defective**

Distance (ft): **25.1**
Structural Grade: **0**
O&M Grade: **2**
Clock Start/From: **10**
Clock To:
1st Value: **4.000**
2nd Value:
Value Percent:
Continuous Index:
Within 8" of Joint:
Remarks: **roots**

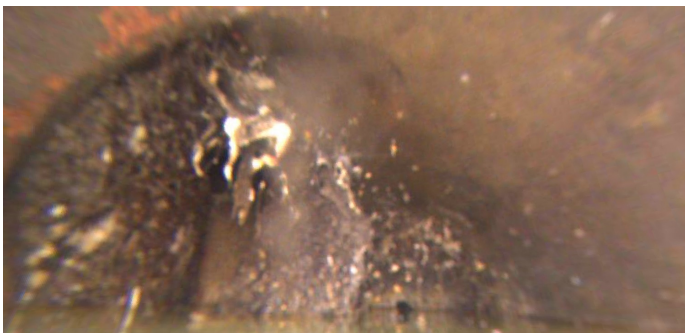
Code: **RML**
Description: **Roots Medium Lateral**

Distance (ft): **25.1**
Structural Grade: **0**
O&M Grade: **3**
Clock Start/From: **6**
Clock To: **12**
1st Value:
2nd Value:
Value Percent: **40.000**
Continuous Index:
Within 8" of Joint: **NO**
Remarks:

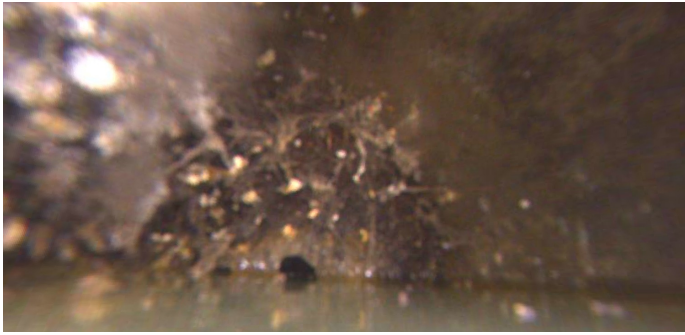
Code: **RBJ**
Description: **Roots Ball Joint**

Distance (ft): **25.7**
Structural Grade: **0**
O&M Grade: **4**
Clock Start/From: **8**
Clock To: **4**
1st Value:
2nd Value:
Value Percent: **90.000**
Continuous Index:
Within 8" of Joint: **YES**
Remarks:

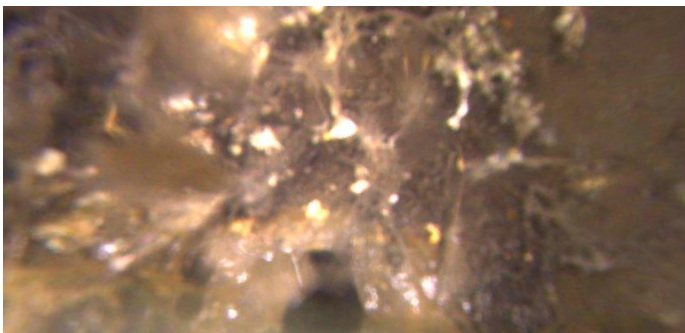
Code: **MSA**
Description: **Abandoned Survey**

Distance (ft): **25.9**
Structural Grade: **0**
O&M Grade: **0**
Clock Start/From:
Clock To:
1st Value:
2nd Value:
Value Percent:
Continuous Index:
Within 8" of Joint: **NO**
Remarks: **roots**
