Profile/Photo Observation Report

Date:	04/13/2018	Weather:		Coding:	PACP 6.0
Pipe Length (ft):	230.8	Owner:	NA	Pre Clean:	Not Known
P.O.#:		Surveyor:	Jen Costello	PSR:	P-707-031-032
Customer:		Clean Date:	01/01/1900	Shape:	C

Street:	Capitol	Flow Control:	Not Controlled
City:	Hobart, IN	Year Renewed:	
Location:	Light Highway	Tape/Media #:	
Purpose:	Maintenance Related	Dia/Height:	8"
Use:	Sanitary	Material:	VCP
Drain Area:	NA	Lining:	Cured in Place
Category:	NA		
Comment:	Reverse setup-heavy silt at 24'.flow incorrect.		
Location Details:		Direction of Survey:	Downstream
US MH:	M-707-032	DS MH:	M-707-031
		Total Length Surveyed (ft):	25.9

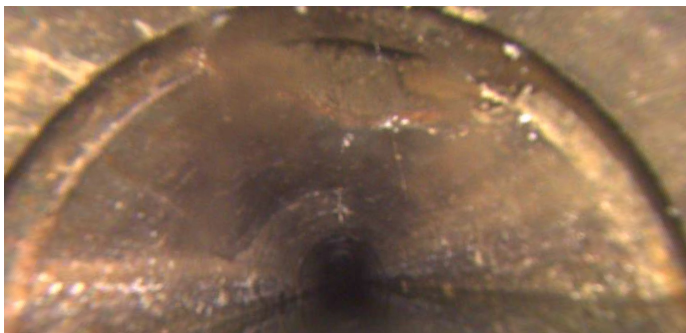
Code: **AMH**
Description: **Manhole**

Distance (ft): **.0**
Structural Grade: **0**
O&M Grade: **0**
Clock Start/From:
Clock To:
1st Value:
2nd Value:
Value Percent:
Continuous Index:
Within 8" of Joint: **NO**
Remarks: **M-707-032**

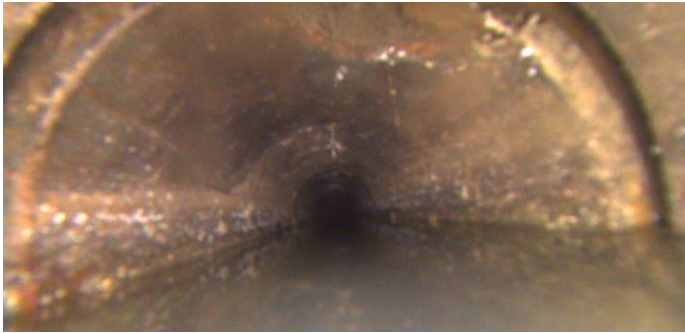
Code:	MWL
Description:	Water Level

Distance (ft):	.0
Structural Grade:	0
O&M Grade:	0
Clock Start/From:	
Clock To:	
1st Value:	
2nd Value:	
Value Percent:	40.000
Continuous Index:	
Within 8" of Joint:	NO
Remarks:

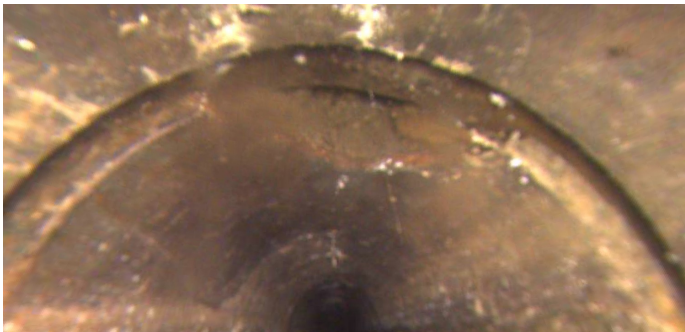
Code:	HSV
Description:	Hole Soil Visible

Distance (ft):	.0
Structural Grade:	5
O&M Grade:	0
Clock Start/From:	12
Clock To:	1
1st Value:	
2nd Value:	
Value Percent:	
Continuous Index:	
Within 8" of Joint:	YES
Remarks:

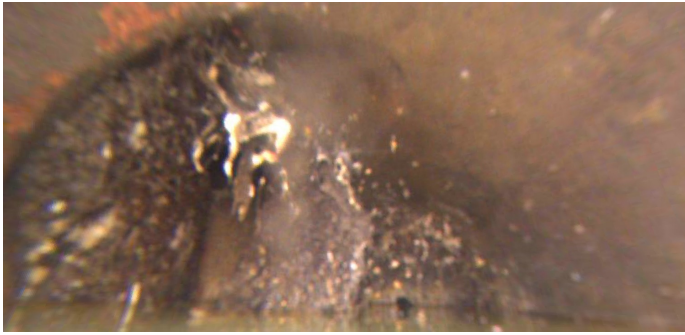
Code: **TFD**
Description: **Tap Factory Defective**

Distance (ft): **25.1**
Structural Grade: **0**
O&M Grade: **2**
Clock Start/From: **10**
Clock To:
1st Value: **4.000**
2nd Value:
Value Percent:
Continuous Index:
Within 8" of Joint:
Remarks: **roots**

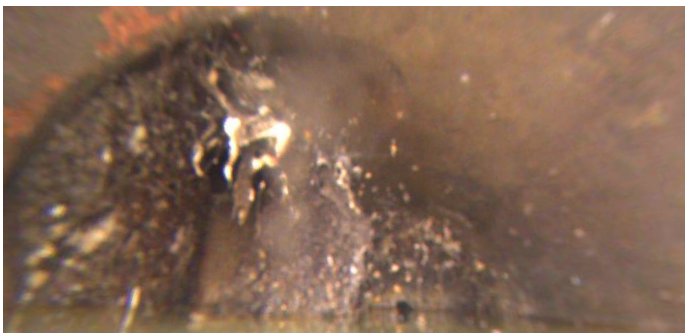
Code: **RML**
Description: **Roots Medium Lateral**

Distance (ft): **25.1**
Structural Grade: **0**
O&M Grade: **3**
Clock Start/From: **6**
Clock To: **12**
1st Value:
2nd Value:
Value Percent: **40.000**
Continuous Index:
Within 8" of Joint: **NO**
Remarks:

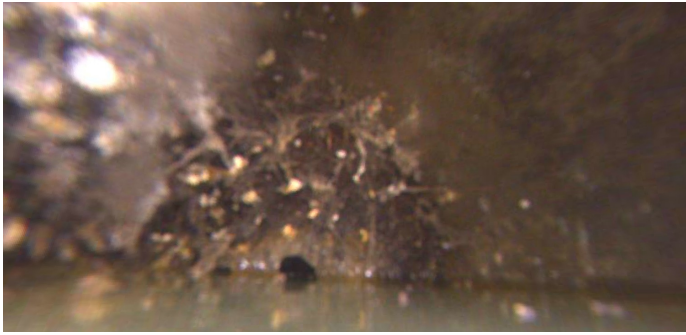
Code: **RBJ**
Description: **Roots Ball Joint**

Distance (ft): **25.7**
Structural Grade: **0**
O&M Grade: **4**
Clock Start/From: **8**
Clock To: **4**
1st Value:
2nd Value:
Value Percent: **90.000**
Continuous Index:
Within 8" of Joint: **YES**
Remarks:

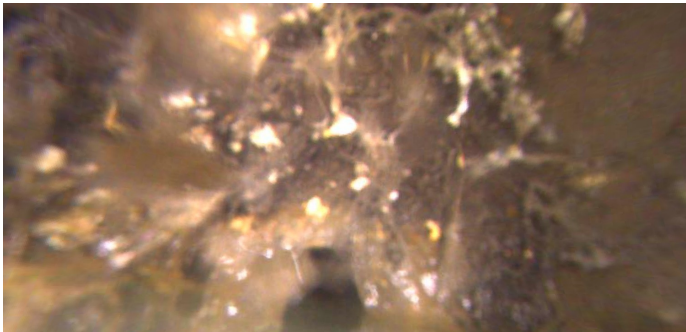
Code: **MSA**
Description: **Abandoned Survey**

Distance (ft): **25.9**
Structural Grade: **0**
O&M Grade: **0**
Clock Start/From:
Clock To:
1st Value:
2nd Value:
Value Percent:
Continuous Index:
Within 8" of Joint: **NO**
Remarks: **roots**
