## Profile/Photo Observation Report

Date:	<b>04/17/2018</b>	Weather:		Coding:	<b>PACP 6.0</b>
Pipe Length (ft):	<b>233.7</b>	Owner:	<b>NA</b>	Pre Clean:	<b>Not Known</b>
P.O.#:		Surveyor:	<b>Jen Costello</b>	PSR:	<b>P-707-032-033</b>
Customer:		Clean Date:	<b>01/01/1900</b>	Shape:	<b>C</b>

Street:	<b>LINCOLN ST</b>	Flow Control:	<b>Not Controlled</b>
City:	<b>Hobart, IN</b>	Year Renewed:	
Location:	<b>Light Highway</b>	Tape/Media #:	
Purpose:	<b>Maintenance Related</b>	Dia/Height:	<b>8"</b>
Use:	<b>Sanitary</b>	Material:	<b>VCP</b>
Drain Area:	<b>NA</b>	Lining:	<b>Cured in Place</b>
Category:	<b>NA</b>		
Comment:	<b>Reverse setup.roots at 9'.-flow incorrect.</b>		
Location Details:		Direction of Survey:	<b>Downstream</b>
US MH:	<b>M-707-033</b>	DS MH:	<b>M-707-032</b>
		Total Length Surveyed (ft):	<b>10.3</b>

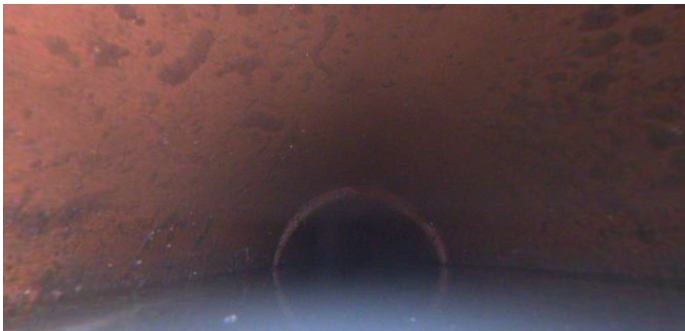
Code: **AMH**  
Description: **Manhole**

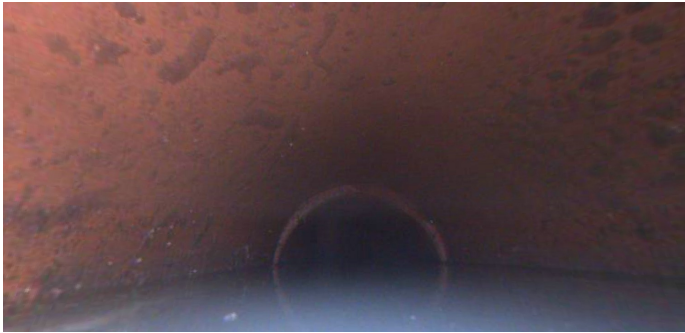
Code:	<b>MWL</b>
Description:	<b>Water Level</b>

Distance (ft):	<b>.0</b>
Structural Grade:	<b>0</b>
O&M Grade:	<b>0</b>
Clock Start/From:	
Clock To:	
1st Value:	
2nd Value:	
Value Percent:	<b>40.000</b>
Continuous Index:	
Within 8" of Joint:	<b>NO</b>
Remarks:

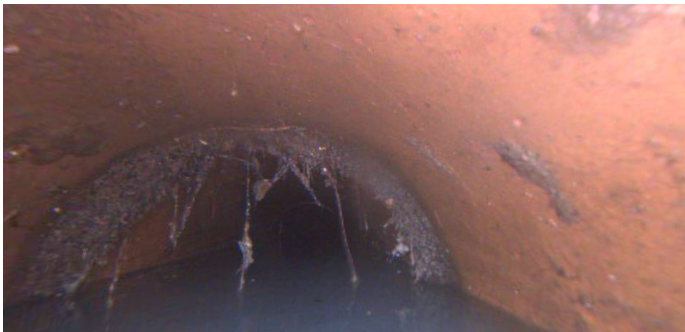
Code:	<b>RMJ</b>
Description:	<b>Roots Medium Joint</b>

Distance (ft):	<b>3.6</b>
Structural Grade:	<b>0</b>
O&M Grade:	<b>3</b>
Clock Start/From:	<b>8</b>
Clock To:	<b>4</b>
1st Value:	
2nd Value:	
Value Percent:	<b>10.000</b>
Continuous Index:	
Within 8" of Joint:	<b>YES</b>
Remarks:

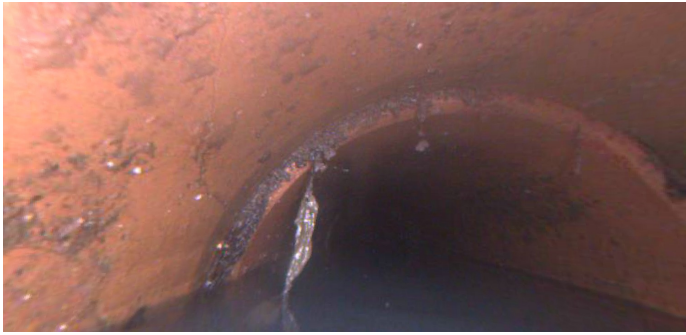
Code: **RFJ**  
Description: **Roots Fine Joint**

Distance (ft): **5.9**  
Structural Grade: **0**  
O&M Grade: **1**  
Clock Start/From: **8**  
Clock To: **4**  
1st Value:  
2nd Value:  
Value Percent:  
Continuous Index:  
Within 8" of Joint: **YES**  
Remarks:

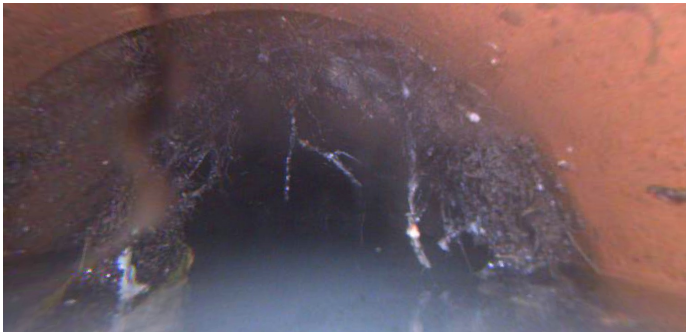
Code: **RMJ**  
Description: **Roots Medium Joint**

Distance (ft): **7.9**  
Structural Grade: **0**  
O&M Grade: **3**  
Clock Start/From: **8**  
Clock To: **4**  
1st Value:  
2nd Value:  
Value Percent: **15.000**  
Continuous Index:  
Within 8" of Joint: **YES**  
Remarks:
