## Profile/Photo Observation Report

Date:	<b>04/17/2018</b>	Weather:		Coding:	<b>PACP 6.0</b>
Pipe Length (ft):	<b>233.7</b>	Owner:	<b>NA</b>	Pre Clean:	<b>Not Known</b>
P.O.#:		Surveyor:	<b>Jen Costello</b>	PSR:	<b>P-707-032-033</b>
Customer:		Clean Date:	<b>01/01/1900</b>	Shape:	<b>C</b>

Street:	<b>Capitol</b>	Flow Control:	<b>Not Controlled</b>
City:	<b>Hobart, IN</b>	Year Renewed:	
Location:	<b>Light Highway</b>	Tape/Media #:	
Purpose:	<b>Maintenance Related</b>	Dia/Height:	<b>8"</b>
Use:	<b>Sanitary</b>	Material:	<b>VCP</b>
Drain Area:	<b>NA</b>	Lining:	<b>Cured in Place</b>
Category:	<b>NA</b>		
Comment:	<b>Reverse setup.roots at 9'.-flow incorrect.</b>		
Location Details:		Direction of Survey:	<b>Downstream</b>
US MH:	<b>M-707-033</b>	DS MH:	<b>M-707-032</b>
		Total Length Surveyed (ft):	<b>10.3</b>

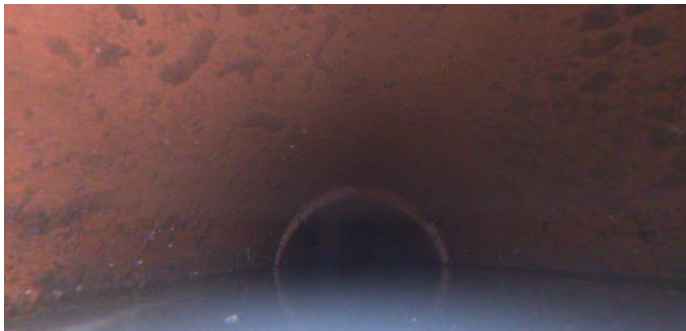
Code: **AMH**  
Description: **Manhole**

Distance (ft): **.0**  
Structural Grade: **0**  
O&M Grade: **0**  
Clock Start/From:  
Clock To:  
1st Value:  
2nd Value:  
Value Percent:  
Continuous Index:  
Within 8" of Joint: **NO**  
Remarks: **M-707-033**

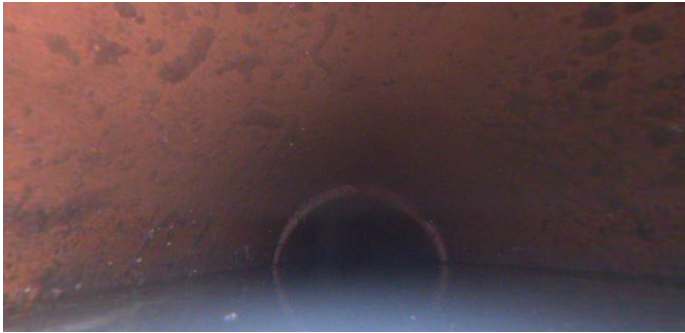
Code:	<b>MWL</b>
Description:	<b>Water Level</b>

Distance (ft):	<b>.0</b>
Structural Grade:	<b>0</b>
O&M Grade:	<b>0</b>
Clock Start/From:	
Clock To:	
1st Value:	
2nd Value:	
Value Percent:	<b>40.000</b>
Continuous Index:	
Within 8" of Joint:	<b>NO</b>
Remarks:

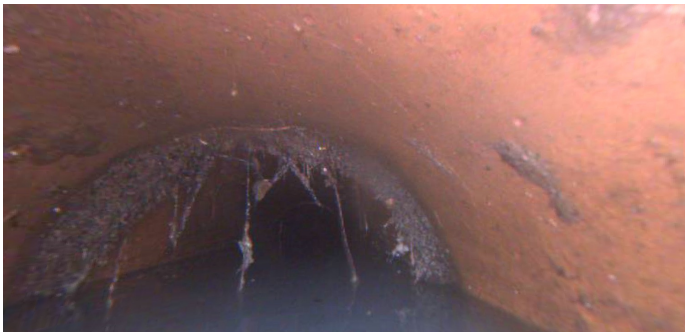
Code:	<b>RMJ</b>
Description:	<b>Roots Medium Joint</b>

Distance (ft):	<b>3.6</b>
Structural Grade:	<b>0</b>
O&M Grade:	<b>3</b>
Clock Start/From:	<b>8</b>
Clock To:	<b>4</b>
1st Value:	
2nd Value:	
Value Percent:	<b>10.000</b>
Continuous Index:	
Within 8" of Joint:	<b>YES</b>
Remarks:

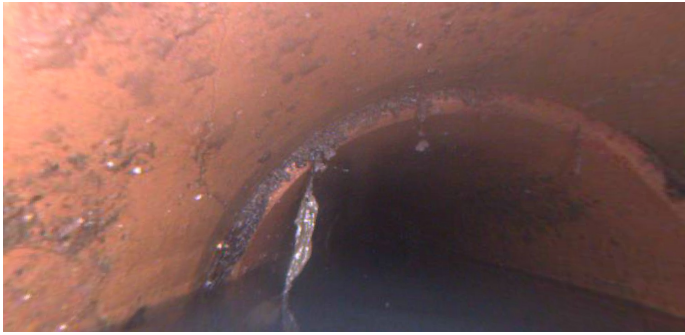
Code: **RFJ**  
Description: **Roots Fine Joint**

Distance (ft): **5.9**  
Structural Grade: **0**  
O&M Grade: **1**  
Clock Start/From: **8**  
Clock To: **4**  
1st Value:  
2nd Value:  
Value Percent:  
Continuous Index:  
Within 8" of Joint: **YES**  
Remarks:

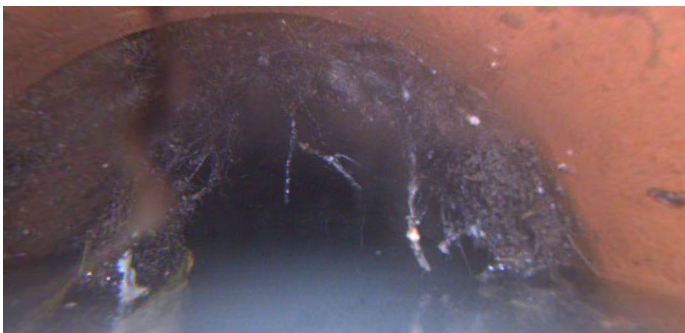
Code: **RMJ**  
Description: **Roots Medium Joint**

Distance (ft): **7.9**  
Structural Grade: **0**  
O&M Grade: **3**  
Clock Start/From: **8**  
Clock To: **4**  
1st Value:  
2nd Value:  
Value Percent: **15.000**  
Continuous Index:  
Within 8" of Joint: **YES**  
Remarks:
