## Profile/Photo Observation Report

Street:	<b>LINCOLN ST</b>	Flow Control:	<b>Not Controlled</b>
City:	<b>Hobart, IN</b>	Year Renewed:	
Location:	<b>Light Highway</b>	Tape/Media #:	
Purpose:	<b>Maintenance Related</b>	Dia/Height:	<b>8"</b>
Use:	<b>Sanitary</b>	Material:	<b>VCP</b>
Drain Area:	<b>NA</b>	Lining:	<b>Cured in Place</b>
Category:	<b>NA</b>		
Comment:	<b>blk silt at 48'-flow incorrect.</b>		
Location Details:		Direction of Survey:	<b>Upstream</b>
US MH:	<b>M-707-033</b>	DS MH:	<b>M-707-032</b>
		Total Length Surveyed (ft):	<b>49.3</b>

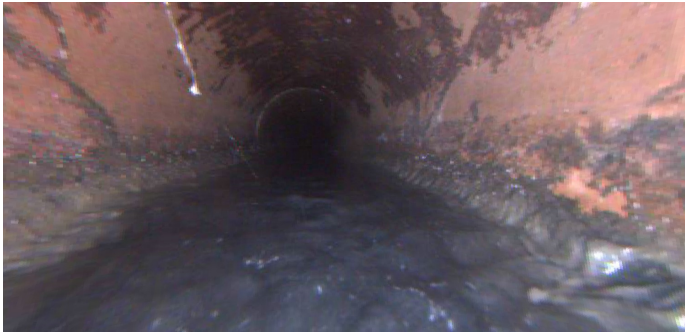
Code:	<b>MWL</b>
Description:	<b>Water Level</b>

Distance (ft):	<b>.0</b>
Structural Grade:	<b>0</b>
O&M Grade:	<b>0</b>
Clock Start/From:	
Clock To:	
1st Value:	
2nd Value:	
Value Percent:	<b>5.000</b>
Continuous Index:	
Within 8" of Joint:	<b>NO</b>
Remarks:

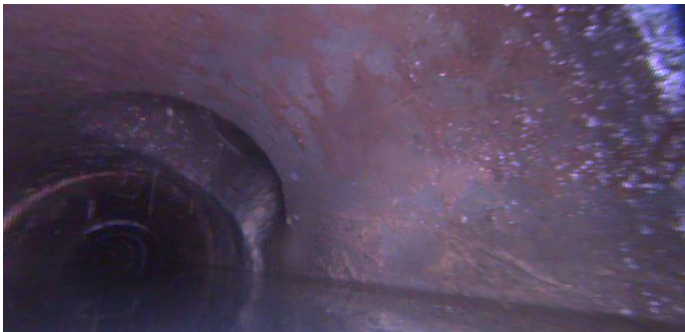
Code:	<b>TF</b>
Description:	<b>Tap Factory</b>

Distance (ft):	<b>17.2</b>
Structural Grade:	<b>0</b>
O&M Grade:	<b>0</b>
Clock Start/From:	<b>11</b>
Clock To:	
1st Value:	<b>4.000</b>
2nd Value:	
Value Percent:	
Continuous Index:	
Within 8" of Joint:	<b>YES</b>
Remarks:

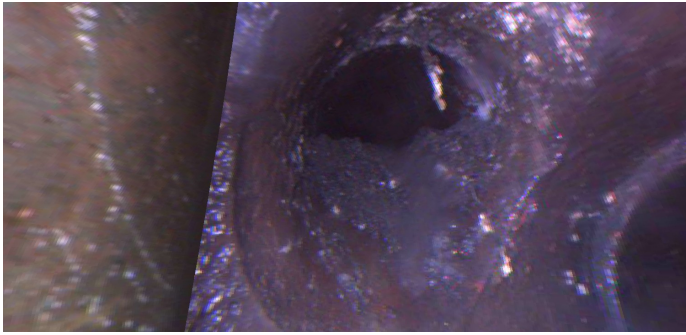
Code: **TFD**  
Description: **Tap Factory Defective**

Distance (ft): **18.6**  
Structural Grade: **0**  
O&M Grade: **2**  
Clock Start/From: **2**  
Clock To:  
1st Value: **4.000**  
2nd Value:  
Value Percent:  
Continuous Index:  
Within 8" of Joint: **YES**  
Remarks: **partially blocked**

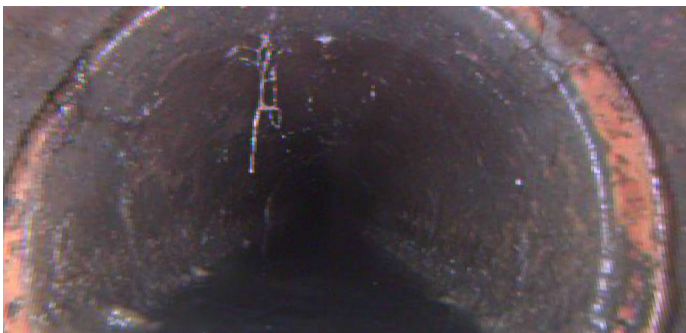
Code: **CM**  
Description: **Crack Multiple**

Distance (ft): **19.4**  
Structural Grade: **3**  
O&M Grade: **0**  
Clock Start/From: **7**  
Clock To: **4**  
1st Value:  
2nd Value:  
Value Percent:  
Continuous Index: **S01**  
Within 8" of Joint: **YES**  
Remarks: **wandering**

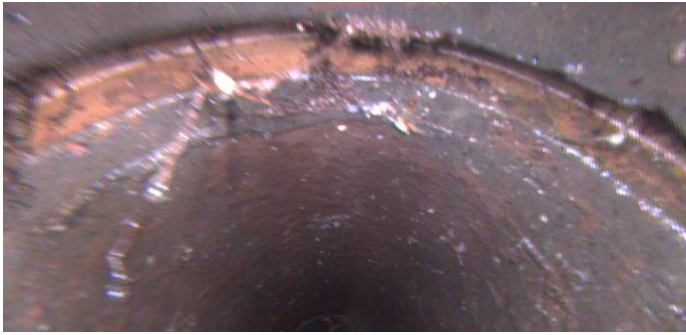
Code: **RFJ**  
Description: **Roots Fine Joint**

Distance (ft): **25.7**  
Structural Grade: **0**  
O&M Grade: **1**  
Clock Start/From: **12**  
Clock To:  
1st Value:  
2nd Value:  
Value Percent:  
Continuous Index: **S02**  
Within 8" of Joint: **YES**  
Remarks: **wandering**

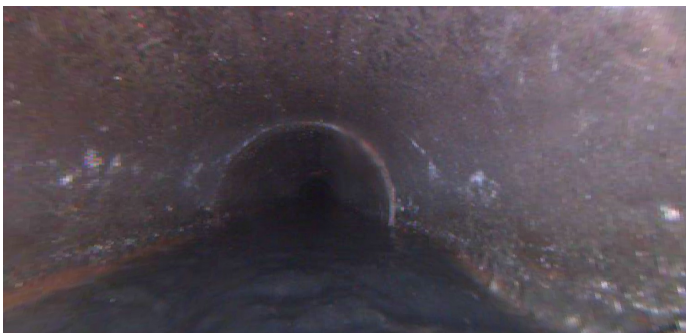
Code: **MSA**  
Description: **Abandoned Survey**

Distance (ft): **49.3**  
Structural Grade: **0**  
O&M Grade: **0**  
Clock Start/From:  
Clock To:  
1st Value:  
2nd Value:  
Value Percent:  
Continuous Index:  
Within 8" of Joint: **NO**  
Remarks: **debris**

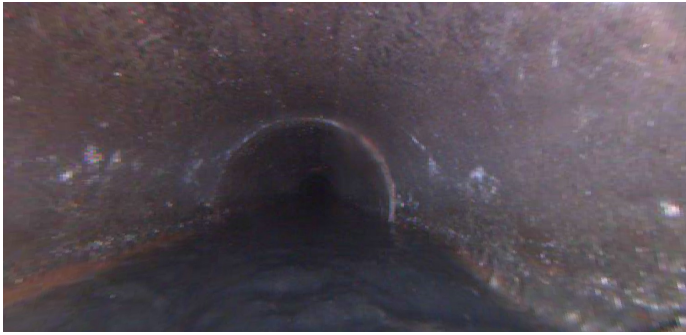
Code: **CM**  
Description: **Crack Multiple**

Distance (ft): **49.3**  
Structural Grade: **3**  
O&M Grade: **0**  
Clock Start/From: **7**  
Clock To: **4**  
1st Value:  
2nd Value:  
Value Percent:  
Continuous Index: **F01**  
Within 8" of Joint: **YES**  
Remarks: **wandering**

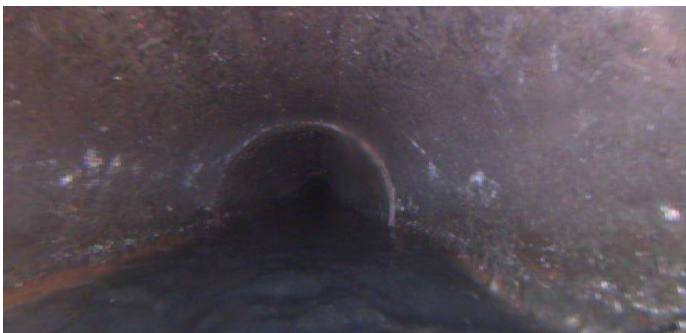
Code: **RFJ**  
Description: **Roots Fine Joint**

Distance (ft): **49.3**  
Structural Grade: **0**  
O&M Grade: **1**  
Clock Start/From: **12**  
Clock To:  
1st Value:  
2nd Value:  
Value Percent:  
Continuous Index: **F02**  
Within 8" of Joint: **YES**  
Remarks: **wandering**
