Profile/Photo Observation Report

Date:	04/17/2018	Weather:		Coding:	PACP 6.0
Pipe Length (ft):	233.7	Owner:	NA	Pre Clean:	Not Known
P.O.#:		Surveyor:	Byrd Fitzgerald	PSR:	P-707-032-033
Customer:		Clean Date:	01/01/1900	Shape:	C

Street:	Capitol	Flow Control:	Not Controlled
City:	Hobart, IN	Year Renewed:	
Location:	Light Highway	Tape/Media #:	
Purpose:	Maintenance Related	Dia/Height:	8"
Use:	Sanitary	Material:	VCP
Drain Area:	NA	Lining:	Cured in Place
Category:	NA		
Comment:	blk silt at 48'-flow incorrect.		
Location Details:		Direction of Survey:	Upstream
US MH:	M-707-033	DS MH:	M-707-032
		Total Length Surveyed (ft):	49.3

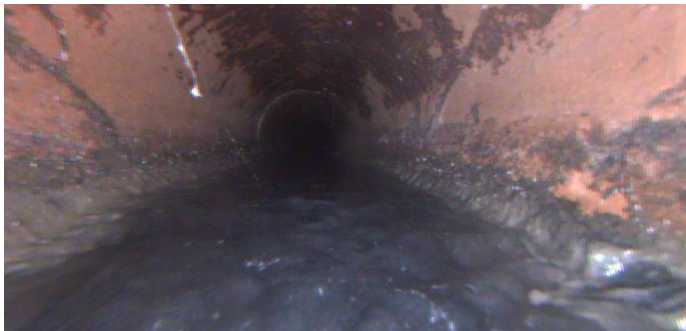
Code: **AMH**
Description: **Manhole**

Distance (ft): **.0**
Structural Grade: **0**
O&M Grade: **0**
Clock Start/From:
Clock To:
1st Value:
2nd Value:
Value Percent:
Continuous Index:
Within 8" of Joint: **NO**
Remarks: **M-707-032**

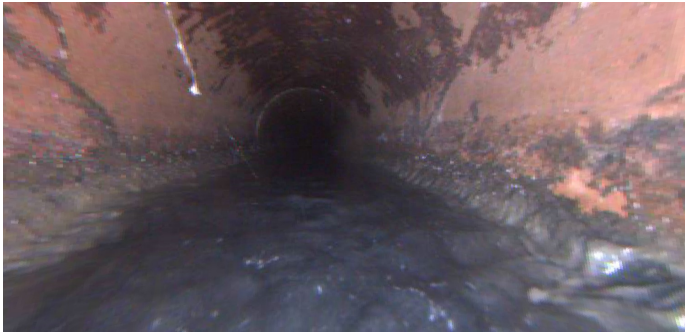
Code:	MWL
Description:	Water Level

Distance (ft):	.0
Structural Grade:	0
O&M Grade:	0
Clock Start/From:	
Clock To:	
1st Value:	
2nd Value:	
Value Percent:	5.000
Continuous Index:	
Within 8" of Joint:	NO
Remarks:

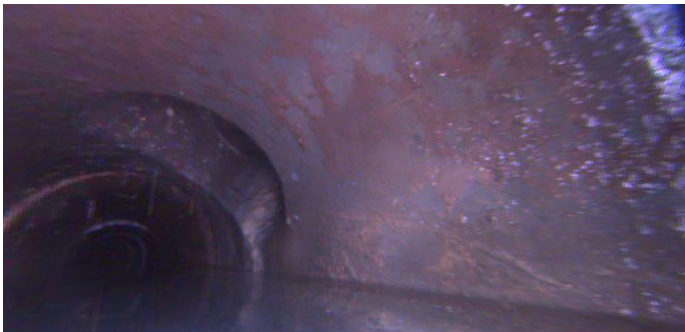
Code:	TF
Description:	Tap Factory

Distance (ft):	17.2
Structural Grade:	0
O&M Grade:	0
Clock Start/From:	11
Clock To:	
1st Value:	4.000
2nd Value:	
Value Percent:	
Continuous Index:	
Within 8" of Joint:	YES
Remarks:

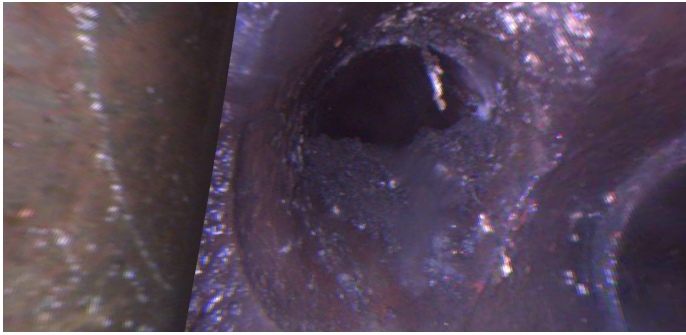
Code: **TFD**
Description: **Tap Factory Defective**

Distance (ft): **18.6**
Structural Grade: **0**
O&M Grade: **2**
Clock Start/From: **2**
Clock To:
1st Value: **4.000**
2nd Value:
Value Percent:
Continuous Index:
Within 8" of Joint: **YES**
Remarks: **partially blocked**

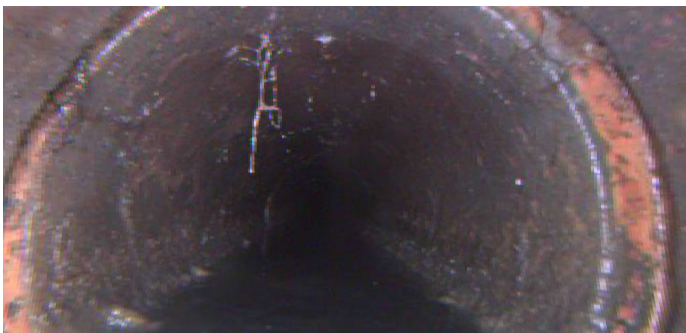
Code: **CM**
Description: **Crack Multiple**

Distance (ft): **19.4**
Structural Grade: **3**
O&M Grade: **0**
Clock Start/From: **7**
Clock To: **4**
1st Value:
2nd Value:
Value Percent:
Continuous Index: **S01**
Within 8" of Joint: **YES**
Remarks: **wandering**

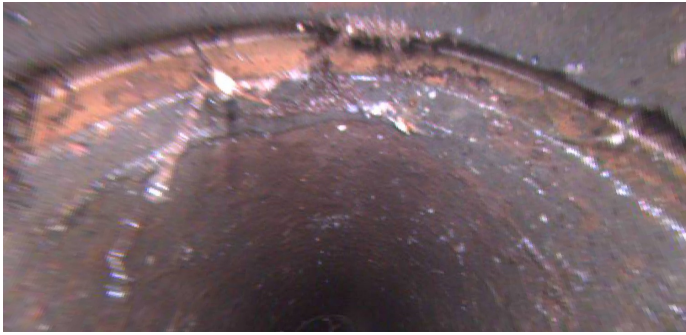
Code: **RFJ**
Description: **Roots Fine Joint**

Distance (ft): **25.7**
Structural Grade: **0**
O&M Grade: **1**
Clock Start/From: **12**
Clock To:
1st Value:
2nd Value:
Value Percent:
Continuous Index: **S02**
Within 8" of Joint: **YES**
Remarks: **wandering**

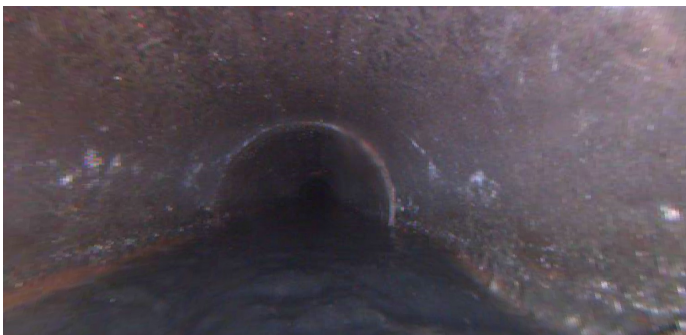
Code: **MSA**
Description: **Abandoned Survey**

Distance (ft): **49.3**
Structural Grade: **0**
O&M Grade: **0**
Clock Start/From:
Clock To:
1st Value:
2nd Value:
Value Percent:
Continuous Index:
Within 8" of Joint: **NO**
Remarks: **debris**

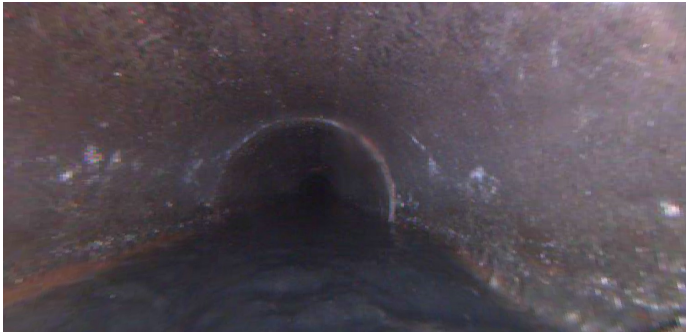
Code: **CM**
Description: **Crack Multiple**

Distance (ft): **49.3**
Structural Grade: **3**
O&M Grade: **0**
Clock Start/From: **7**
Clock To: **4**
1st Value:
2nd Value:
Value Percent:
Continuous Index: **F01**
Within 8" of Joint: **YES**
Remarks: **wandering**

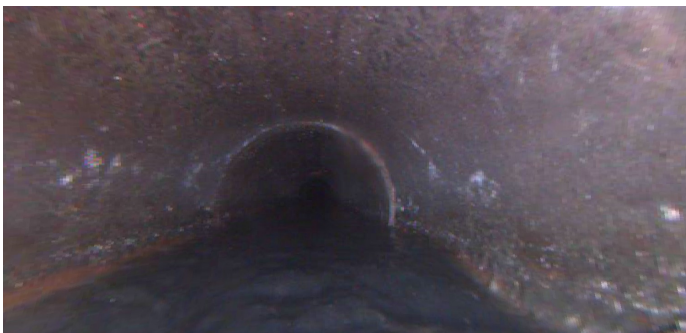
Code: **RFJ**
Description: **Roots Fine Joint**

Distance (ft): **49.3**
Structural Grade: **0**
O&M Grade: **1**
Clock Start/From: **12**
Clock To:
1st Value:
2nd Value:
Value Percent:
Continuous Index: **F02**
Within 8" of Joint: **YES**
Remarks: **wandering**
