Profile/Photo Observation Report

Date:	03/30/2018	Weather:		Coding:	PACP 6.0
Pipe Length (ft):	252.0	Owner:	NA	Pre Clean:	Not Known
P.O.#:		Surveyor:	Jen Costello	PSR:	P-708-008-035
Customer:		Clean Date:	01/01/1900	Shape:	C

Street:	STATE ST	Flow Control:	Not Controlled
City:	Hobart, IN	Year Renewed:	
Location:	Sidewalk	Tape/Media #:	
Purpose:	Maintenance Related	Dia/Height:	8"
Use:	Sanitary	Material:	VCP
Drain Area:	NA	Lining:	Cured in Place
Category:	NA		
Comment:	Flow direction wrong. Reverse setup.		
Location Details:		Direction of Survey:	Downstream
US MH:	M-707-035	DS MH:	M-708-008
		Total Length Surveyed (ft):	250.0

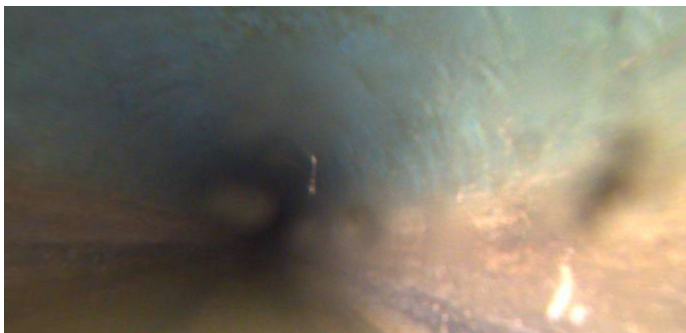
Code: **AMH**
Description: **Manhole**

Distance (ft): **.0**
Structural Grade: **0**
O&M Grade: **0**
Clock Start/From:
Clock To:
1st Value:
2nd Value:
Value Percent:
Continuous Index:
Within 8" of Joint: **NO**
Remarks: **M-707-035**

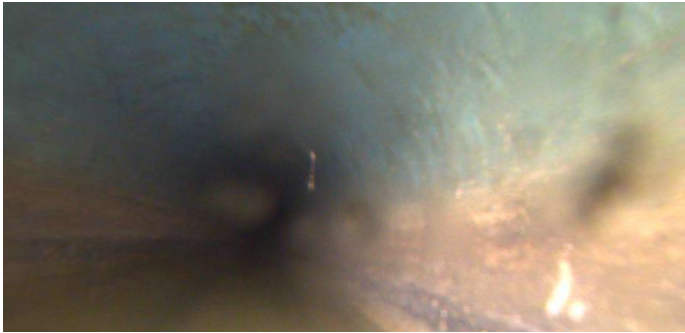
Code:	MWL
Description:	Water Level

Distance (ft):	.0
Structural Grade:	0
O&M Grade:	0
Clock Start/From:	
Clock To:	
1st Value:	
2nd Value:	
Value Percent:	10.000
Continuous Index:	
Within 8" of Joint:	NO
Remarks:

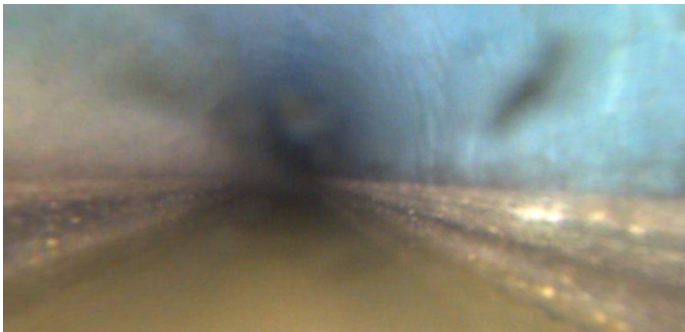
Code:	MWL
Description:	Water Level

Distance (ft):	20.8
Structural Grade:	0
O&M Grade:	0
Clock Start/From:	
Clock To:	
1st Value:	
2nd Value:	
Value Percent:	20.000
Continuous Index:	
Within 8" of Joint:	NO
Remarks:

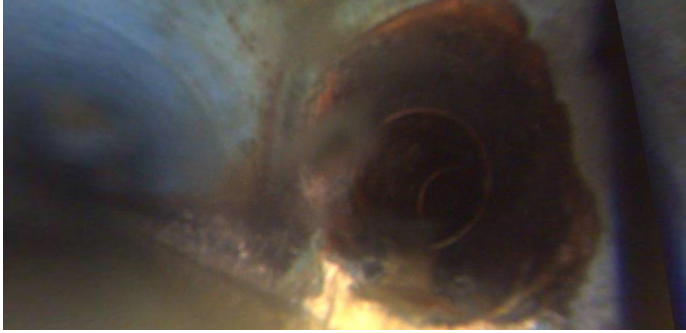
Code: **TF**
Description: **Tap Factory**

Distance (ft): **102.9**
Structural Grade: **0**
O&M Grade: **0**
Clock Start/From: **3**
Clock To:
1st Value: **4.000**
2nd Value:
Value Percent:
Continuous Index:
Within 8" of Joint:
Remarks:

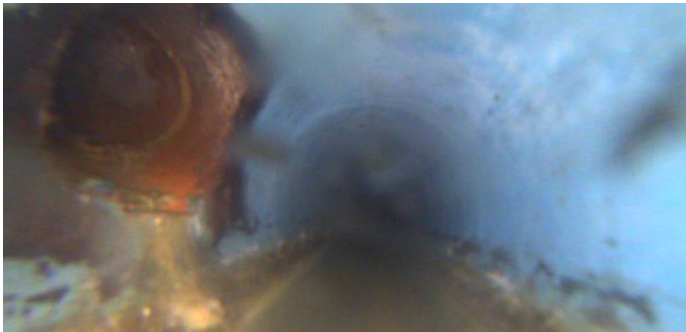
Code: **TF**
Description: **Tap Factory**

Distance (ft): **165.2**
Structural Grade: **0**
O&M Grade: **0**
Clock Start/From: **9**
Clock To:
1st Value: **4.000**
2nd Value:
Value Percent:
Continuous Index:
Within 8" of Joint:
Remarks:

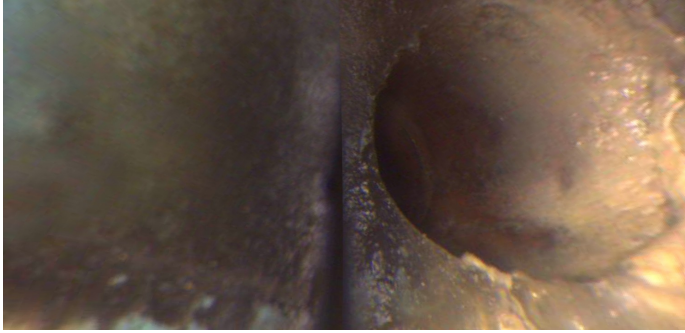
Code: **TF**
Description: **Tap Factory**

Distance (ft): **186.2**
Structural Grade: **0**
O&M Grade: **0**
Clock Start/From: **3**
Clock To:
1st Value: **4.000**
2nd Value:
Value Percent:
Continuous Index:
Within 8" of Joint:
Remarks:

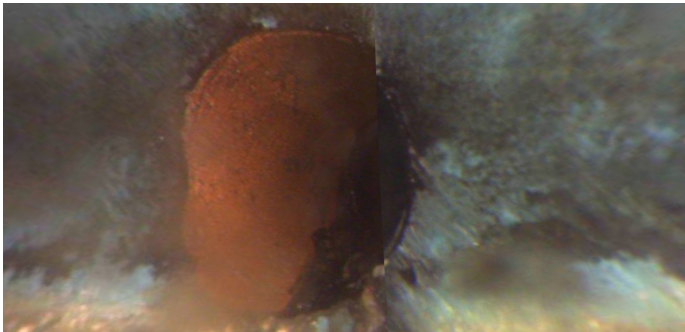
Code: **TF**
Description: **Tap Factory**

Distance (ft): **212.4**
Structural Grade: **0**
O&M Grade: **0**
Clock Start/From: **9**
Clock To:
1st Value: **4.000**
2nd Value:
Value Percent:
Continuous Index:
Within 8" of Joint:
Remarks:

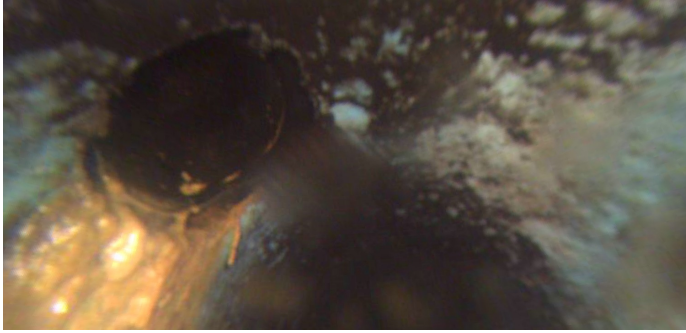
Code: **TF**
Description: **Tap Factory**

Distance (ft): **228.0**
Structural Grade: **0**
O&M Grade: **0**
Clock Start/From: **10**
Clock To:
1st Value: **4.000**
2nd Value:
Value Percent:
Continuous Index:
Within 8" of Joint:
Remarks:

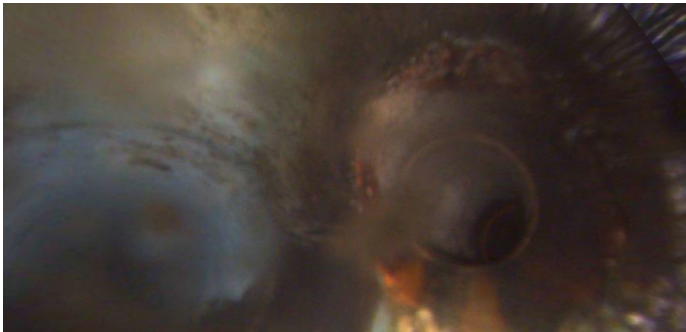
Code: **TF**
Description: **Tap Factory**

Distance (ft): **237.9**
Structural Grade: **0**
O&M Grade: **0**
Clock Start/From: **3**
Clock To:
1st Value: **4.000**
2nd Value:
Value Percent:
Continuous Index:
Within 8" of Joint:
Remarks:

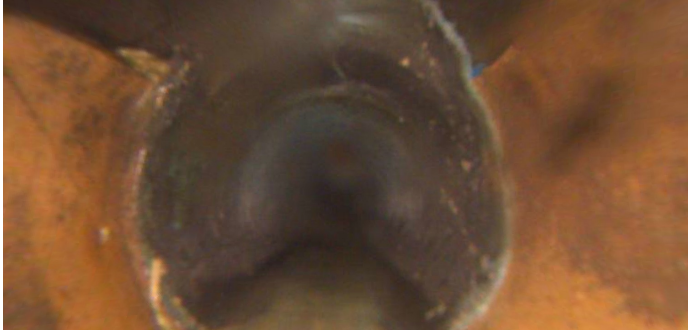
Code:	AMH
Description:	Manhole
Distance (ft):	250.0
Structural Grade:	0
O&M Grade:	0
Clock Start/From:	
Clock To:	
1st Value:	
2nd Value:	
Value Percent:	
Continuous Index:	
Within 8" of Joint:	NO
Remarks:	M-708-008
