Profile/Photo Observation Report

Date:	03/30/2018	Weather:		Coding:	PACP 6.0
Pipe Length (ft):	252.0	Owner:	NA	Pre Clean:	Not Known
P.O.#:		Surveyor:	Jen Costello	PSR:	P-708-008-035
Customer:		Clean Date:	01/01/1900	Shape:	C

Street:	State	Flow Control:	Not Controlled
City:	Hobart, IN	Year Renewed:	
Location:	Sidewalk	Tape/Media #:	
Purpose:	Maintenance Related	Dia/Height:	8"
Use:	Sanitary	Material:	VCP
Drain Area:	NA	Lining:	Cured in Place
Category:	NA		
Comment:	Flow direction wrong. Reverse setup.		
Location Details:		Direction of Survey:	Downstream
US MH:	M-707-035	DS MH:	M-708-008
		Total Length Surveyed (ft):	250.0

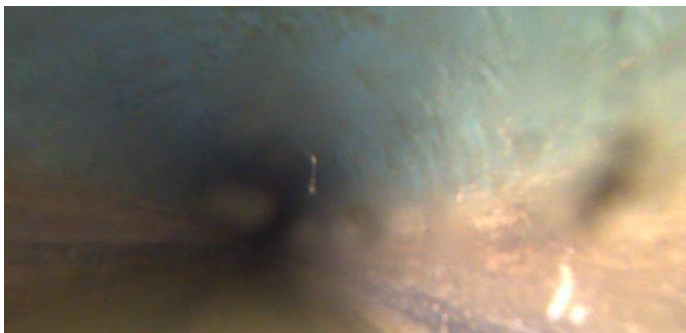
Code: **AMH**
Description: **Manhole**

Distance (ft): **.0**
Structural Grade: **0**
O&M Grade: **0**
Clock Start/From:
Clock To:
1st Value:
2nd Value:
Value Percent:
Continuous Index:
Within 8" of Joint: **NO**
Remarks: **M-707-035**

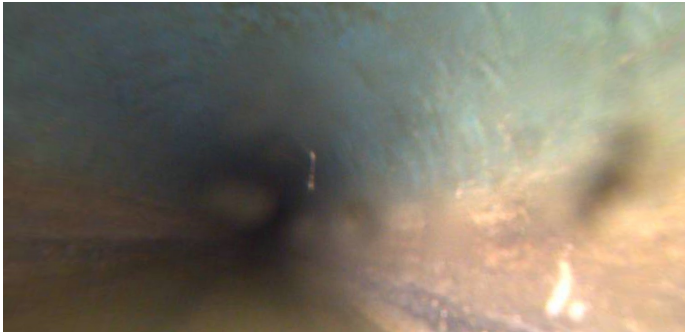
Code:	MWL
Description:	Water Level

Distance (ft):	.0
Structural Grade:	0
O&M Grade:	0
Clock Start/From:	
Clock To:	
1st Value:	
2nd Value:	
Value Percent:	10.000
Continuous Index:	
Within 8" of Joint:	NO
Remarks:

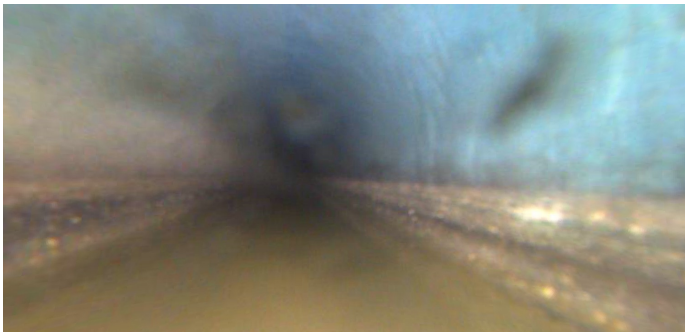
Code:	MWL
Description:	Water Level

Distance (ft):	20.8
Structural Grade:	0
O&M Grade:	0
Clock Start/From:	
Clock To:	
1st Value:	
2nd Value:	
Value Percent:	20.000
Continuous Index:	
Within 8" of Joint:	NO
Remarks:

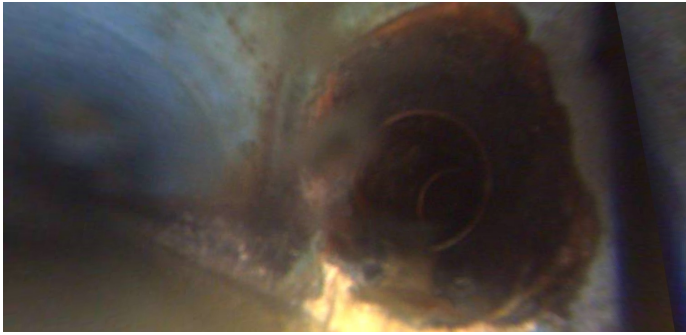
Code: **TF**
Description: **Tap Factory**

Distance (ft): **102.9**
Structural Grade: **0**
O&M Grade: **0**
Clock Start/From: **3**
Clock To:
1st Value: **4.000**
2nd Value:
Value Percent:
Continuous Index:
Within 8" of Joint:
Remarks:

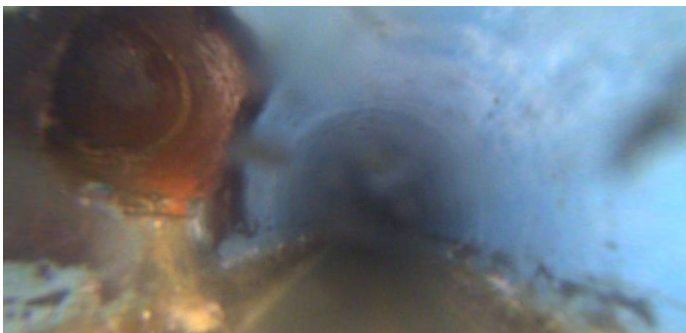
Code: **TF**
Description: **Tap Factory**

Distance (ft): **165.2**
Structural Grade: **0**
O&M Grade: **0**
Clock Start/From: **9**
Clock To:
1st Value: **4.000**
2nd Value:
Value Percent:
Continuous Index:
Within 8" of Joint:
Remarks:

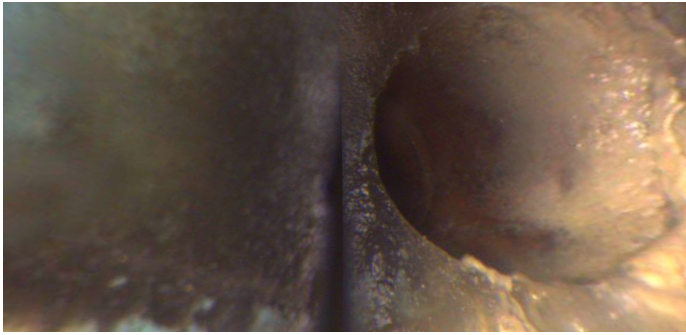
Code: **TF**
Description: **Tap Factory**

Distance (ft): **186.2**
Structural Grade: **0**
O&M Grade: **0**
Clock Start/From: **3**
Clock To:
1st Value: **4.000**
2nd Value:
Value Percent:
Continuous Index:
Within 8" of Joint:
Remarks:

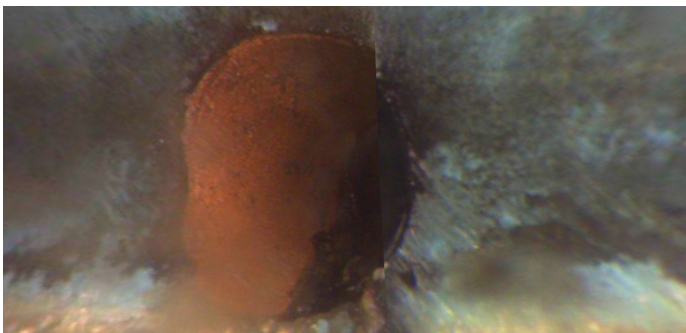
Code: **TF**
Description: **Tap Factory**

Distance (ft): **212.4**
Structural Grade: **0**
O&M Grade: **0**
Clock Start/From: **9**
Clock To:
1st Value: **4.000**
2nd Value:
Value Percent:
Continuous Index:
Within 8" of Joint:
Remarks:

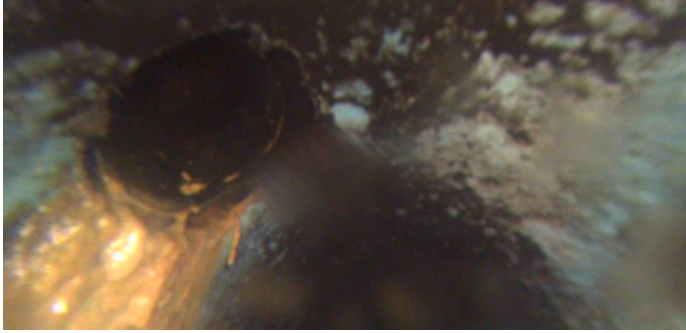
Code: **TF**
Description: **Tap Factory**

Distance (ft): **228.0**
Structural Grade: **0**
O&M Grade: **0**
Clock Start/From: **10**
Clock To:
1st Value: **4.000**
2nd Value:
Value Percent:
Continuous Index:
Within 8" of Joint:
Remarks:

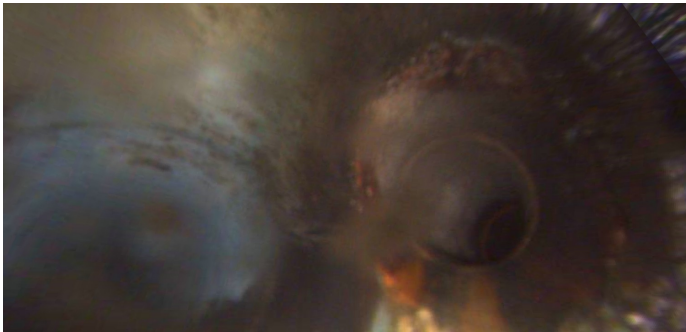
Code: **TF**
Description: **Tap Factory**

Distance (ft): **237.9**
Structural Grade: **0**
O&M Grade: **0**
Clock Start/From: **3**
Clock To:
1st Value: **4.000**
2nd Value:
Value Percent:
Continuous Index:
Within 8" of Joint:
Remarks:

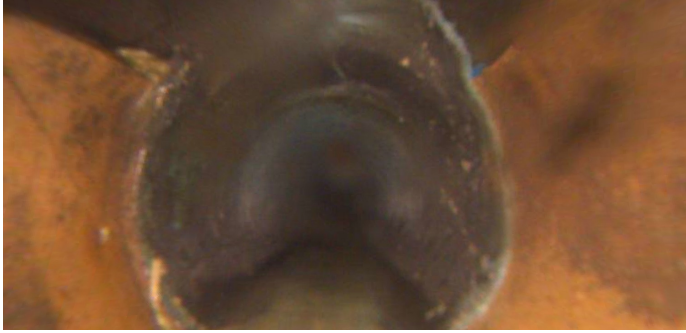
Code:	AMH
Description:	Manhole
Distance (ft):	250.0
Structural Grade:	0
O&M Grade:	0
Clock Start/From:	
Clock To:	
1st Value:	
2nd Value:	
Value Percent:	
Continuous Index:	
Within 8" of Joint:	NO
Remarks:	M-708-008
