Profile/Photo Observation Report

Date:	03/30/2018	Weather:		Coding:	PACP 6.0
Pipe Length (ft):	252.0	Owner:	NA	Pre Clean:	Not Known
P.O.#:		Surveyor:	Jen Costello	PSR:	P-708-008-035
Customer:		Clean Date:	01/01/1900	Shape:	C

Street:	STATE ST	Flow Control:	Not Controlled
City:	Hobart, IN	Year Renewed:	
Location:	Sidewalk	Tape/Media #:	
Purpose:	Maintenance Related	Dia/Height:	12"
Use:	Sanitary	Material:	VCP
Drain Area:	NA	Lining:	Cured in Place
Category:	NA		
Comment:	Flow direction wrong.		
Location Details:		Direction of Survey:	Upstream
US MH:	M-707-035	DS MH:	M-708-008
		Total Length Surveyed (ft):	222.3

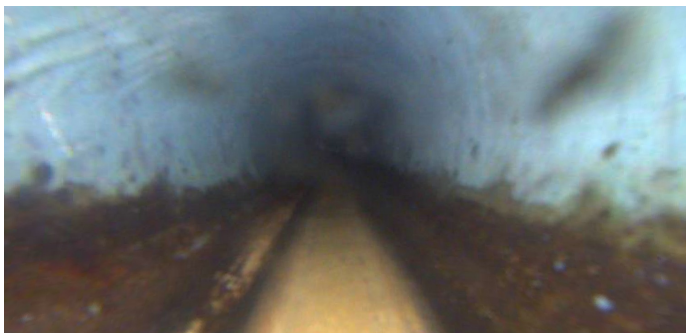
Code: **AMH**
Description: **Manhole**

Distance (ft): **.0**
Structural Grade: **0**
O&M Grade: **0**
Clock Start/From:
Clock To:
1st Value:
2nd Value:
Value Percent:
Continuous Index:
Within 8" of Joint: **NO**
Remarks: **M-708-008**

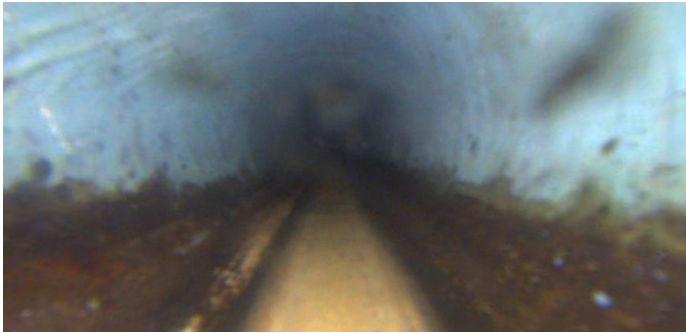
Code:	MWL
Description:	Water Level

Distance (ft):	.0
Structural Grade:	0
O&M Grade:	0
Clock Start/From:	
Clock To:	
1st Value:	
2nd Value:	
Value Percent:	5.000
Continuous Index:	
Within 8" of Joint:	NO
Remarks:

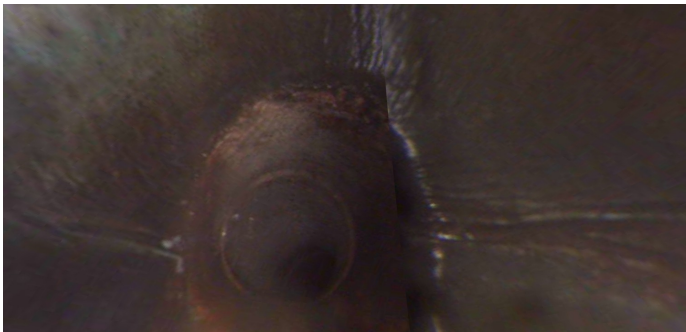
Code:	TFA
Description:	Tap Factory Active

Distance (ft):	9.5
Structural Grade:	0
O&M Grade:	0
Clock Start/From:	10
Clock To:	
1st Value:	4.000
2nd Value:	
Value Percent:	
Continuous Index:	
Within 8" of Joint:	
Remarks:

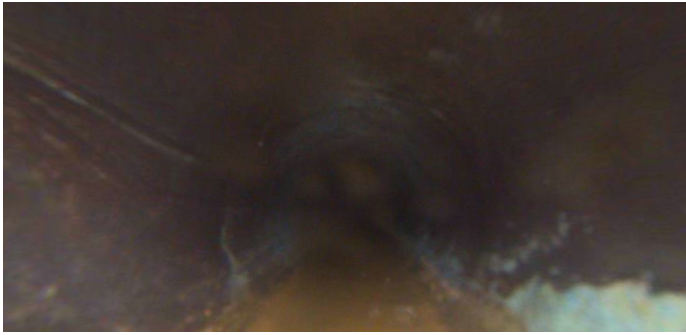
Code: **LFW**
Description: **Lining Failure Wrinkled**

Distance (ft): **9.5**
Structural Grade: **3**
O&M Grade: **0**
Clock Start/From: **9**
Clock To: **10**
1st Value:
2nd Value:
Value Percent:
Continuous Index:
Within 8" of Joint: **NO**
Remarks:

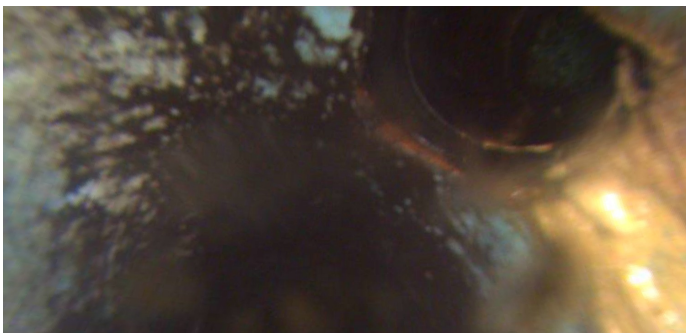
Code: **TB**
Description: **Tap Break-in**

Distance (ft): **18.9**
Structural Grade: **0**
O&M Grade: **0**
Clock Start/From: **2**
Clock To:
1st Value: **4.000**
2nd Value:
Value Percent:
Continuous Index:
Within 8" of Joint:
Remarks:

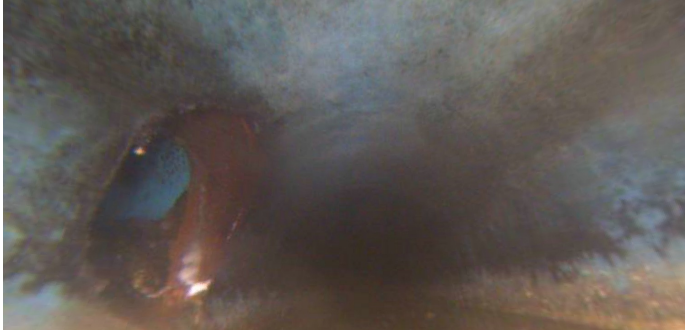
Code: **TF**
Description: **Tap Factory**

Distance (ft): **36.1**
Structural Grade: **0**
O&M Grade: **0**
Clock Start/From: **2**
Clock To:
1st Value: **4.000**
2nd Value:
Value Percent:
Continuous Index:
Within 8" of Joint:
Remarks:

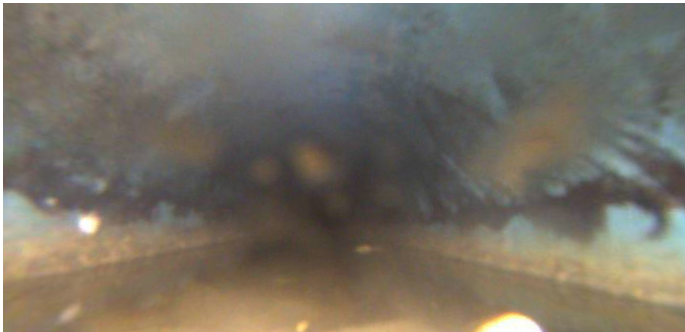
Code: **MWL**
Description: **Water Level**

Distance (ft): **36.1**
Structural Grade: **0**
O&M Grade: **0**
Clock Start/From:
Clock To:
1st Value:
2nd Value:
Value Percent: **40.000**
Continuous Index:
Within 8" of Joint: **NO**
Remarks:

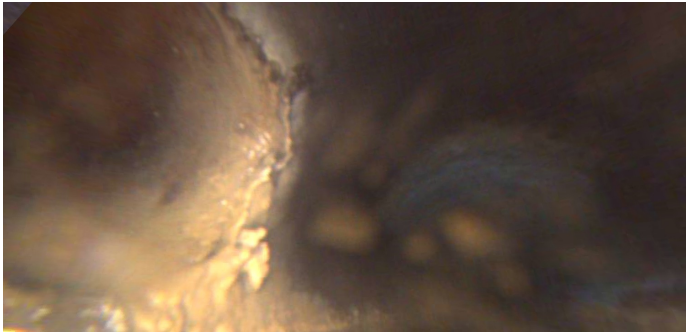
Code: **TB**
Description: **Tap Break-in**

Distance (ft): **61.4**
Structural Grade: **0**
O&M Grade: **0**
Clock Start/From: **9**
Clock To:
1st Value: **4.000**
2nd Value:
Value Percent:
Continuous Index:
Within 8" of Joint:
Remarks:

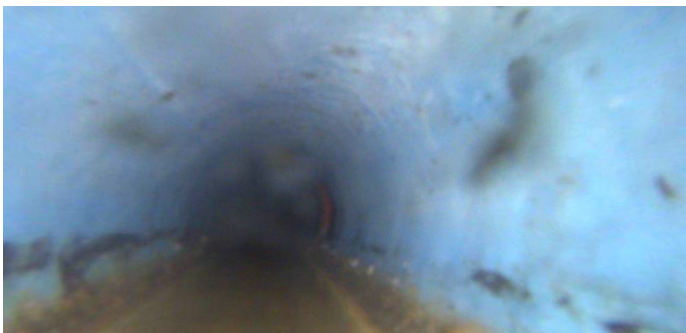
Code: **MWL**
Description: **Water Level**

Distance (ft): **79.0**
Structural Grade: **0**
O&M Grade: **0**
Clock Start/From:
Clock To:
1st Value:
2nd Value:
Value Percent: **5.000**
Continuous Index:
Within 8" of Joint: **NO**
Remarks:

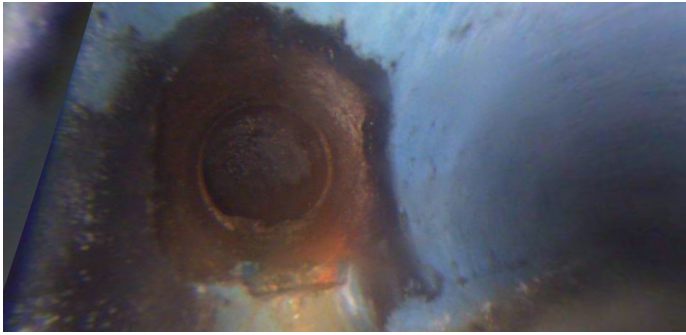
Code: **TF**
Description: **Tap Factory**

Distance (ft): **82.0**
Structural Grade: **0**
O&M Grade: **0**
Clock Start/From: **3**
Clock To:
1st Value: **4.000**
2nd Value:
Value Percent:
Continuous Index:
Within 8" of Joint:
Remarks:

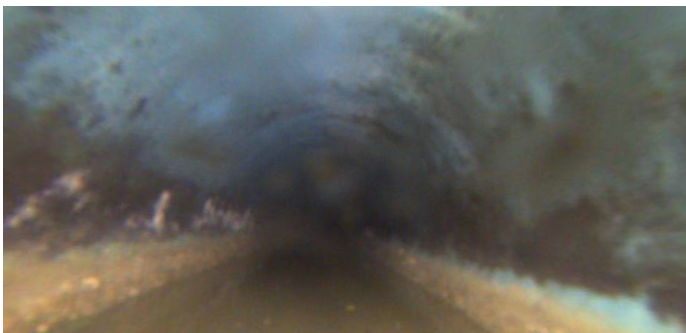
Code: **MWL**
Description: **Water Level**

Distance (ft): **121.4**
Structural Grade: **0**
O&M Grade: **0**
Clock Start/From:
Clock To:
1st Value:
2nd Value:
Value Percent: **20.000**
Continuous Index:
Within 8" of Joint: **NO**
Remarks:

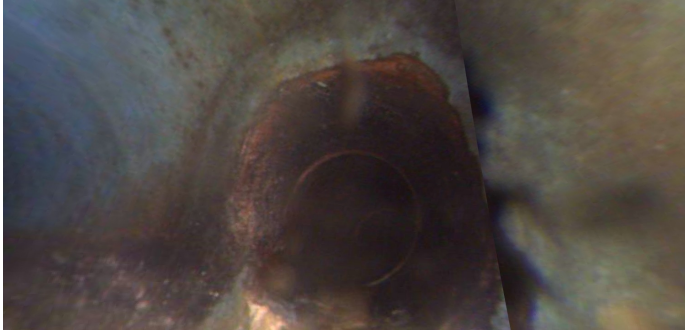
Code: **TF**
Description: **Tap Factory**

Distance (ft): **144.2**
Structural Grade: **0**
O&M Grade: **0**
Clock Start/From: **9**
Clock To:
1st Value: **4.000**
2nd Value:
Value Percent:
Continuous Index:
Within 8" of Joint:
Remarks:

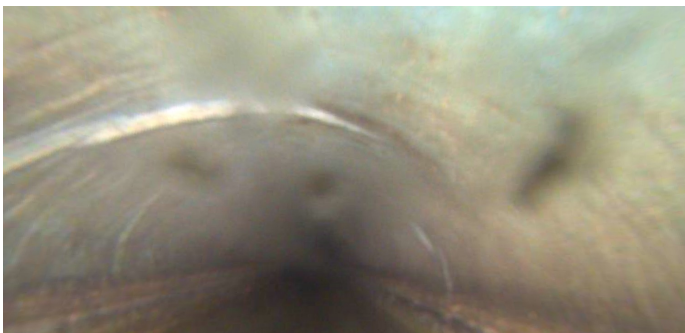
Code: **LFW**
Description: **Lining Failure Wrinkled**

Distance (ft): **203.3**
Structural Grade: **3**
O&M Grade: **0**
Clock Start/From: **8**
Clock To: **4**
1st Value:
2nd Value:
Value Percent:
Continuous Index:
Within 8" of Joint: **NO**
Remarks:

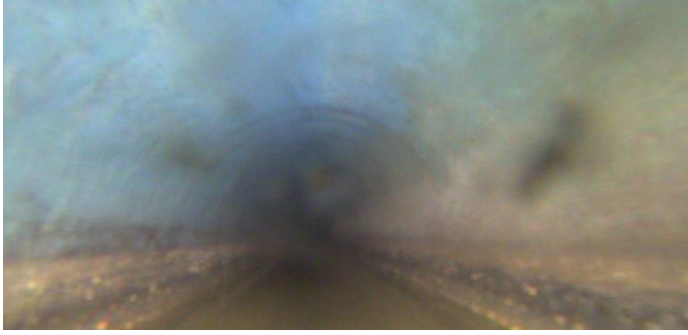
Code:	MSA
Description:	Abandoned Survey
Distance (ft):	222.3
Structural Grade:	0
O&M Grade:	0
Clock Start/From:	
Clock To:	
1st Value:	
2nd Value:	
Value Percent:	
Continuous Index:	
Within 8" of Joint:	NO
Remarks:	DEBRIS UNDER WATER
