Profile/Photo Observation Report

Date:	03/30/2018	Weather:		Coding:	PACP 6.0
Pipe Length (ft):	252.0	Owner:	NA	Pre Clean:	Not Known
P.O.#:		Surveyor:	Jen Costello	PSR:	P-708-008-035
Customer:		Clean Date:	01/01/1900	Shape:	C

Street:	State	Flow Control:	Not Controlled
City:	Hobart, IN	Year Renewed:	
Location:	Sidewalk	Tape/Media #:	
Purpose:	Maintenance Related	Dia/Height:	12"
Use:	Sanitary	Material:	VCP
Drain Area:	NA	Lining:	Cured in Place
Category:	NA		
Comment:	Flow direction wrong.

Location Details:		Direction of Survey:	Upstream
US MH:	M-707-035	DS MH:	M-708-008
		Total Length Surveyed (ft):	222.3

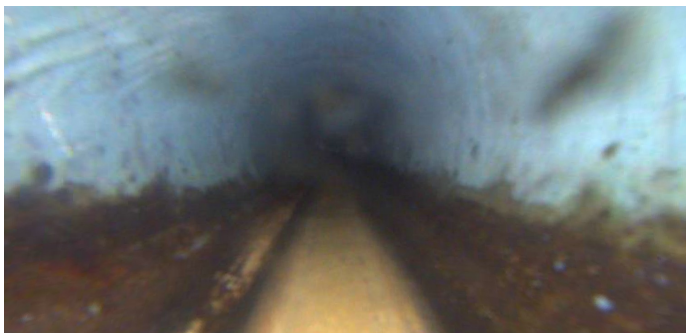
Code: **AMH**
Description: **Manhole**

Distance (ft): **.0**
Structural Grade: **0**
O&M Grade: **0**
Clock Start/From:
Clock To:
1st Value:
2nd Value:
Value Percent:
Continuous Index:
Within 8" of Joint: **NO**
Remarks: **M-708-008**

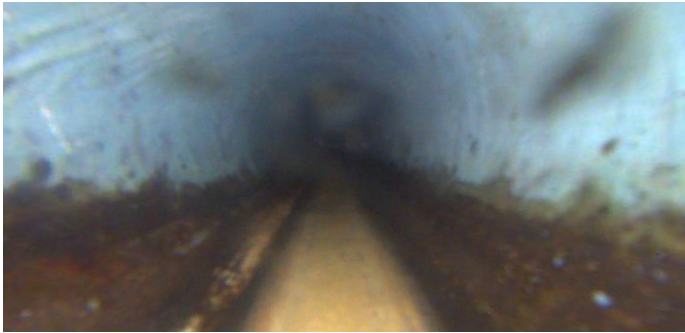
Code:	MWL
Description:	Water Level

Distance (ft):	.0
Structural Grade:	0
O&M Grade:	0
Clock Start/From:	
Clock To:	
1st Value:	
2nd Value:	
Value Percent:	5.000
Continuous Index:	
Within 8" of Joint:	NO
Remarks:

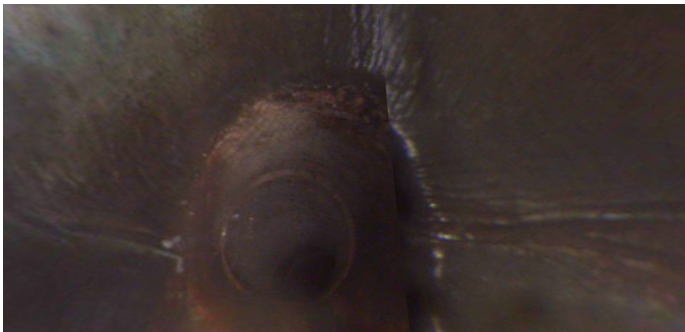
Code:	TFA
Description:	Tap Factory Active

Distance (ft):	9.5
Structural Grade:	0
O&M Grade:	0
Clock Start/From:	10
Clock To:	
1st Value:	4.000
2nd Value:	
Value Percent:	
Continuous Index:	
Within 8" of Joint:	
Remarks:

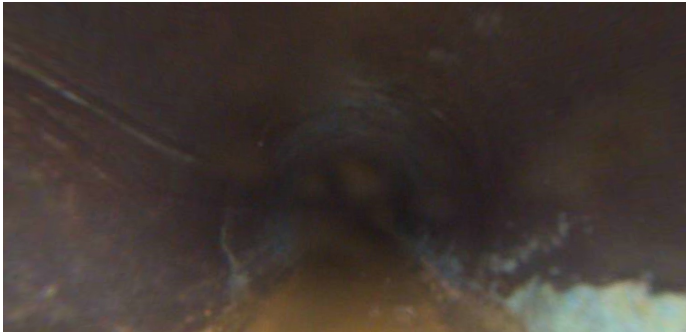
Code: **LFW**
Description: **Lining Failure Wrinkled**

Distance (ft): **9.5**
Structural Grade: **3**
O&M Grade: **0**
Clock Start/From: **9**
Clock To: **10**
1st Value:
2nd Value:
Value Percent:
Continuous Index:
Within 8" of Joint: **NO**
Remarks:

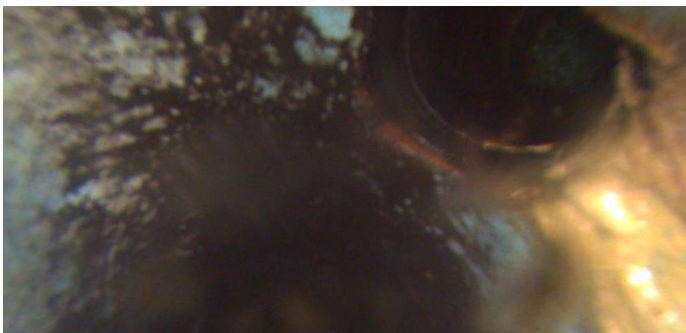
Code: **TB**
Description: **Tap Break-in**

Distance (ft): **18.9**
Structural Grade: **0**
O&M Grade: **0**
Clock Start/From: **2**
Clock To:
1st Value: **4.000**
2nd Value:
Value Percent:
Continuous Index:
Within 8" of Joint:
Remarks:

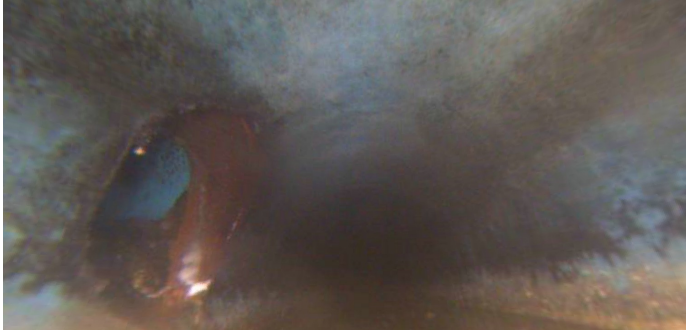
Code: **TF**
Description: **Tap Factory**

Distance (ft): **36.1**
Structural Grade: **0**
O&M Grade: **0**
Clock Start/From: **2**
Clock To:
1st Value: **4.000**
2nd Value:
Value Percent:
Continuous Index:
Within 8" of Joint:
Remarks:

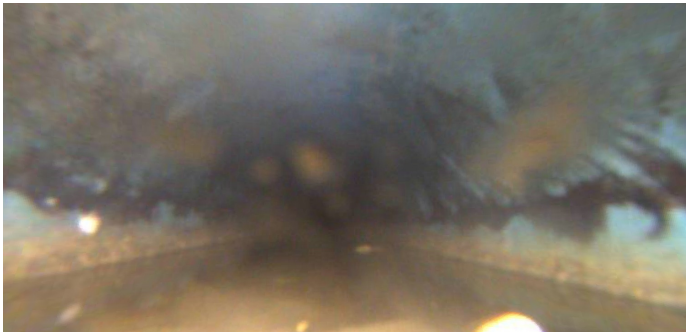
Code: **MWL**
Description: **Water Level**

Distance (ft): **36.1**
Structural Grade: **0**
O&M Grade: **0**
Clock Start/From:
Clock To:
1st Value:
2nd Value:
Value Percent: **40.000**
Continuous Index:
Within 8" of Joint: **NO**
Remarks:

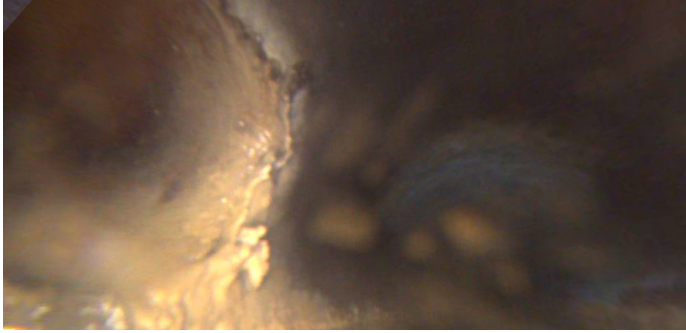
Code: **TB**
Description: **Tap Break-in**

Distance (ft): **61.4**
Structural Grade: **0**
O&M Grade: **0**
Clock Start/From: **9**
Clock To:
1st Value: **4.000**
2nd Value:
Value Percent:
Continuous Index:
Within 8" of Joint:
Remarks:

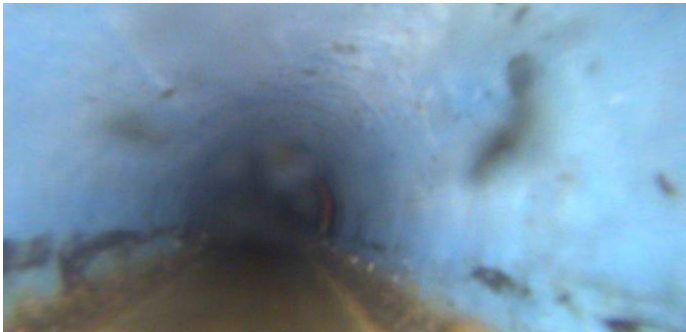
Code: **MWL**
Description: **Water Level**

Distance (ft): **79.0**
Structural Grade: **0**
O&M Grade: **0**
Clock Start/From:
Clock To:
1st Value:
2nd Value:
Value Percent: **5.000**
Continuous Index:
Within 8" of Joint: **NO**
Remarks:

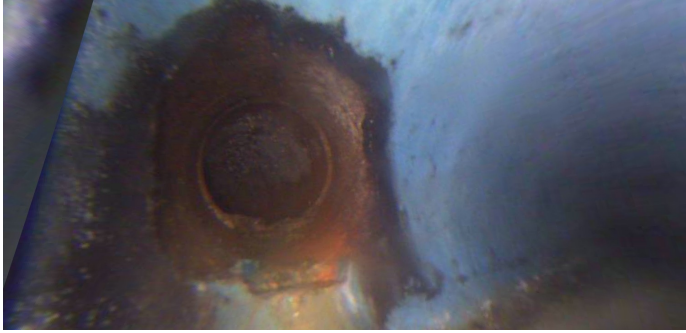
Code: **TF**
Description: **Tap Factory**

Distance (ft): **82.0**
Structural Grade: **0**
O&M Grade: **0**
Clock Start/From: **3**
Clock To:
1st Value: **4.000**
2nd Value:
Value Percent:
Continuous Index:
Within 8" of Joint:
Remarks:

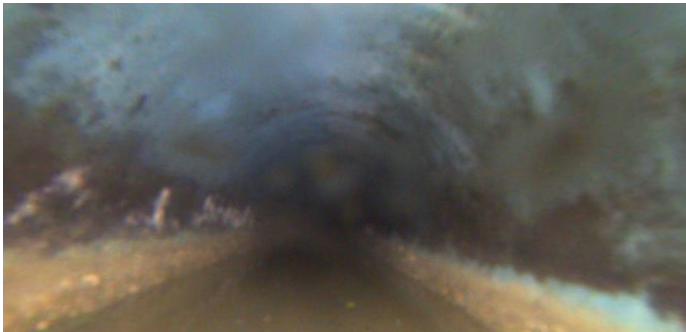
Code: **MWL**
Description: **Water Level**

Distance (ft): **121.4**
Structural Grade: **0**
O&M Grade: **0**
Clock Start/From:
Clock To:
1st Value:
2nd Value:
Value Percent: **20.000**
Continuous Index:
Within 8" of Joint: **NO**
Remarks:

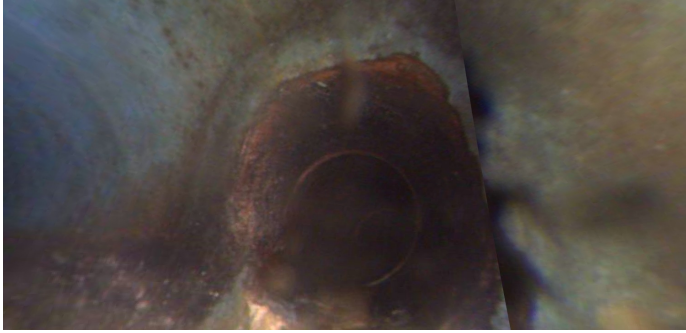
Code: **TF**
Description: **Tap Factory**

Distance (ft): **144.2**
Structural Grade: **0**
O&M Grade: **0**
Clock Start/From: **9**
Clock To:
1st Value: **4.000**
2nd Value:
Value Percent:
Continuous Index:
Within 8" of Joint:
Remarks:

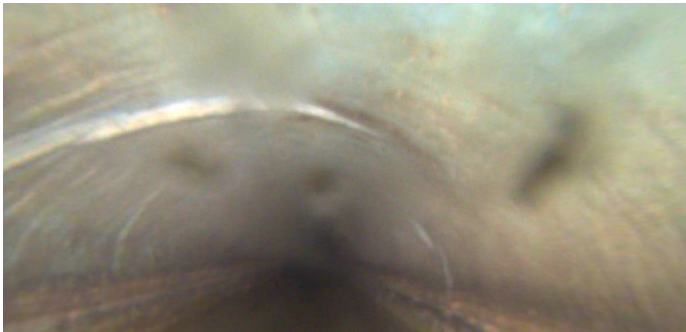
Code: **LFW**
Description: **Lining Failure Wrinkled**

Distance (ft): **203.3**
Structural Grade: **3**
O&M Grade: **0**
Clock Start/From: **8**
Clock To: **4**
1st Value:
2nd Value:
Value Percent:
Continuous Index:
Within 8" of Joint: **NO**
Remarks:

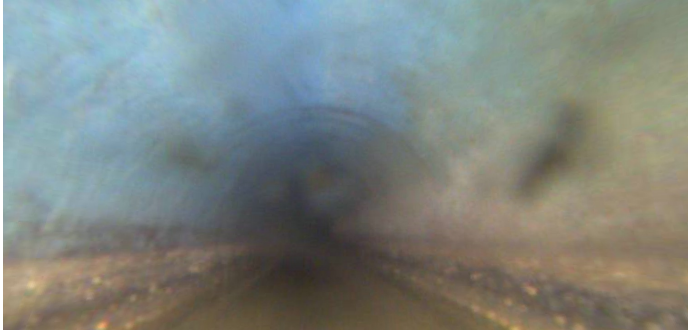
Code:	MSA
Description:	Abandoned Survey
Distance (ft):	222.3
Structural Grade:	0
O&M Grade:	0
Clock Start/From:	
Clock To:	
1st Value:	
2nd Value:	
Value Percent:	
Continuous Index:	
Within 8" of Joint:	NO
Remarks:	DEBRIS UNDER WATER
