Profile/Photo Observation Report

| Street: | STATE ST & E 13TH ST | Flow Control: | Not Controlled |
| City: | Hobart, IN | Year Renewed: | |

| US MH: | M-707-036 | DS MH: | M-707-076 |

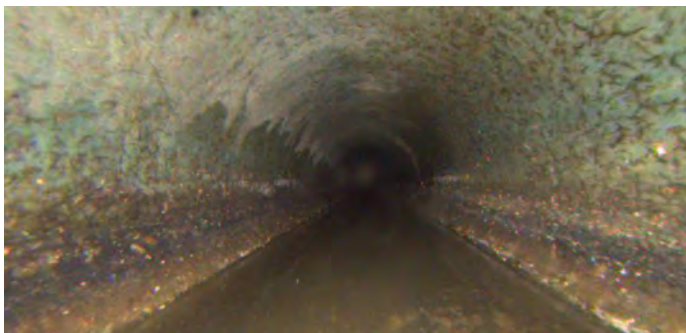
Code: **AMH**
Description: **Manhole**

Distance (ft): **.0**
Structural Grade: **0**
O&M Grade: **0**
Clock Start/From:
Clock To:
1st Value:
2nd Value:
Value Percent:
Continuous Index:
Within 8" of Joint: **NO**
Remarks: **M-707-076**

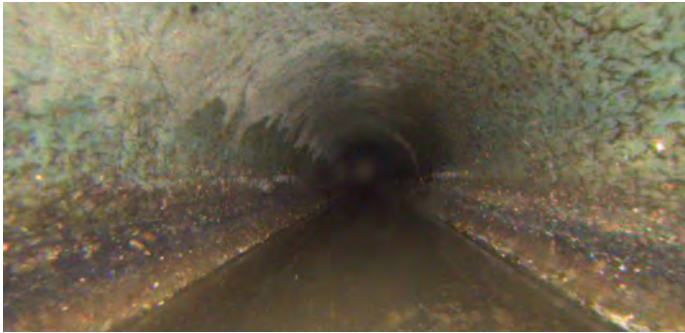
Code: **MWL**
Description: **Water Level**

Distance (ft): **.0**
Structural Grade: **0**
O&M Grade: **0**
Clock Start/From:
Clock To:
1st Value:
2nd Value:
Value Percent: **20.000**
Continuous Index:
Within 8" of Joint: **NO**
Remarks:

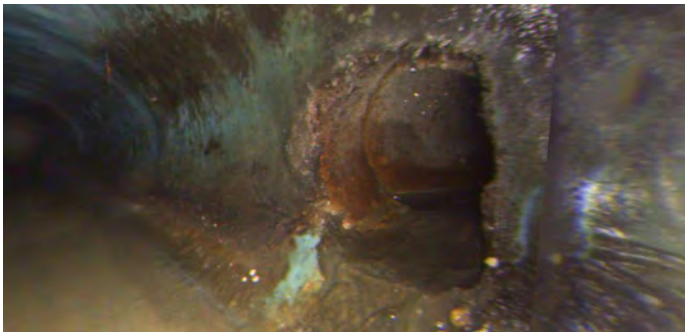
Code: **TBA**
Description: **Tap Break-in Active**

Distance (ft): **122.8**
Structural Grade: **0**
O&M Grade: **0**
Clock Start/From: **3**
Clock To:
1st Value: **4.000**
2nd Value:
Value Percent:
Continuous Index:
Within 8" of Joint:
Remarks:

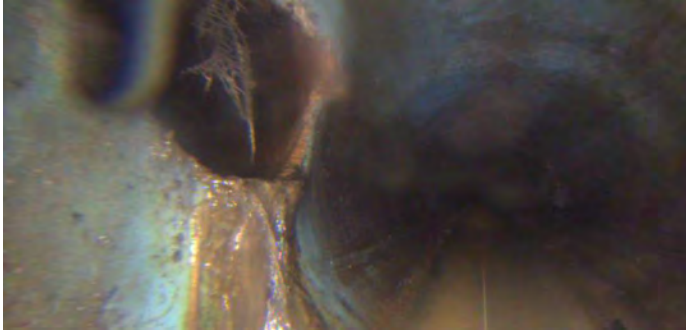
Code: **TBA**
Description: **Tap Break-in Active**

Distance (ft): **200.8**
Structural Grade: **0**
O&M Grade: **0**
Clock Start/From: **2**
Clock To:
1st Value: **4.000**
2nd Value:
Value Percent:
Continuous Index:
Within 8" of Joint:
Remarks:

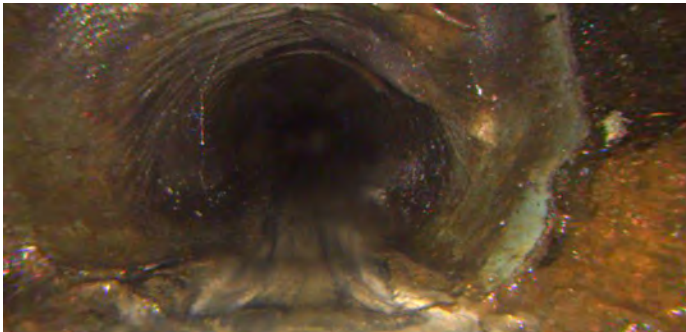
Code: **AMH**
Description: **Manhole**

Distance (ft): **251.0**
Structural Grade: **0**
O&M Grade: **0**
Clock Start/From:
Clock To:
1st Value:
2nd Value:
Value Percent:
Continuous Index:
Within 8" of Joint: **NO**
Remarks: **M-707-036**
