Profile/Photo Observation Report

| Street: | E 13TH ST | Flow Control: | Not Controlled |
| City: | Hobart, IN | Year Renewed: | |

| US MH: | M-707-036 | DS MH: | M-707-078 |

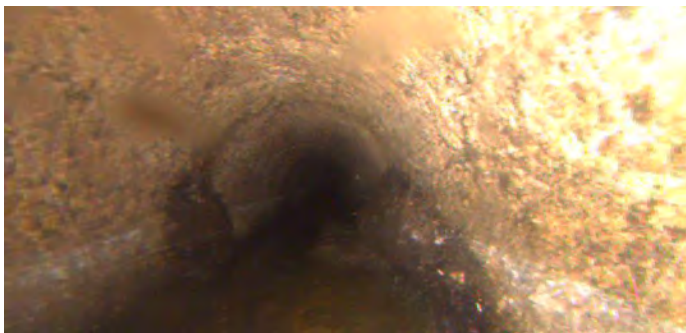
Code: **AMH**
Description: **Manhole**

Distance (ft): **.0**
Structural Grade: **0**
O&M Grade: **0**
Clock Start/From:
Clock To:
1st Value:
2nd Value:
Value Percent:
Continuous Index:
Within 8" of Joint: **NO**
Remarks: **M-707-078**

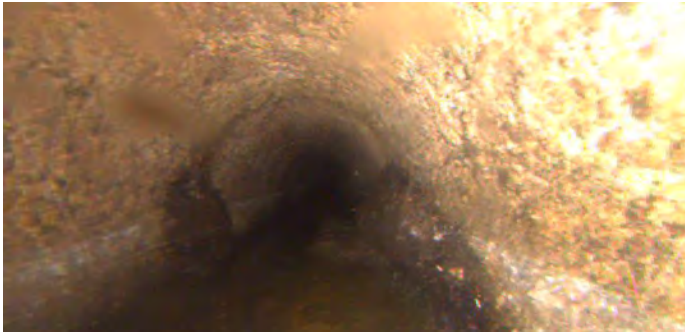
| Code: | MWL |
| Description: | Water Level |

| Distance (ft): | .0 |
| Value Percent: | 5.000 |

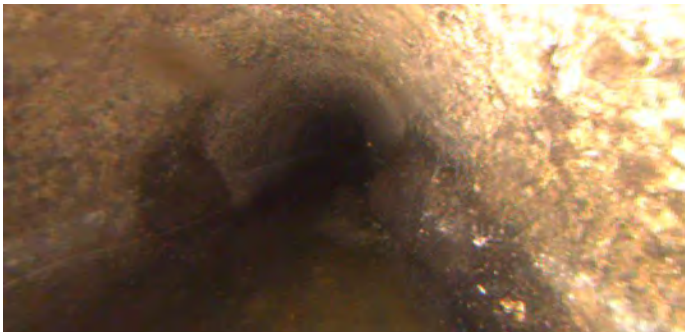
| Code: | RMJ |
| Description: | Roots Medium Joint |

| Distance (ft): | .6 |
| O&M Grade: | 3 |
| Clock Start/From: | 7 |
| Clock To: | 5 |
| Value Percent: | 10.000 |
| Remarks: | into barrel |

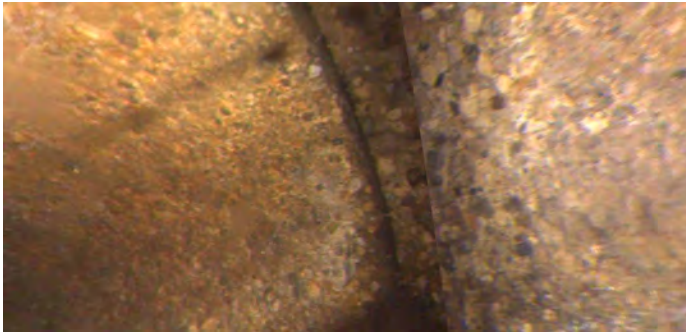
Code: **SAV**
Description: **Surface Aggregate Visible**

Distance (ft): **5.5**
Structural Grade: **3**
O&M Grade: **0**
Clock Start/From: **7**
Clock To: **5**
1st Value:
2nd Value:
Value Percent:
Continuous Index: **S01**
Within 8" of Joint:
Remarks:

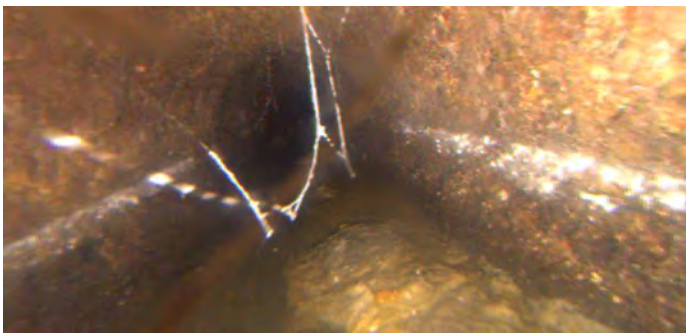
Code: **DSZ**
Description: **Deposits Settled Other**

Distance (ft): **6.7**
Structural Grade: **0**
O&M Grade: **2**
Clock Start/From: **6**
Clock To:
1st Value:
2nd Value:
Value Percent: **5.000**
Continuous Index: **S02**
Within 8" of Joint: **NO**
Remarks: **debris**

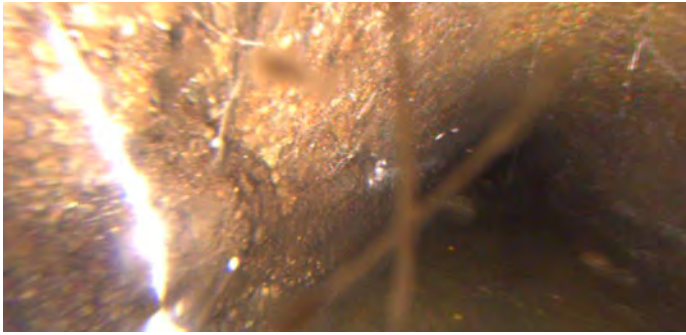
Code: **RFJ**
Description: **Roots Fine Joint**

Distance (ft): **8.5**
Structural Grade: **0**
O&M Grade: **1**
Clock Start/From: **7**
Clock To: **5**
1st Value:
2nd Value:
Value Percent:
Continuous Index: **S03**
Within 8" of Joint: **YES**
Remarks: **wandering**

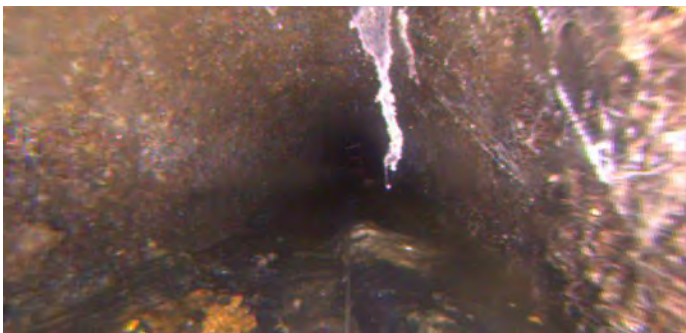
Code: **MGO**
Description: **General Observation**

Distance (ft): **14.9**
Structural Grade: **0**
O&M Grade: **0**
Clock Start/From:
Clock To:
1st Value:
2nd Value:
Value Percent:
Continuous Index:
Within 8" of Joint: **NO**
Remarks: **rear camera/cob webs**

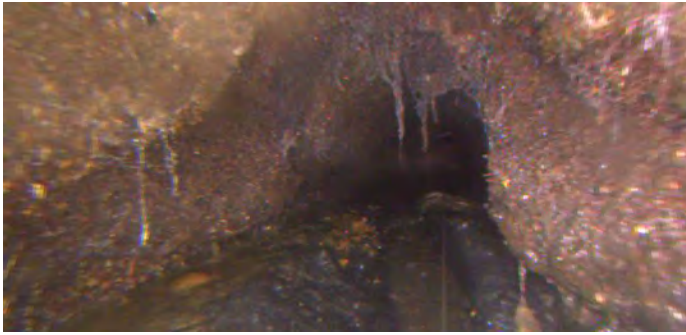
Code: **RMJ**
Description: **Roots Medium Joint**

Distance (ft): **15.5**
Structural Grade: **0**
O&M Grade: **3**
Clock Start/From: **7**
Clock To: **5**
1st Value:
2nd Value:
Value Percent: **10.000**
Continuous Index: **S04**
Within 8" of Joint: **YES**
Remarks: **wandering**

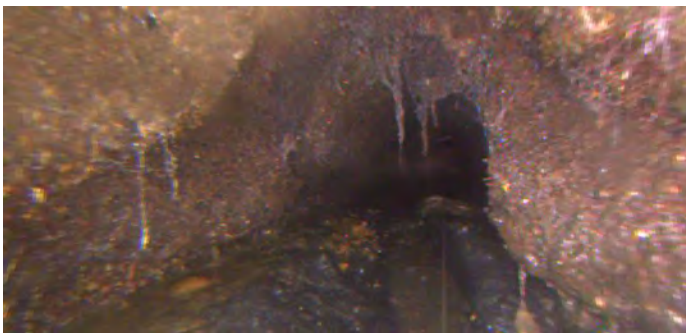
Code: **RFJ**
Description: **Roots Fine Joint**

Distance (ft): **15.5**
Structural Grade: **0**
O&M Grade: **1**
Clock Start/From: **7**
Clock To: **5**
1st Value:
2nd Value:
Value Percent:
Continuous Index: **F03**
Within 8" of Joint: **YES**
Remarks: **wandering**

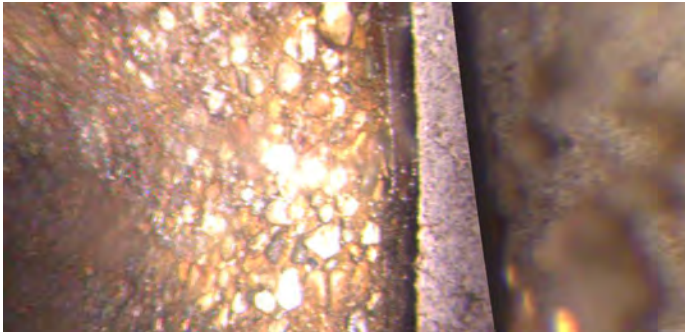
Code: **MMC**
Description: **Material Change**

Distance (ft): **48.1**
Structural Grade: **0**
O&M Grade: **0**
Clock Start/From:
Clock To:
1st Value:
2nd Value:
Value Percent:
Continuous Index:
Within 8" of Joint: **NO**
Remarks: **vcp**

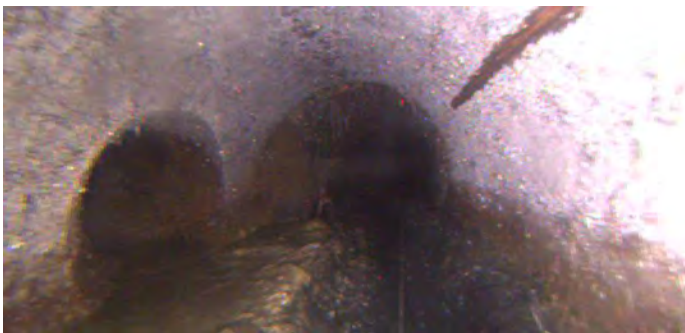
Code: **TF**
Description: **Tap Factory**

Distance (ft): **49.7**
Structural Grade: **0**
O&M Grade: **0**
Clock Start/From: **3**
Clock To:
1st Value: **4.000**
2nd Value:
Value Percent:
Continuous Index:
Within 8" of Joint: **YES**
Remarks:

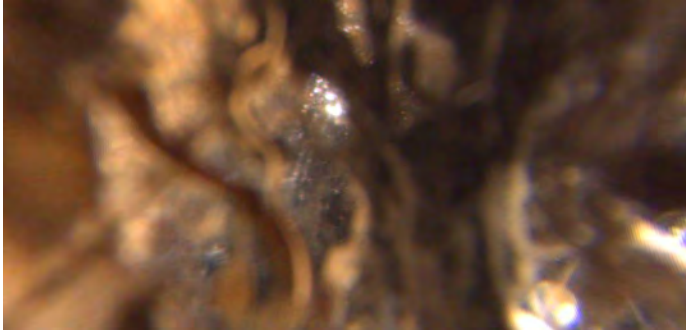
| Comment: | Heavy mud at 57'. | | |

Code: **MSA**
Description: **Abandoned Survey**

Distance (ft): **58.7**
Structural Grade: **0**
O&M Grade: **0**
Clock Start/From:
Clock To:
1st Value:
2nd Value:
Value Percent:
Continuous Index:
Within 8" of Joint: **NO**
Remarks: **unknown blockage**

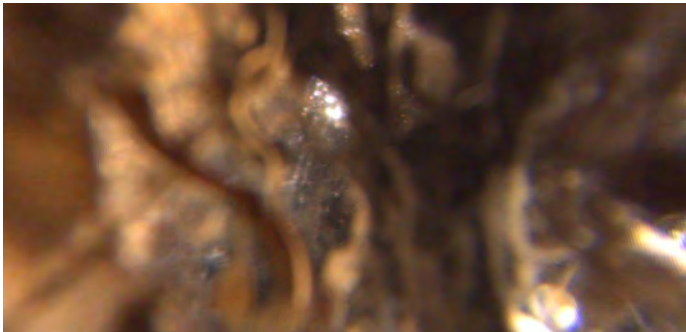
Code: **RMJ**
Description: **Roots Medium Joint**

Distance (ft): **58.7**
Structural Grade: **0**
O&M Grade: **3**
Clock Start/From: **7**
Clock To: **5**
1st Value:
2nd Value:
Value Percent: **10.000**
Continuous Index: **F04**
Within 8" of Joint: **YES**
Remarks: **wandering**

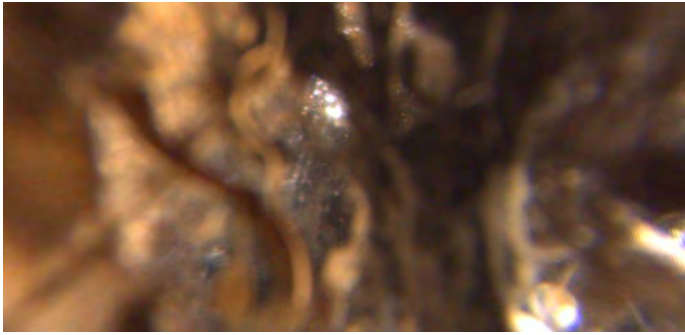
Code: **DSZ**
Description: **Deposits Settled Other**

Distance (ft): **58.7**
Structural Grade: **0**
O&M Grade: **2**
Clock Start/From: **6**
Clock To:
1st Value:
2nd Value:
Value Percent: **5.000**
Continuous Index: **F02**
Within 8" of Joint: **NO**
Remarks: **debris**

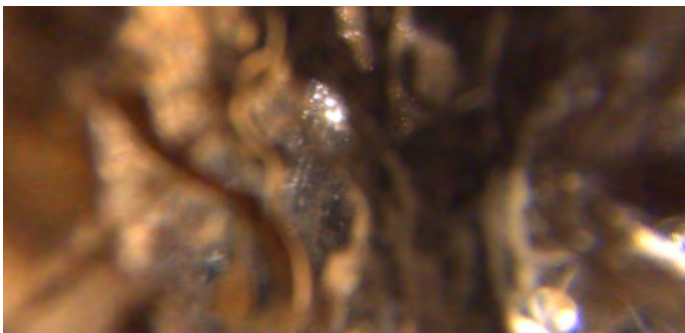
Code: **SAV**
Description: **Surface Aggregate Visible**

Distance (ft): **58.7**
Structural Grade: **3**
O&M Grade: **0**
Clock Start/From: **7**
Clock To: **5**
1st Value:
2nd Value:
Value Percent:
Continuous Index: **F01**
Within 8" of Joint:
Remarks:
