## Profile/Photo Observation Report

Date:	<b>04/10/2018</b>	Weather:		Coding:	<b>PACP 6.0</b>
Pipe Length (ft):	<b>283.8</b>	Owner:	<b>NA</b>	Pre Clean:	<b>Not Known</b>
P.O.#:		Surveyor:	<b>Byrd Fitzgerald</b>	PSR:	<b>P-707-078-036</b>
Customer:		Clean Date:	<b>01/01/1900</b>	Shape:	<b>C</b>

Street:	<b>Capitol</b>	Flow Control:	<b>Not Controlled</b>
City:	<b>Hobart, IN</b>	Year Renewed:	
Location:	<b>Light Highway</b>	Tape/Media #:	
Purpose:	<b>Maintenance Related</b>	Dia/Height:	<b>12"</b>
Use:	<b>Sanitary</b>	Material:	<b>CP</b>
Drain Area:	<b>NA</b>	Lining:	<b>Cured in Place</b>
Category:	<b>NA</b>		
Comment:	<b>Heavy mud at 57'.</b>

Location Details:		Direction of Survey:	<b>Upstream</b>
US MH:	<b>M-707-036</b>	DS MH:	<b>M-707-078</b>
		Total Length Surveyed (ft):	<b>58.7</b>

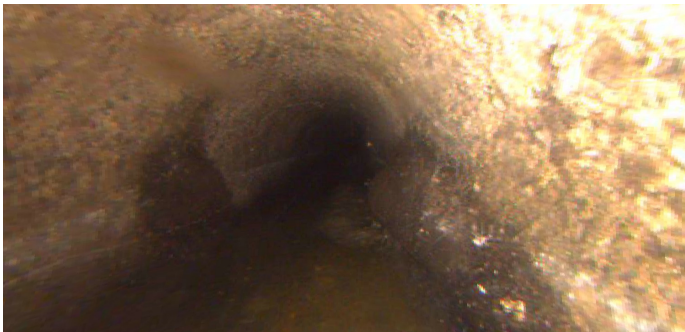
Code:	<b>RMJ</b>
Description:	<b>Roots Medium Joint</b>

Distance (ft):	<b>.6</b>
Structural Grade:	<b>0</b>
O&M Grade:	<b>3</b>
Clock Start/From:	<b>7</b>
Clock To:	<b>5</b>
1st Value:	
2nd Value:	
Value Percent:	<b>10.000</b>
Continuous Index:	
Within 8" of Joint:	<b>YES</b>
Remarks:	<b>into barrel</b>

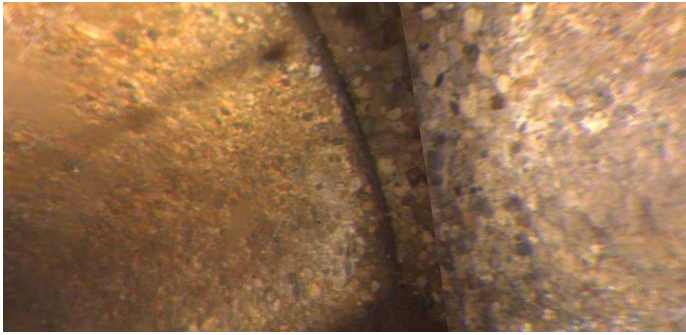
Code: **SAV**  
Description: **Surface Aggregate Visible**

Distance (ft): **5.5**  
Structural Grade: **3**  
O&M Grade: **0**  
Clock Start/From: **7**  
Clock To: **5**  
1st Value:  
2nd Value:  
Value Percent:  
Continuous Index: **S01**  
Within 8" of Joint:  
Remarks:

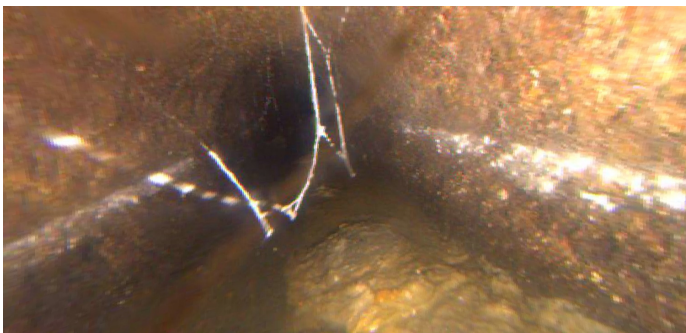
Code: **DSZ**  
Description: **Deposits Settled Other**

Distance (ft): **6.7**  
Structural Grade: **0**  
O&M Grade: **2**  
Clock Start/From: **6**  
Clock To:  
1st Value:  
2nd Value:  
Value Percent: **5.000**  
Continuous Index: **S02**  
Within 8" of Joint: **NO**  
Remarks: **debris**

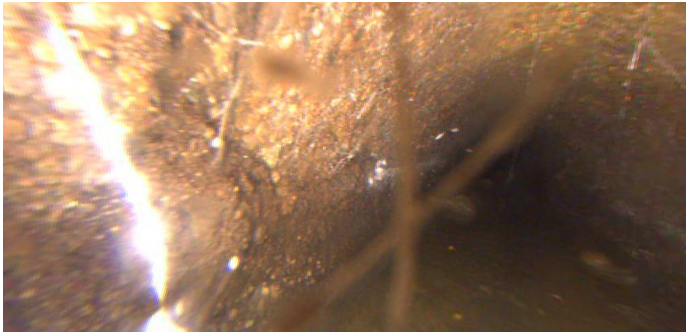
Code: **RFJ**  
Description: **Roots Fine Joint**

Distance (ft): **8.5**  
Structural Grade: **0**  
O&M Grade: **1**  
Clock Start/From: **7**  
Clock To: **5**  
1st Value:  
2nd Value:  
Value Percent:  
Continuous Index: **S03**  
Within 8" of Joint: **YES**  
Remarks: **wandering**

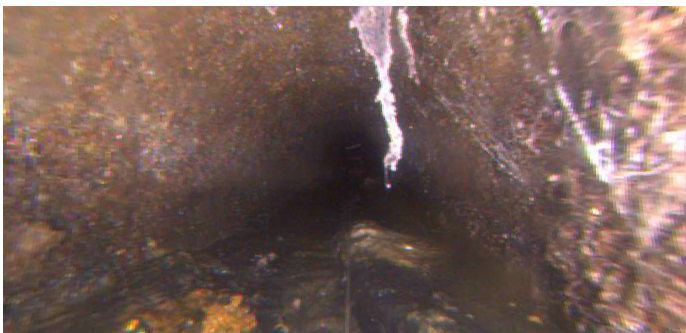
Code: **MGO**  
Description: **General Observation**

Distance (ft): **14.9**  
Structural Grade: **0**  
O&M Grade: **0**  
Clock Start/From:  
Clock To:  
1st Value:  
2nd Value:  
Value Percent:  
Continuous Index:  
Within 8" of Joint: **NO**  
Remarks: **rear camera/cob webs**

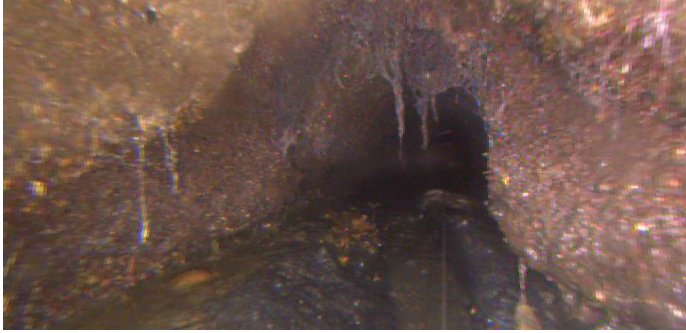
Code: **RMJ**  
Description: **Roots Medium Joint**

Distance (ft): **15.5**  
Structural Grade: **0**  
O&M Grade: **3**  
Clock Start/From: **7**  
Clock To: **5**  
1st Value:  
2nd Value:  
Value Percent: **10.000**  
Continuous Index: **S04**  
Within 8" of Joint: **YES**  
Remarks: **wandering**

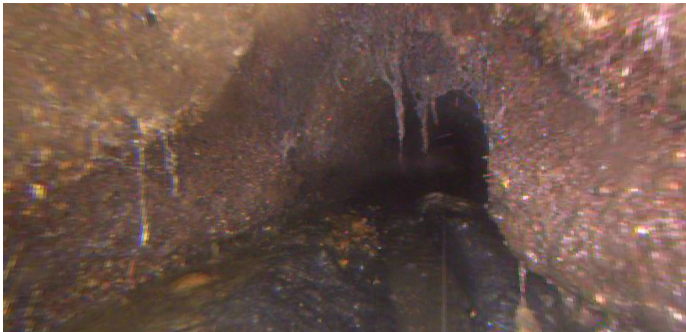
Code: **RFJ**  
Description: **Roots Fine Joint**

Distance (ft): **15.5**  
Structural Grade: **0**  
O&M Grade: **1**  
Clock Start/From: **7**  
Clock To: **5**  
1st Value:  
2nd Value:  
Value Percent:  
Continuous Index: **F03**  
Within 8" of Joint: **YES**  
Remarks: **wandering**

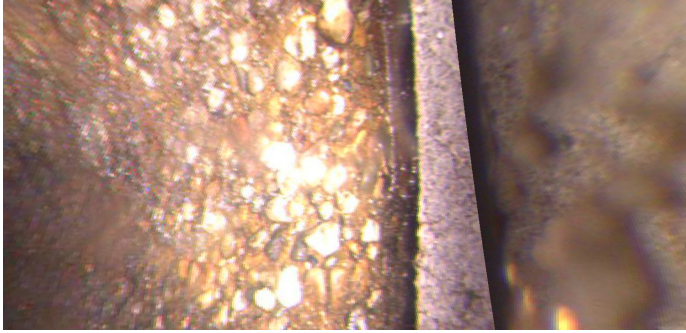
Code: **MMC**  
Description: **Material Change**

Distance (ft): **48.1**  
Structural Grade: **0**  
O&M Grade: **0**  
Clock Start/From:  
Clock To:  
1st Value:  
2nd Value:  
Value Percent:  
Continuous Index:  
Within 8" of Joint: **NO**  
Remarks: **vcp**

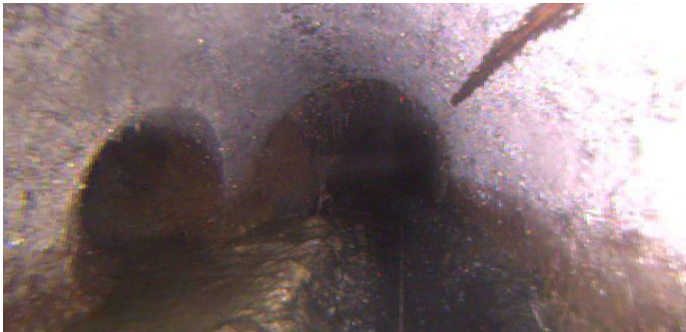
Code: **TF**  
Description: **Tap Factory**

Distance (ft): **49.7**  
Structural Grade: **0**  
O&M Grade: **0**  
Clock Start/From: **3**  
Clock To:  
1st Value: **4.000**  
2nd Value:  
Value Percent:  
Continuous Index:  
Within 8" of Joint: **YES**  
Remarks:

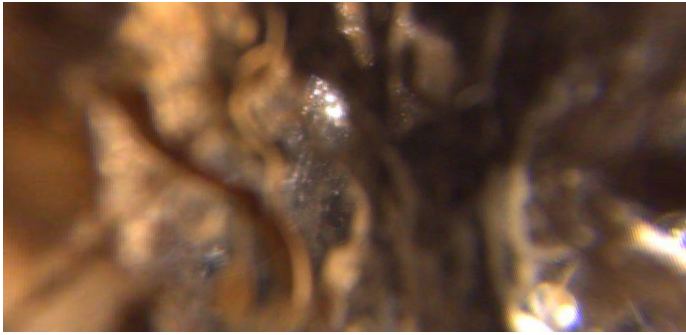
Code: **MSA**  
Description: **Abandoned Survey**

Distance (ft): **58.7**  
Structural Grade: **0**  
O&M Grade: **0**  
Clock Start/From:  
Clock To:  
1st Value:  
2nd Value:  
Value Percent:  
Continuous Index:  
Within 8" of Joint: **NO**  
Remarks: **unknown blockage**

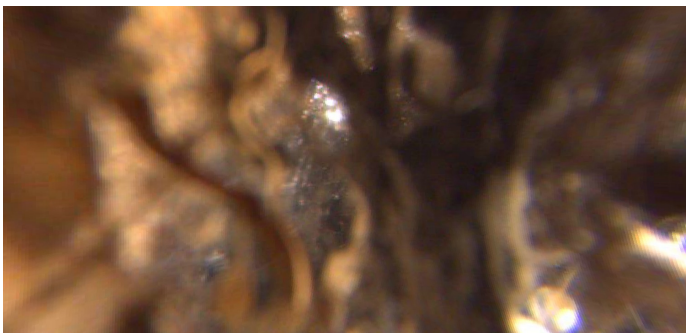
Code: **RMJ**  
Description: **Roots Medium Joint**

Distance (ft): **58.7**  
Structural Grade: **0**  
O&M Grade: **3**  
Clock Start/From: **7**  
Clock To: **5**  
1st Value:  
2nd Value:  
Value Percent: **10.000**  
Continuous Index: **F04**  
Within 8" of Joint: **YES**  
Remarks: **wandering**

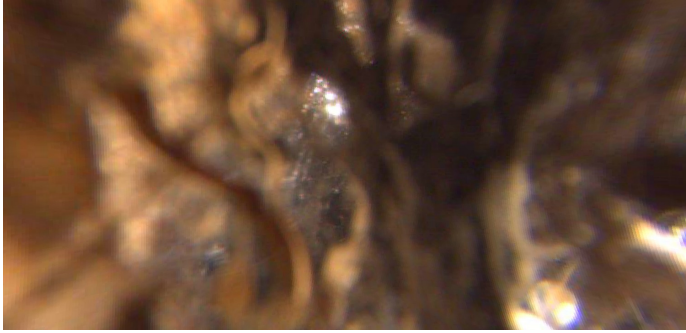
Code: **DSZ**  
Description: **Deposits Settled Other**

Distance (ft): **58.7**  
Structural Grade: **0**  
O&M Grade: **2**  
Clock Start/From: **6**  
Clock To:  
1st Value:  
2nd Value:  
Value Percent: **5.000**  
Continuous Index: **F02**  
Within 8" of Joint: **NO**  
Remarks: **debris**

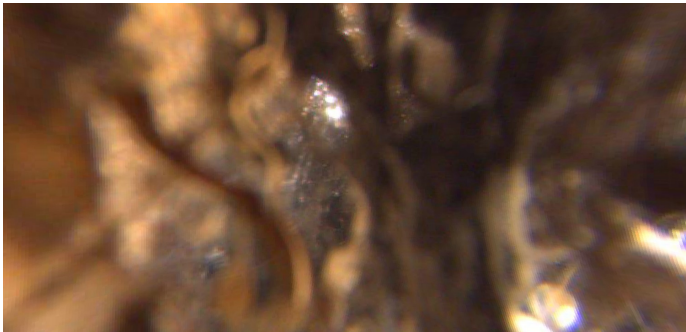
Code: **SAV**  
Description: **Surface Aggregate Visible**

Distance (ft): **58.7**  
Structural Grade: **3**  
O&M Grade: **0**  
Clock Start/From: **7**  
Clock To: **5**  
1st Value:  
2nd Value:  
Value Percent:  
Continuous Index: **F01**  
Within 8" of Joint:  
Remarks:
