Profile/Photo Observation Report

Date:	04/11/2018	Weather:		Coding:	PACP 6.0
Pipe Length (ft):	283.8	Owner:	NA	Pre Clean:	Not Known
P.O.#:		Surveyor:	Jen Costello	PSR:	P-707-078-036
Customer:		Clean Date:	01/01/1900	Shape:	C

Street:	Capitol	Flow Control:	Not Controlled
City:	Hobart, IN	Year Renewed:	
Location:	Light Highway	Tape/Media #:	
Purpose:	Maintenance Related	Dia/Height:	12"
Use:	Sanitary	Material:	VCP
Drain Area:	NA	Lining:	Cured in Place
Category:	NA		
Comment:	Reverse setup. heavy silt caused rollover at 4'.		
Location Details:		Direction of Survey:	Downstream
US MH:	M-707-036	DS MH:	M-707-078
		Total Length Surveyed (ft):	5.1

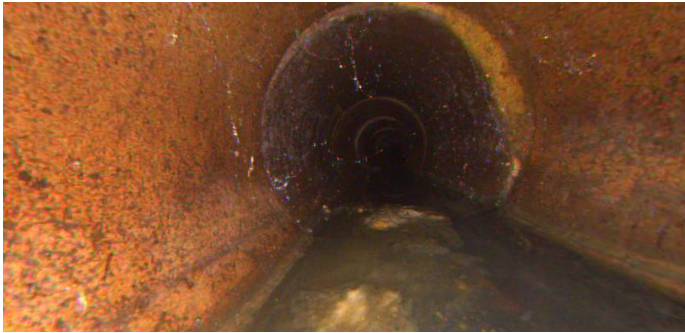
Code:	MWL
Description:	Water Level

Distance (ft):	.0
Structural Grade:	0
O&M Grade:	0
Clock Start/From:	
Clock To:	
1st Value:	
2nd Value:	
Value Percent:	10.000
Continuous Index:	
Within 8" of Joint:	NO
Remarks:

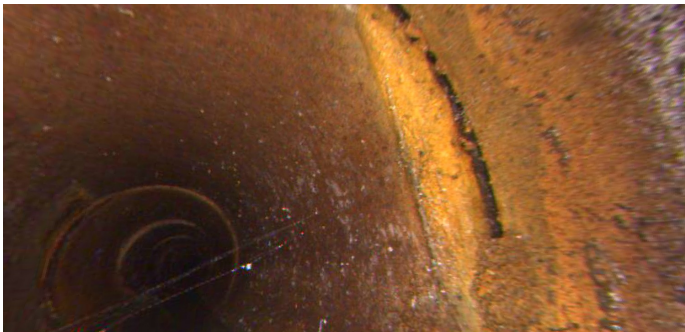
Code:	DAE
Description:	Deposits Attached Encrustation

Distance (ft):	2.3
Structural Grade:	0
O&M Grade:	2
Clock Start/From:	1
Clock To:	4
1st Value:	
2nd Value:	
Value Percent:	5.000
Continuous Index:	
Within 8" of Joint:	YES
Remarks:

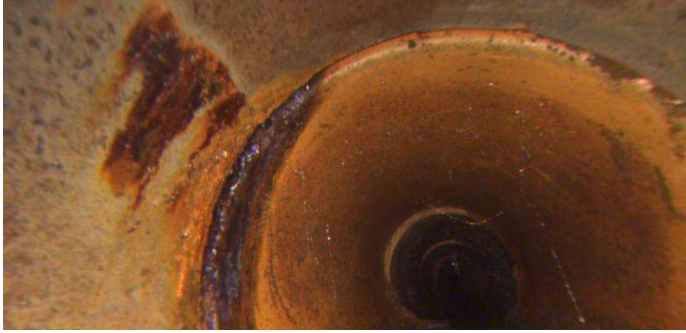
Code: **CL**
Description: **Crack Longitudinal**

Distance (ft): **3.9**
Structural Grade: **2**
O&M Grade: **0**
Clock Start/From: **10**
Clock To:
1st Value:
2nd Value:
Value Percent:
Continuous Index:
Within 8" of Joint: **YES**
Remarks:

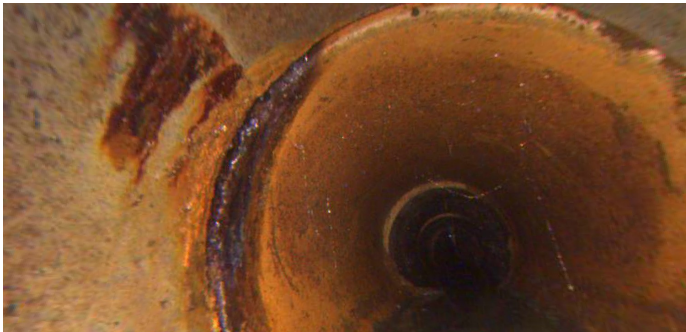
Code: **IW**
Description: **Infil Weeper**

Distance (ft): **3.9**
Structural Grade: **0**
O&M Grade: **2**
Clock Start/From: **7**
Clock To: **11**
1st Value:
2nd Value:
Value Percent:
Continuous Index:
Within 8" of Joint: **YES**
Remarks:

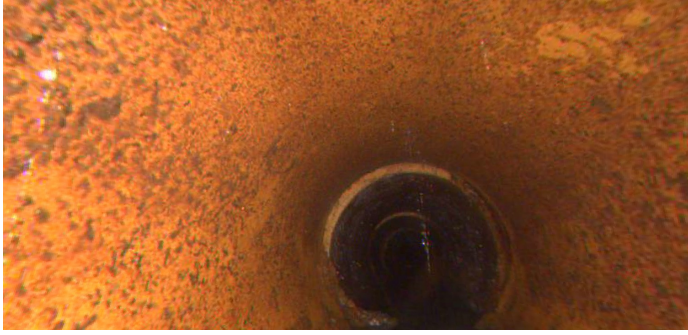
Code:	MSA
Description:	Abandoned Survey
Distance (ft):	5.1
Structural Grade:	0
O&M Grade:	0
Clock Start/From:	
Clock To:	
1st Value:	
2nd Value:	
Value Percent:	
Continuous Index:	
Within 8" of Joint:	NO
Remarks:	debris
