RedZone
ROBOTICS

Street:	East 13th Street	Flow Control:	Not Controlled
City:	Hobart, IN	Year Renewed:	
Location:	Local rural streets with light traffic, typical	Tape/Media #:	
Purpose:	Routine Assessment	Dia/Height:	12"
Use:	Sanitary Sewage Pipe	Material:	CP
Drain Area:		Lining:	None
Category:	NA		
Comment:			
Location Details:		Direction of Survey:	Downstream
US MH:	M-707-036	DS MH:	M-707-078
		Total Length Surveyed (ft):	282.0

Tuesday, April 25, 2023

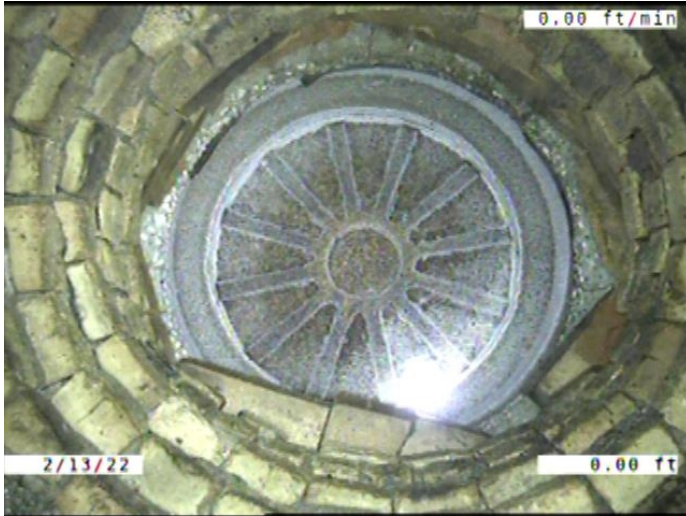
Code: **AMH**
Description: **Manhole**

Distance (ft): **.0**
Structural Grade: **0**
O&M Grade: **0**
Clock Start/From:
Clock To:
1st Value:
2nd Value:
Value Percent:
Continuous Index:
Within 8" of Joint: **NO**
Remarks: **M-707-036**

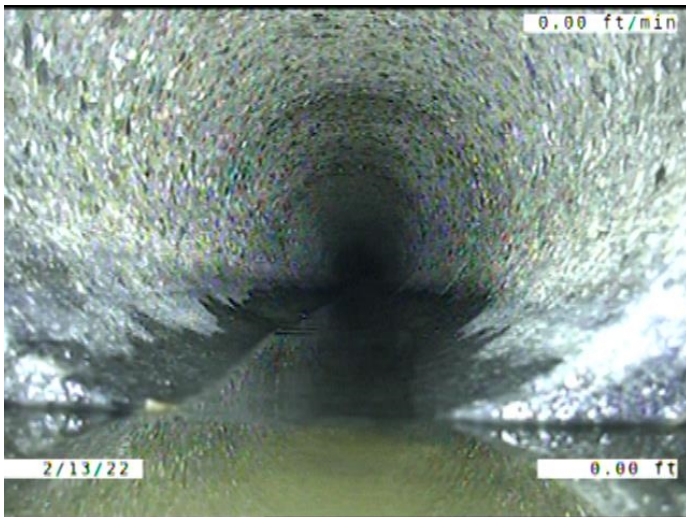
Code: **MWL**
Description: **Miscellaneous Water Level**

Distance (ft): **.0**
Structural Grade: **0**
O&M Grade: **0**
Clock Start/From:
Clock To:
1st Value:
2nd Value:
Value Percent: **5.000**
Continuous Index:
Within 8" of Joint: **NO**
Remarks:

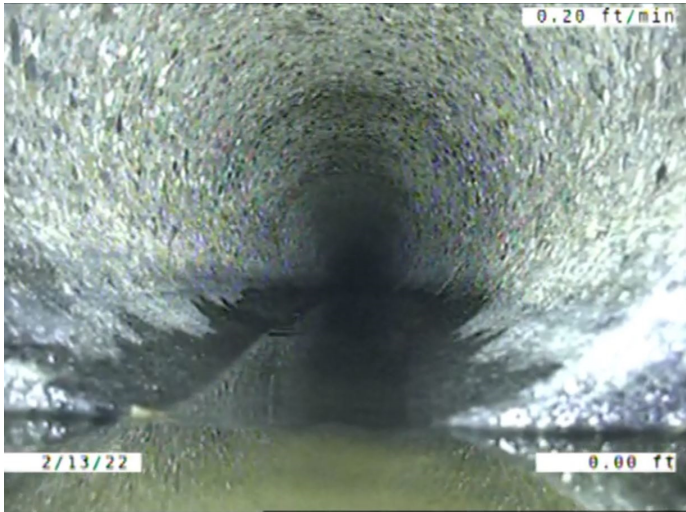
Code: **SAV**
Description: **Surface Damage Aggregate Visible**

Distance (ft): **.0**
Structural Grade: **2**
O&M Grade: **0**
Clock Start/From: **7**
Clock To: **5**
1st Value:
2nd Value:
Value Percent:
Continuous Index: **S06**
Within 8" of Joint: **NO**
Remarks:

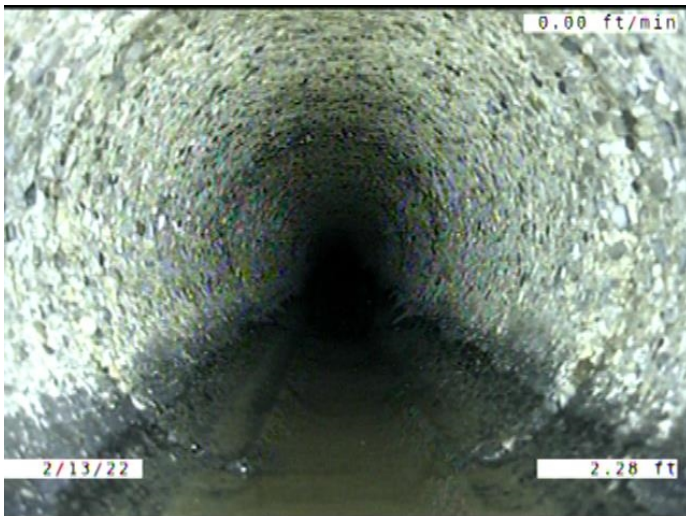
Code: **DSF**
Description: **Deposits Settled Fine**

Distance (ft): **2.3**
Structural Grade: **0**
O&M Grade: **2**
Clock Start/From: **5**
Clock To: **7**
1st Value:
2nd Value:
Value Percent: **5.000**
Continuous Index: **S01**
Within 8" of Joint: **YES**
Remarks:

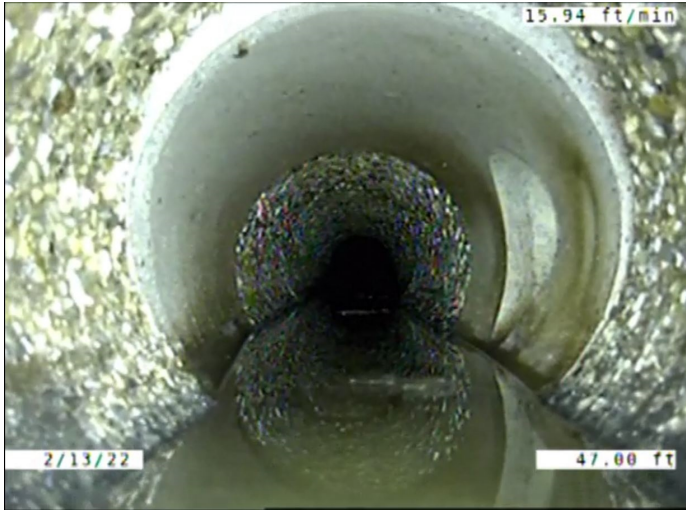
Code: **SAV**
Description: **Surface Damage Aggregate Visible**

Distance (ft): **47.0**
Structural Grade: **2**
O&M Grade: **0**
Clock Start/From: **7**
Clock To: **5**
1st Value:
2nd Value:
Value Percent:
Continuous Index: **F06**
Within 8" of Joint: **NO**
Remarks:

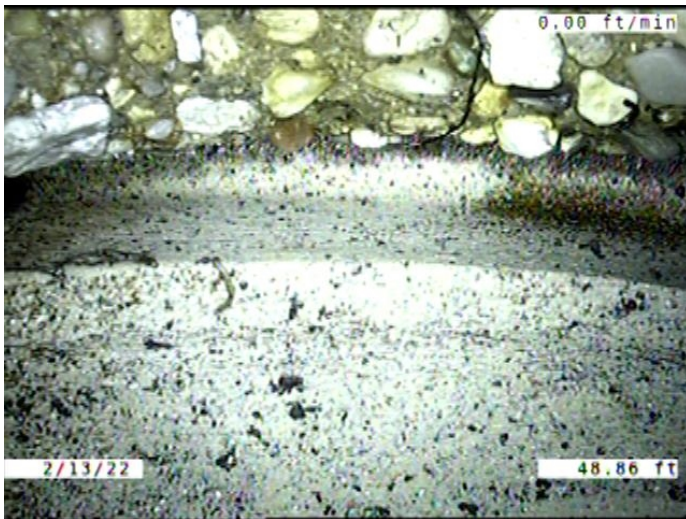
Code: **MMC**
Description: **Miscellaneous Material Change**

Distance (ft): **48.9**
Structural Grade: **0**
O&M Grade: **0**
Clock Start/From:
Clock To:
1st Value:
2nd Value:
Value Percent:
Continuous Index:
Within 8" of Joint: **NO**
Remarks: **CONCRETE TO VCP**

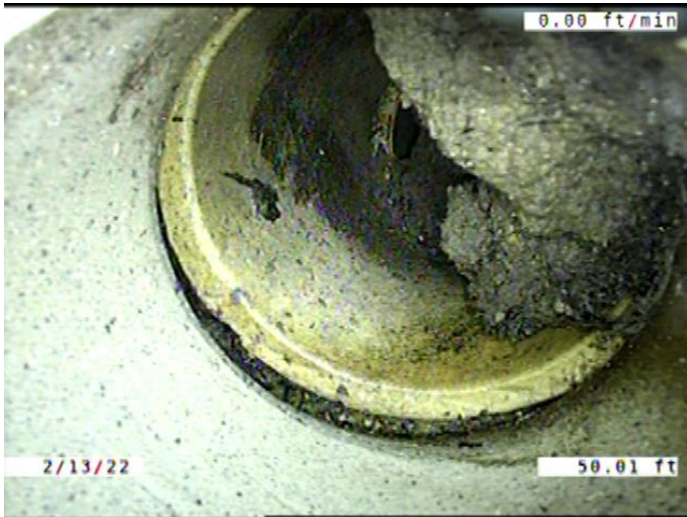
Code: **TF**
Description: **Tap Factory**

Distance (ft): **50.0**
Structural Grade: **0**
O&M Grade: **0**
Clock Start/From: **3**
Clock To:
1st Value: **6.000**
2nd Value:
Value Percent:
Continuous Index:
Within 8" of Joint: **YES**
Remarks: **LOOKS TO BE 80% PLUGGED**

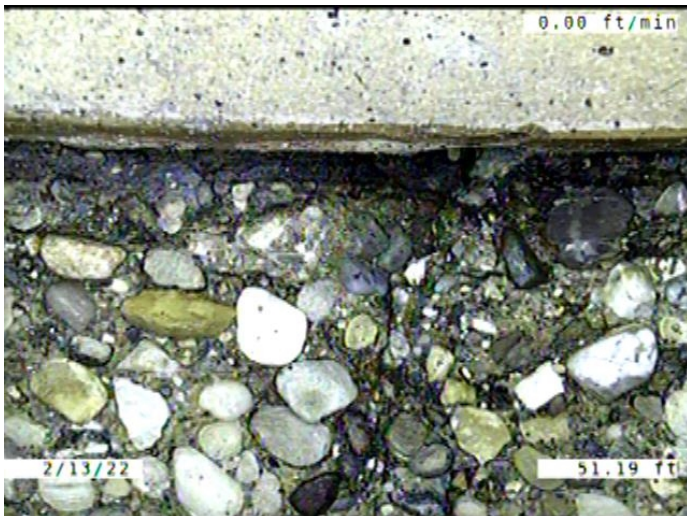
Code: **MMC**
Description: **Miscellaneous Material Change**

Distance (ft): **51.2**
Structural Grade: **0**
O&M Grade: **0**
Clock Start/From:
Clock To:
1st Value:
2nd Value:
Value Percent:
Continuous Index:
Within 8" of Joint: **NO**
Remarks: **VCP TO CONCRETE**

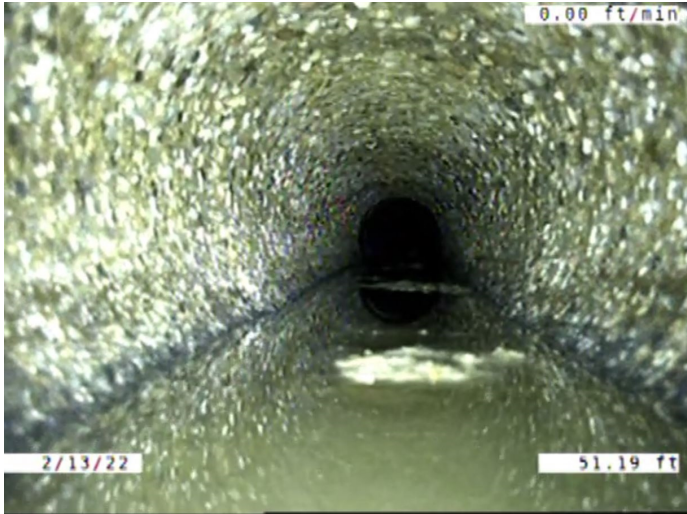
Code: **SAP**
Description: **Surface Damage Aggregate Projecting**

Distance (ft): **51.2**
Structural Grade: **3**
O&M Grade: **0**
Clock Start/From: **8**
Clock To: **4**
1st Value:
2nd Value:
Value Percent:
Continuous Index: **S07**
Within 8" of Joint: **NO**
Remarks:

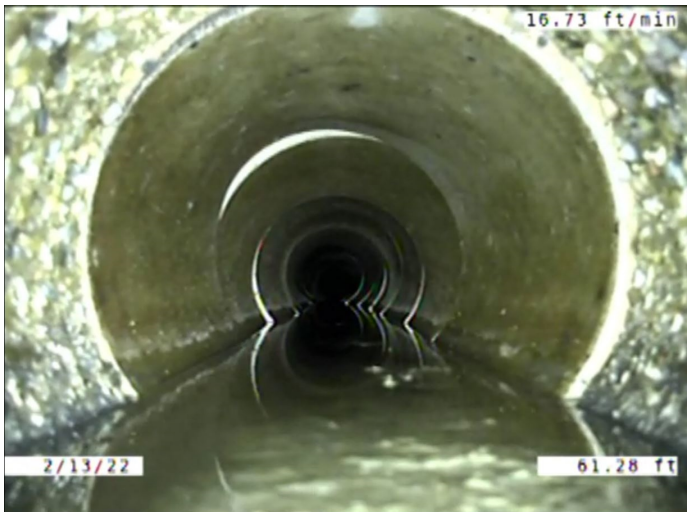
Code: **SAP**
Description: **Surface Damage Aggregate Projecting**

Distance (ft): **61.3**
Structural Grade: **3**
O&M Grade: **0**
Clock Start/From: **8**
Clock To: **4**
1st Value:
2nd Value:
Value Percent:
Continuous Index: **F07**
Within 8" of Joint: **NO**
Remarks:

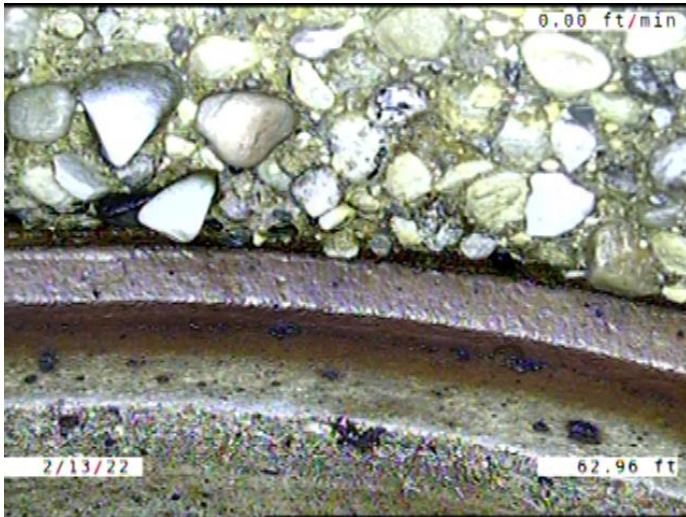
Code: **MMC**
Description: **Miscellaneous Material Change**

Distance (ft): **63.0**
Structural Grade: **0**
O&M Grade: **0**
Clock Start/From:
Clock To:
1st Value:
2nd Value:
Value Percent:
Continuous Index:
Within 8" of Joint: **NO**
Remarks: **CONCRETE TO VCP**

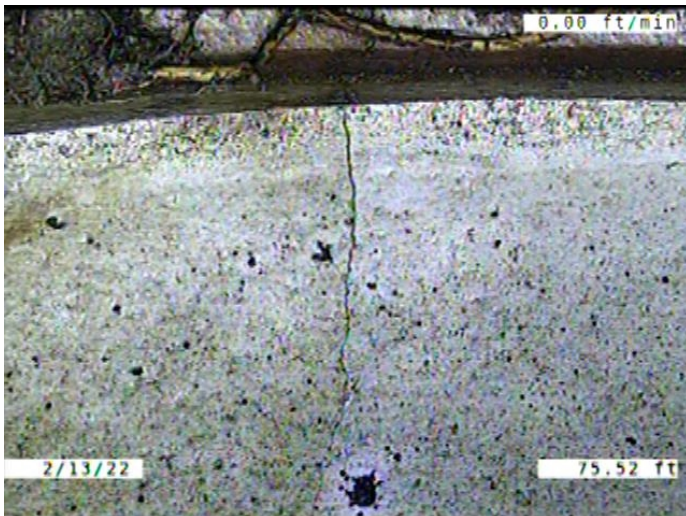
Code: **CL**
Description: **Crack Longitudinal**

Distance (ft): **75.5**
Structural Grade: **2**
O&M Grade: **0**
Clock Start/From: **10**
Clock To:
1st Value:
2nd Value:
Value Percent:
Continuous Index:
Within 8" of Joint: **YES**
Remarks:

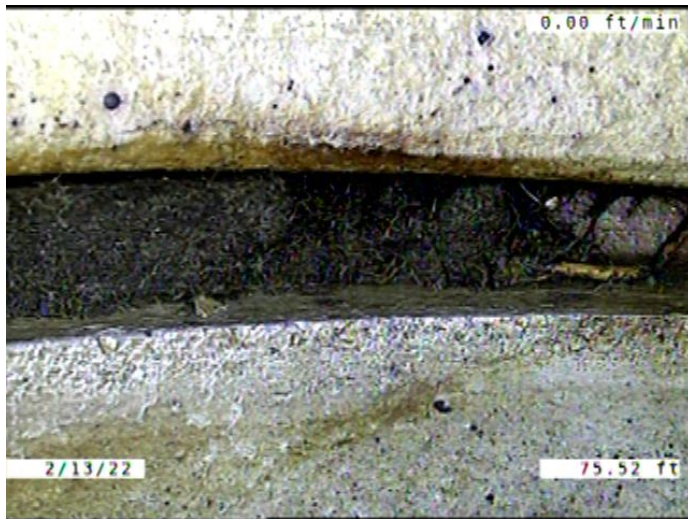
Code: **RFJ**
 Description: **Roots Fine Joint**

Distance (ft): **75.5**
 Structural Grade: **0**
 O&M Grade: **1**
 Clock Start/From: **8**
 Clock To: **11**
 1st Value:
 2nd Value:
 Value Percent:
 Continuous Index:
 Within 8" of Joint: **YES**
 Remarks:

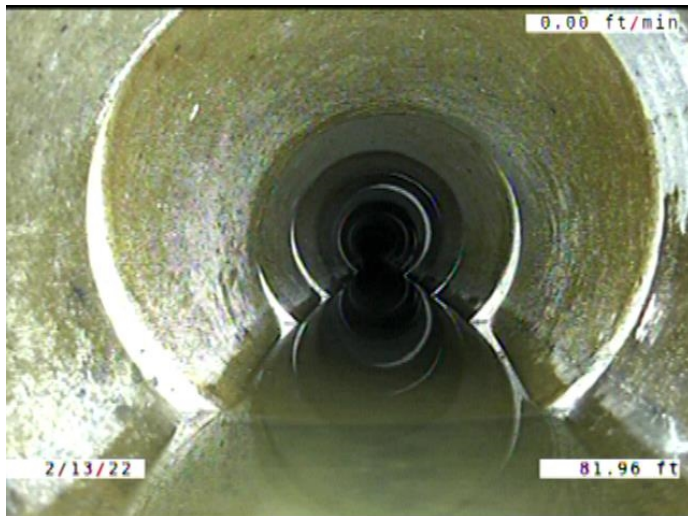
Code: **MWLS**
 Description: **Miscellaneous Water Level Sag**

Distance (ft): **82.0**
 Structural Grade: **2**
 O&M Grade: **0**
 Clock Start/From:
 Clock To:
 1st Value:
 2nd Value:
 Value Percent: **10.000**
 Continuous Index: **S02**
 Within 8" of Joint: **NO**
 Remarks:

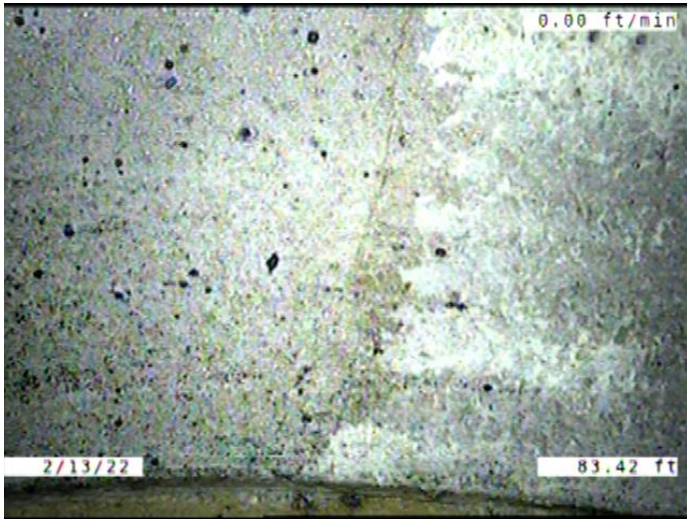
Code: **CL**
Description: **Crack Longitudinal**

Distance (ft): **83.4**
Structural Grade: **2**
O&M Grade: **0**
Clock Start/From: **1**
Clock To:
1st Value:
2nd Value:
Value Percent:
Continuous Index:
Within 8" of Joint: **YES**
Remarks:

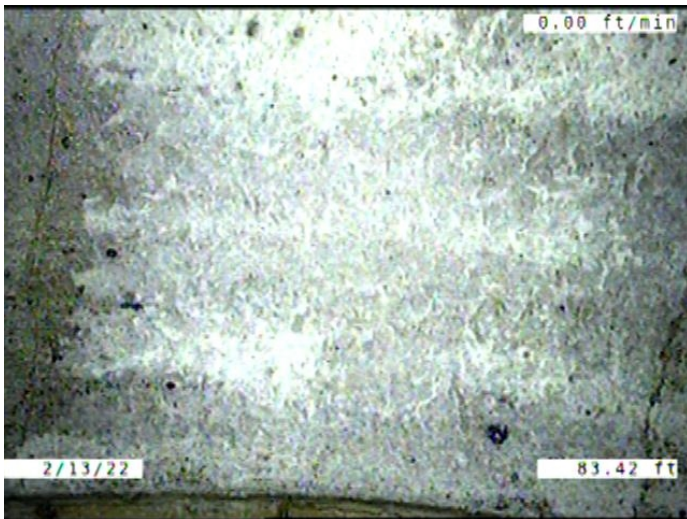
Code: **ISB**
Description: **Infiltration Stain Barrel**

Distance (ft): **83.4**
Structural Grade: **0**
O&M Grade: **1**
Clock Start/From: **1**
Clock To: **4**
1st Value:
2nd Value:
Value Percent:
Continuous Index:
Within 8" of Joint: **YES**
Remarks:

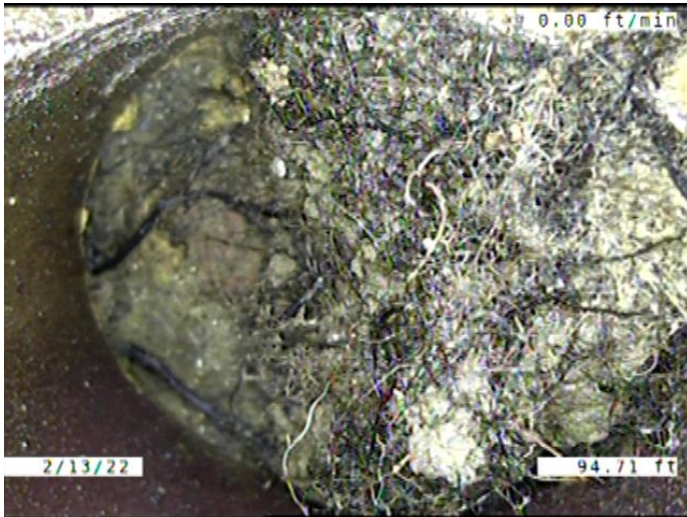
Code:	TFD
Description:	Tap Factory Defective
Distance (ft):	94.7
Structural Grade:	0
O&M Grade:	3
Clock Start/From:	3
Clock To:	
1st Value:	6.000
2nd Value:	
Value Percent:	
Continuous Index:	
Within 8" of Joint:	YES
Remarks:	LOOKS TO BE 100% PLUGGED. ROOTS GROWING FROM THE SERVIC

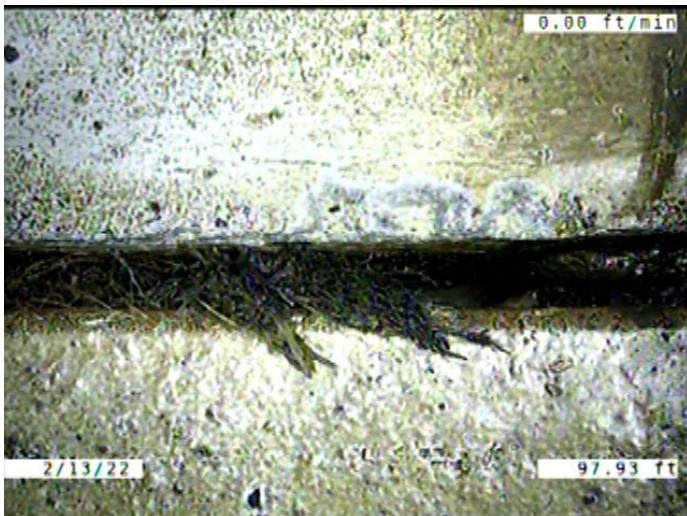
Code:	RFJ
Description:	Roots Fine Joint
Distance (ft):	97.9
Structural Grade:	0
O&M Grade:	1
Clock Start/From:	8
Clock To:	11
1st Value:	
2nd Value:	
Value Percent:	
Continuous Index:	
Within 8" of Joint:	YES
Remarks:

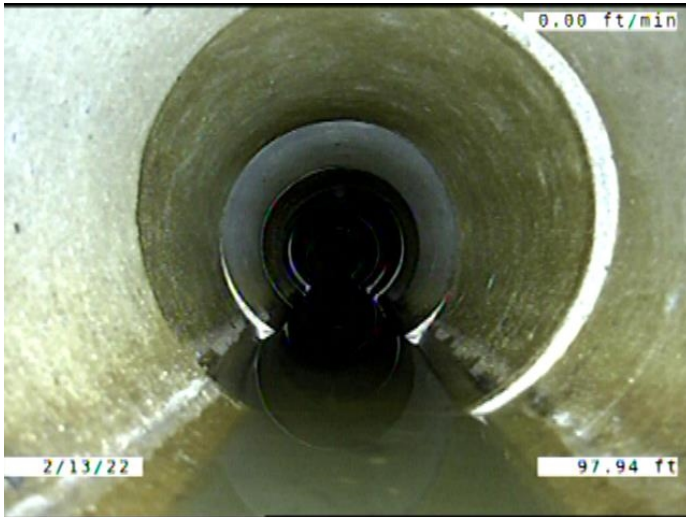
Code: **MWLS**
 Description: **Miscellaneous Water Level Sag**

Distance (ft): **97.9**
 Structural Grade: **2**
 O&M Grade: **0**
 Clock Start/From:
 Clock To:
 1st Value:
 2nd Value:
 Value Percent: **10.000**
 Continuous Index: **F02**
 Within 8" of Joint: **NO**
 Remarks:

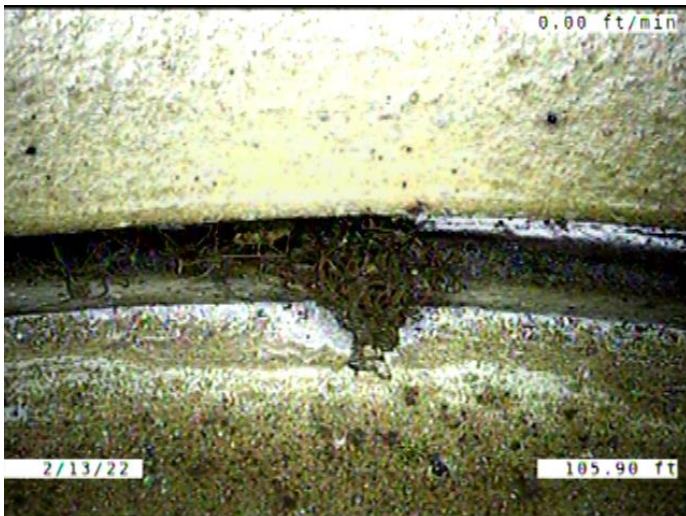
105.9	RFJ	Roots Fine Joint	923	M 1
114.3	DAE	Deposits Attached Encrustation	983	M 2
115.0	TFI	Tap Factory Intruding	1015	M 2
115.0	CC	Crack Circumferential	1026	S 1

Code: **RFJ**
 Description: **Roots Fine Joint**

Distance (ft): **105.9**
 Structural Grade: **0**
 O&M Grade: **1**
 Clock Start/From: **9**
 Clock To: **12**
 1st Value:
 2nd Value:
 Value Percent:
 Continuous Index:
 Within 8" of Joint: **YES**
 Remarks:

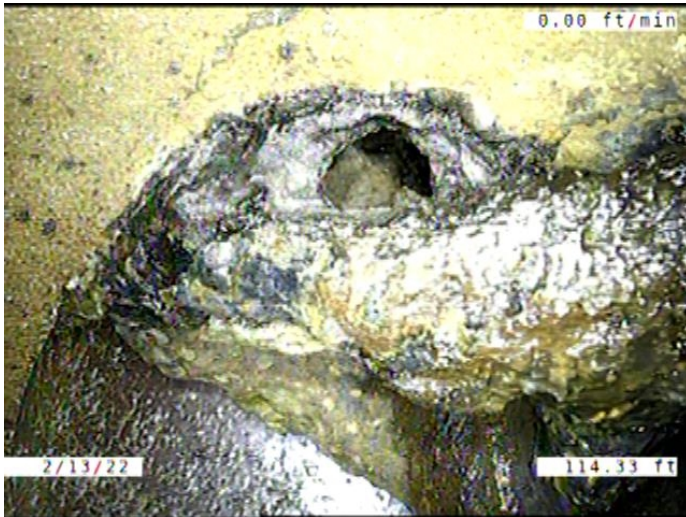
Code: **DAE**
Description: **Deposits Attached Encrustation**

Distance (ft): **114.3**
Structural Grade: **0**
O&M Grade: **2**
Clock Start/From: **1**
Clock To: **4**
1st Value:
2nd Value:
Value Percent: **5.000**
Continuous Index:
Within 8" of Joint: **YES**
Remarks:

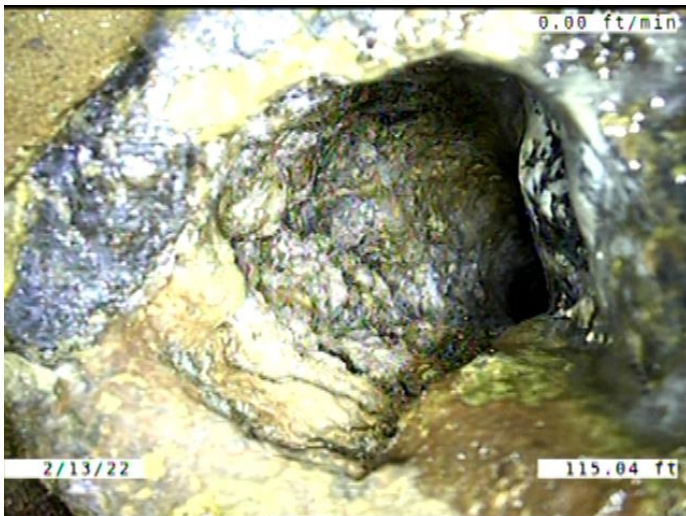
Code: **TFI**
Description: **Tap Factory Intruding**

Distance (ft): **115.0**
Structural Grade: **0**
O&M Grade: **2**
Clock Start/From: **2**
Clock To:
1st Value: **6.000**
2nd Value: **1.000**
Value Percent:
Continuous Index:
Within 8" of Joint: **YES**
Remarks: **CONSTANTLY RUNNING WATER.
ENCrustATION COMING FROM THE**

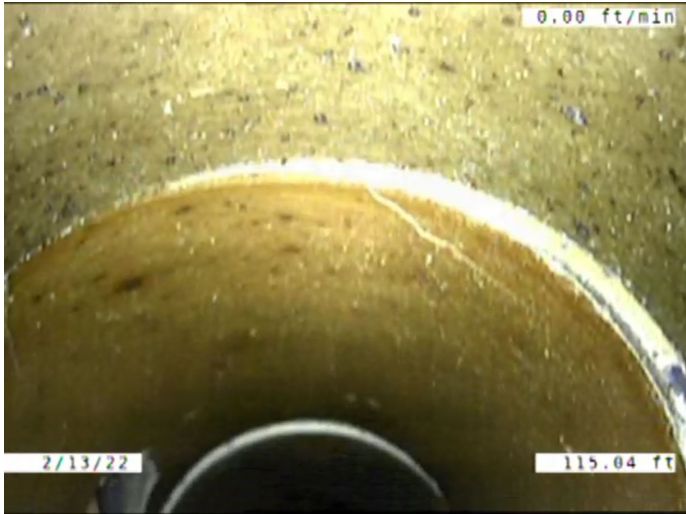
Code: **CC**
Description: **Crack Circumferential**

Distance (ft): **115.0**
Structural Grade: **1**
O&M Grade: **0**
Clock Start/From: **1**
Clock To: **2**
1st Value:
2nd Value:
Value Percent:
Continuous Index:
Within 8" of Joint: **YES**
Remarks:

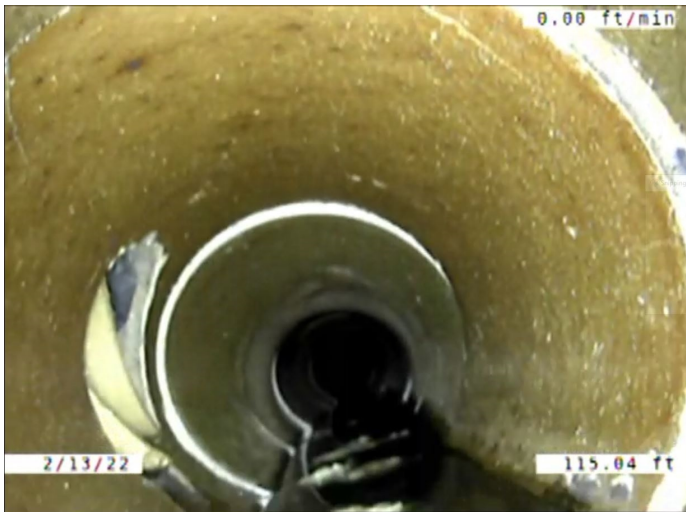
Code: **CL**
Description: **Crack Longitudinal**

Distance (ft): **115.0**
Structural Grade: **2**
O&M Grade: **0**
Clock Start/From: **11**
Clock To:
1st Value:
2nd Value:
Value Percent:
Continuous Index:
Within 8" of Joint: **NO**
Remarks:

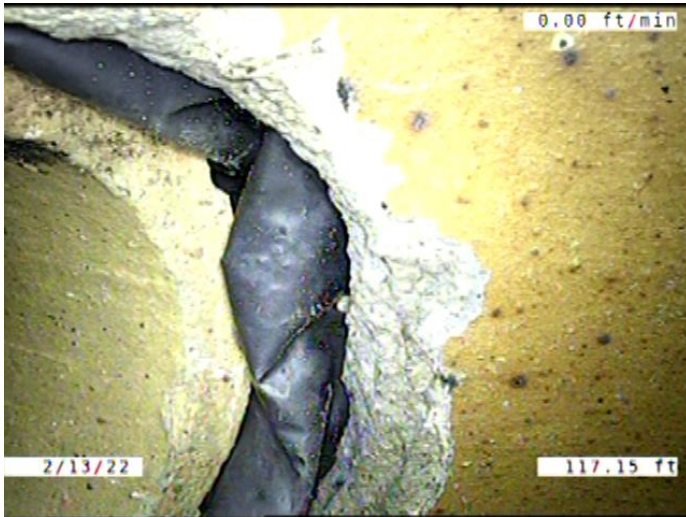
Code:	SSS
Description:	Surface Damage Surface Spalling
Distance (ft):	117.2
Structural Grade:	2
O&M Grade:	0
Clock Start/From:	8
Clock To:	10
1st Value:	
2nd Value:	
Value Percent:	
Continuous Index:	
Within 8" of Joint:	YES
Remarks:

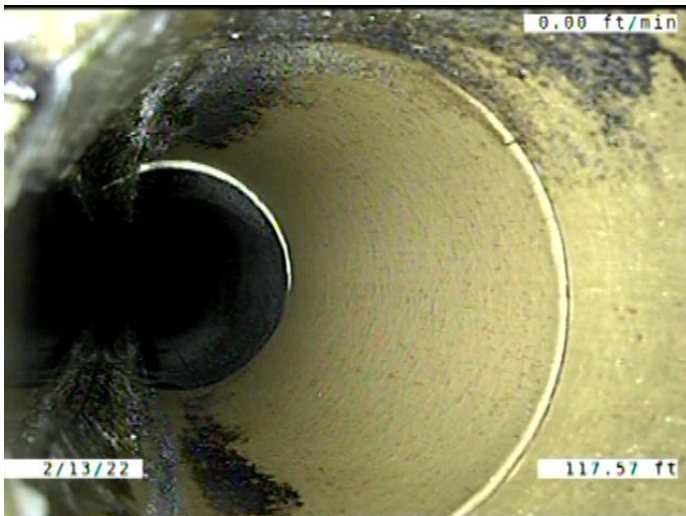
Code:	TBI
Description:	Tap Break-in Intruding
Distance (ft):	117.6
Structural Grade:	0
O&M Grade:	2
Clock Start/From:	9
Clock To:	
1st Value:	6.000
2nd Value:	1.000
Value Percent:	
Continuous Index:	
Within 8" of Joint:	YES
Remarks:

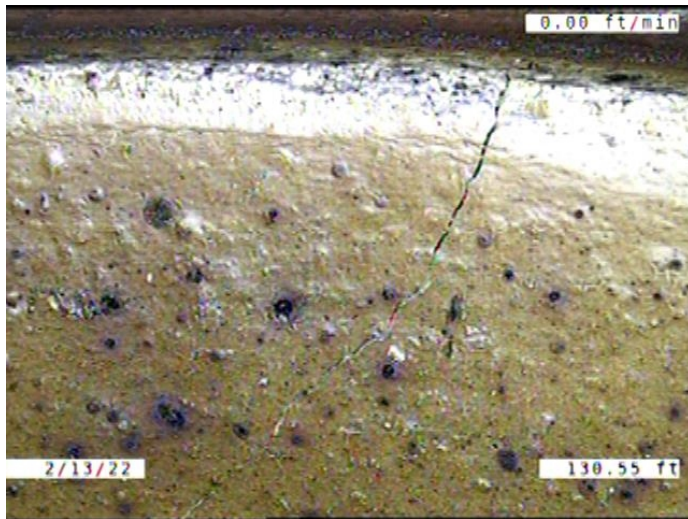
Code: **CM**
 Description: **Crack Multiple**

Distance (ft): **130.5**
 Structural Grade: **3**
 O&M Grade: **0**
 Clock Start/From: **9**
 Clock To: **3**
 1st Value:
 2nd Value:
 Value Percent:
 Continuous Index:
 Within 8" of Joint: **YES**
 Remarks:

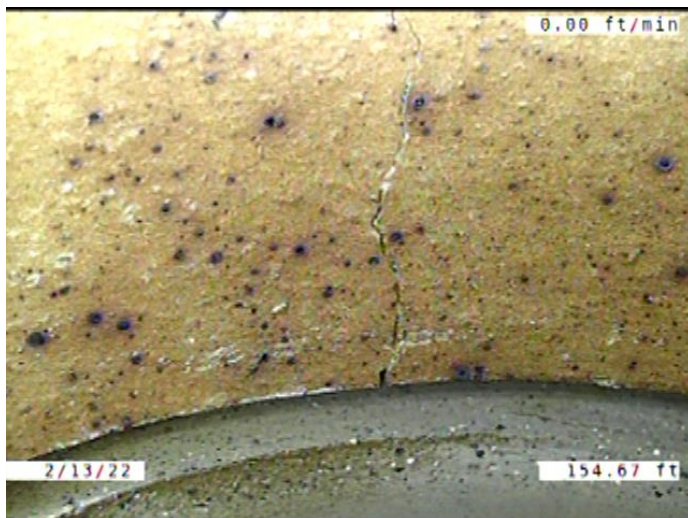
Code: **CL**
 Description: **Crack Longitudinal**

Distance (ft): **154.7**
 Structural Grade: **2**
 O&M Grade: **0**
 Clock Start/From: **9**
 Clock To:
 1st Value:
 2nd Value:
 Value Percent:
 Continuous Index:
 Within 8" of Joint: **YES**
 Remarks:

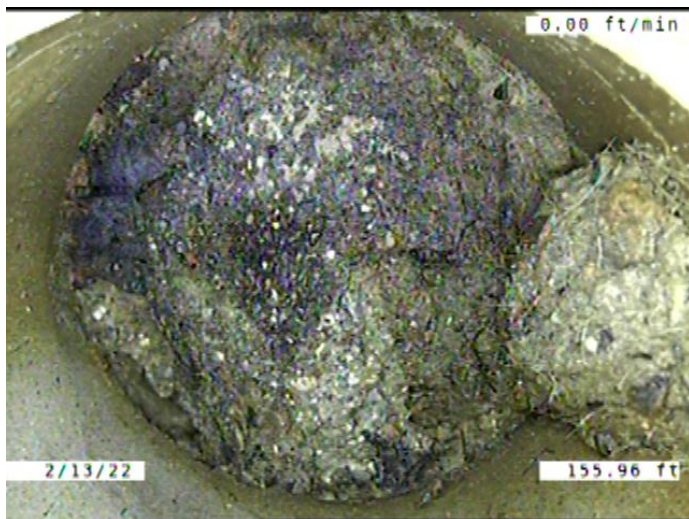
Code: **TF**
 Description: **Tap Factory**

Distance (ft): **156.0**
 Structural Grade: **0**
 O&M Grade: **0**
 Clock Start/From: **2**
 Clock To:
 1st Value: **6.000**
 2nd Value:
 Value Percent:
 Continuous Index:
 Within 8" of Joint: **YES**
 Remarks: **100% PLUGGED. ROOTS GROWING FROM THE SERVICE INTO THE MAIN.**

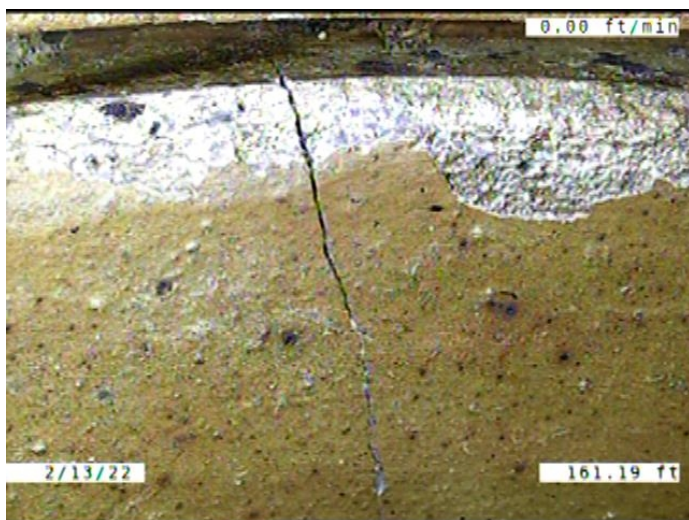
Code: **CM**
 Description: **Crack Multiple**

Distance (ft): **161.2**
 Structural Grade: **3**
 O&M Grade: **0**
 Clock Start/From: **9**
 Clock To: **3**
 1st Value:
 2nd Value:
 Value Percent:
 Continuous Index:
 Within 8" of Joint: **YES**
 Remarks:

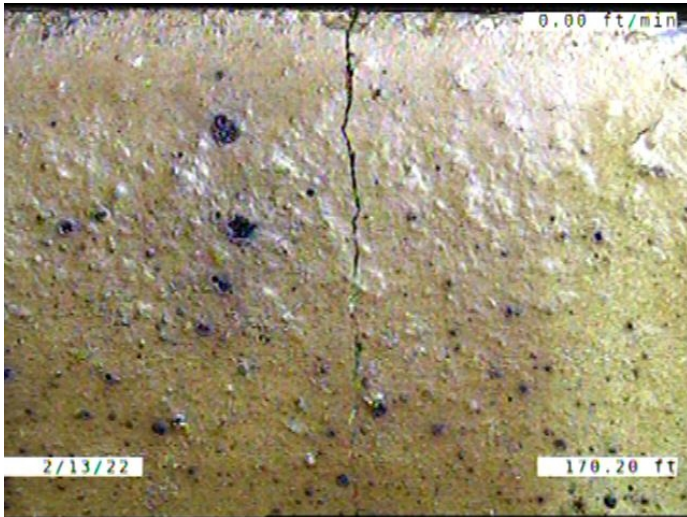
Code: **CM**
 Description: **Crack Multiple**

Distance (ft): **170.2**
 Structural Grade: **3**
 O&M Grade: **0**
 Clock Start/From: **10**
 Clock To: **3**
 1st Value:
 2nd Value:
 Value Percent:
 Continuous Index:
 Within 8" of Joint: **YES**
 Remarks:

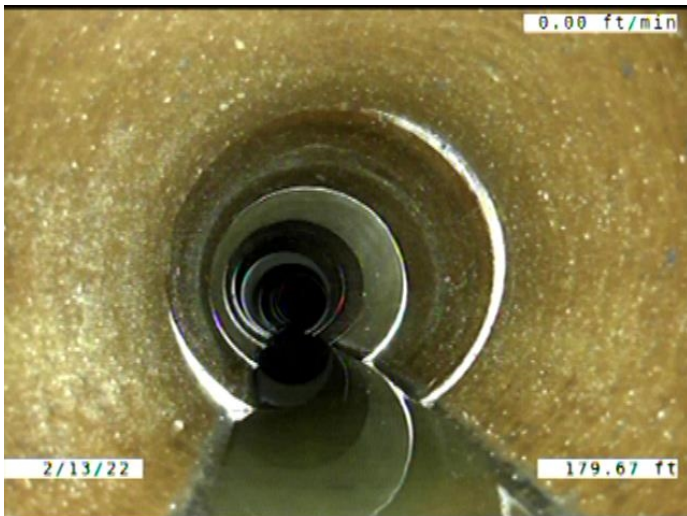
Code: **LL**
 Description: **Line Left**

Distance (ft): **179.7**
 Structural Grade: **0**
 O&M Grade: **1**
 Clock Start/From:
 Clock To:
 1st Value:
 2nd Value:
 Value Percent: **5.000**
 Continuous Index:
 Within 8" of Joint: **NO**
 Remarks:

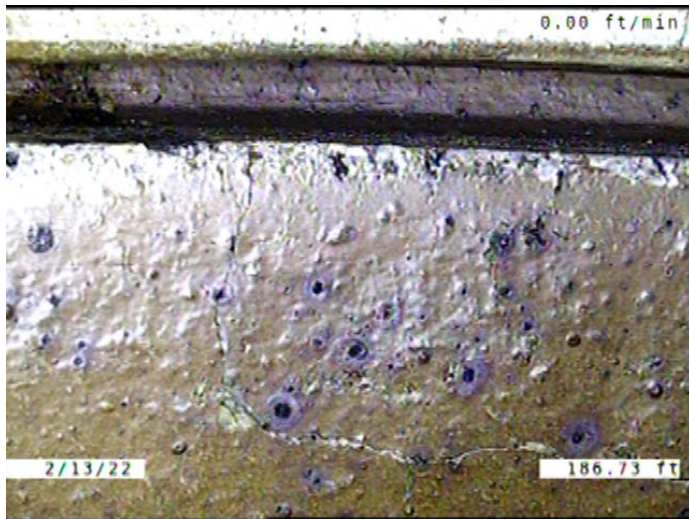
Code: **CM**
 Description: **Crack Multiple**

Distance (ft): **186.7**
 Structural Grade: **3**
 O&M Grade: **0**
 Clock Start/From: **10**
 Clock To: **12**
 1st Value:
 2nd Value:
 Value Percent:
 Continuous Index:
 Within 8" of Joint: **YES**
 Remarks:

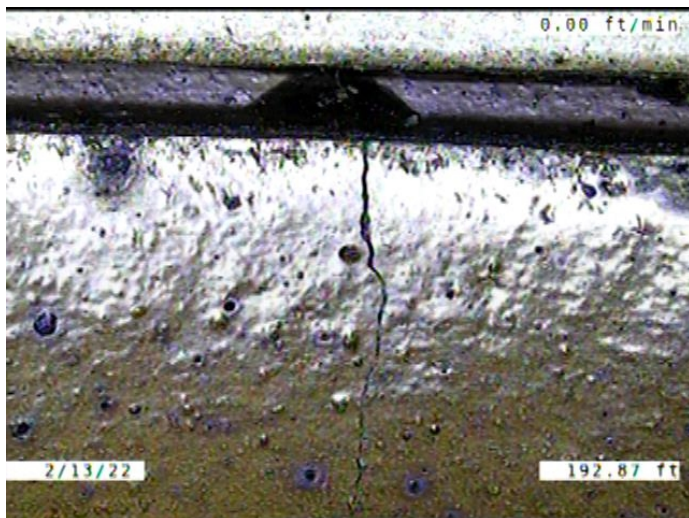
Code: **CL**
 Description: **Crack Longitudinal**

Distance (ft): **192.9**
 Structural Grade: **2**
 O&M Grade: **0**
 Clock Start/From: **11**
 Clock To:
 1st Value:
 2nd Value:
 Value Percent:
 Continuous Index:
 Within 8" of Joint: **YES**
 Remarks:

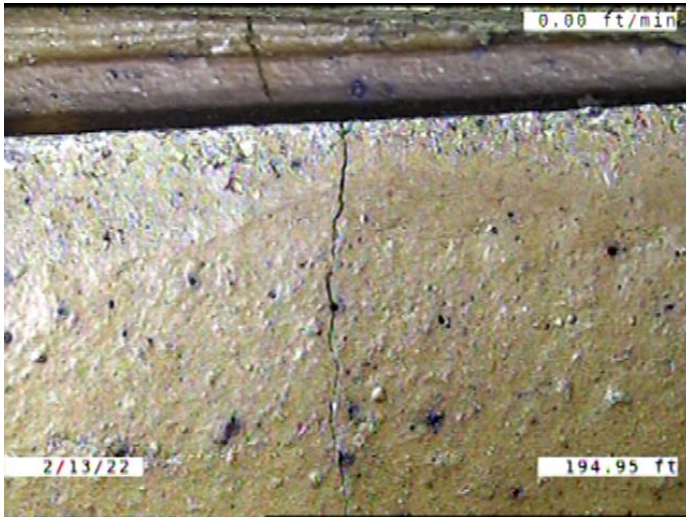
Code: **CL**
Description: **Crack Longitudinal**

Distance (ft): **194.9**
Structural Grade: **2**
O&M Grade: **0**
Clock Start/From: **10**
Clock To:
1st Value:
2nd Value:
Value Percent:
Continuous Index:
Within 8" of Joint: **YES**
Remarks:

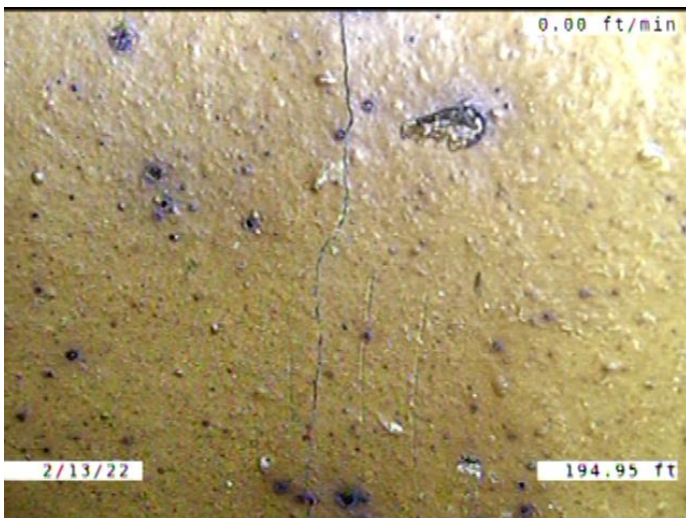
Code: **CL**
Description: **Crack Longitudinal**

Distance (ft): **195.0**
Structural Grade: **2**
O&M Grade: **0**
Clock Start/From: **2**
Clock To:
1st Value:
2nd Value:
Value Percent:
Continuous Index:
Within 8" of Joint: **YES**
Remarks:

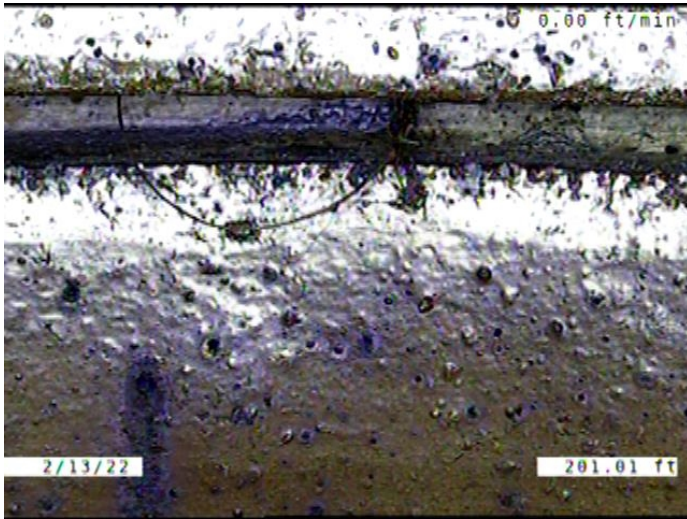
Code: **RFJ**
Description: **Roots Fine Joint**

Distance (ft): **201.0**
Structural Grade: **0**
O&M Grade: **1**
Clock Start/From: **1**
Clock To:
1st Value:
2nd Value:
Value Percent:
Continuous Index:
Within 8" of Joint: **YES**
Remarks:

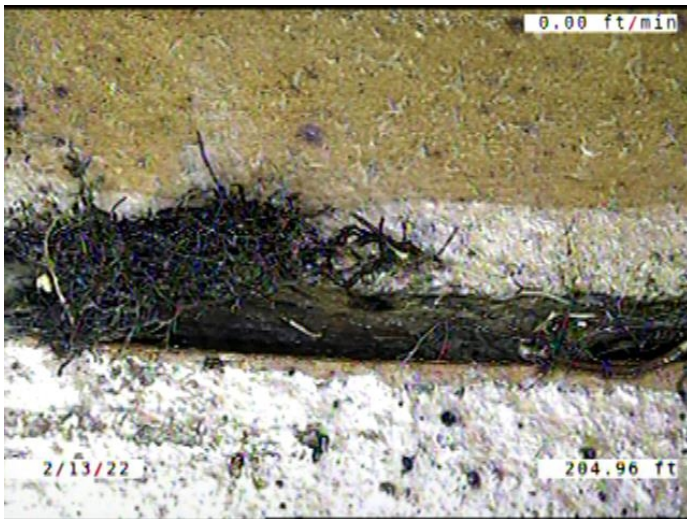
Code: **RFJ**
Description: **Roots Fine Joint**

Distance (ft): **205.0**
Structural Grade: **0**
O&M Grade: **1**
Clock Start/From: **2**
Clock To: **5**
1st Value:
2nd Value:
Value Percent:
Continuous Index:
Within 8" of Joint: **YES**
Remarks:

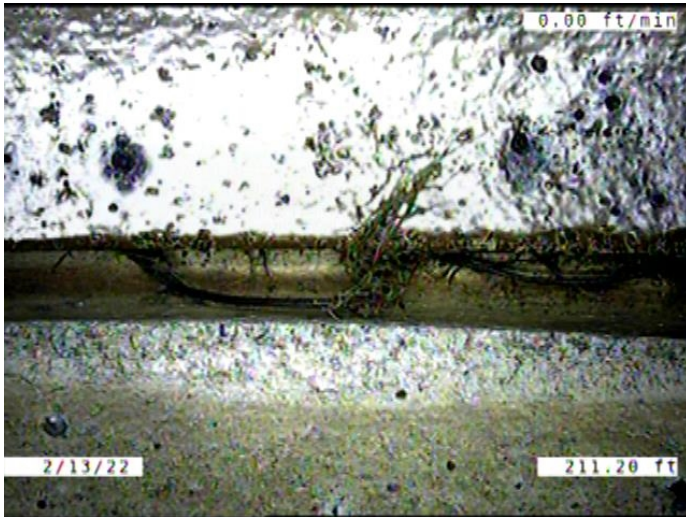
Code: **RFJ**
 Description: **Roots Fine Joint**

Distance (ft): **211.2**
 Structural Grade: **0**
 O&M Grade: **1**
 Clock Start/From: **1**
 Clock To: **4**
 1st Value:
 2nd Value:
 Value Percent:
 Continuous Index:
 Within 8" of Joint: **YES**
 Remarks:

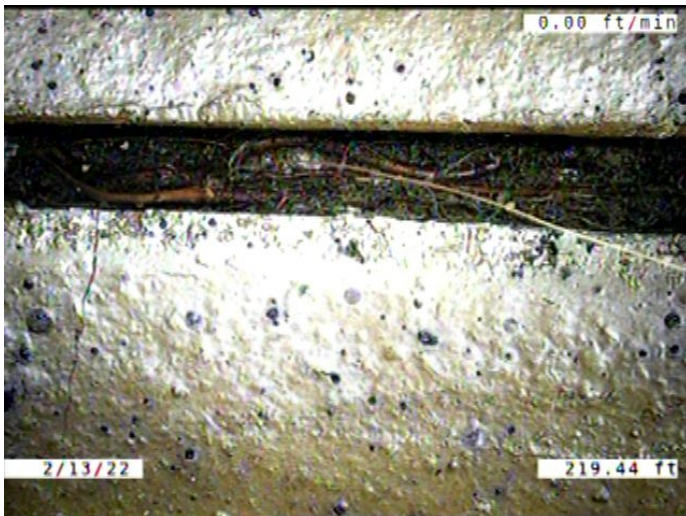
Code: **RFJ**
 Description: **Roots Fine Joint**

Distance (ft): **219.4**
 Structural Grade: **0**
 O&M Grade: **1**
 Clock Start/From: **12**
 Clock To: **4**
 1st Value:
 2nd Value:
 Value Percent:
 Continuous Index: **S03**
 Within 8" of Joint: **YES**
 Remarks:

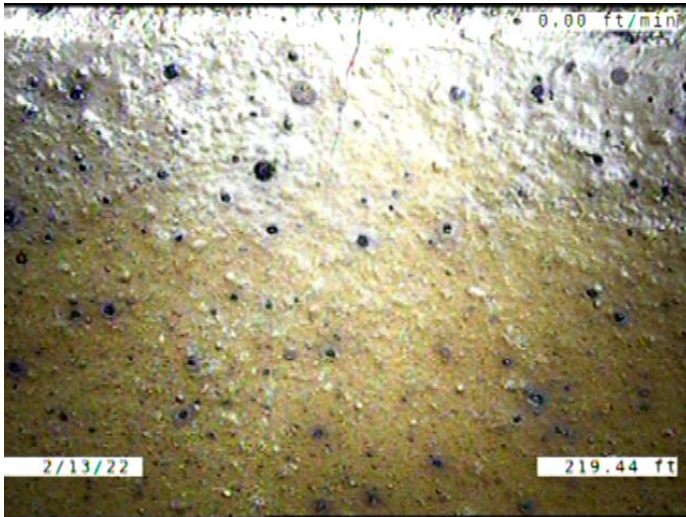
Code: **CL**
 Description: **Crack Longitudinal**

Distance (ft): **219.4**
 Structural Grade: **2**
 O&M Grade: **0**
 Clock Start/From: **1**
 Clock To:
 1st Value:
 2nd Value:
 Value Percent:
 Continuous Index:
 Within 8" of Joint: **YES**
 Remarks:

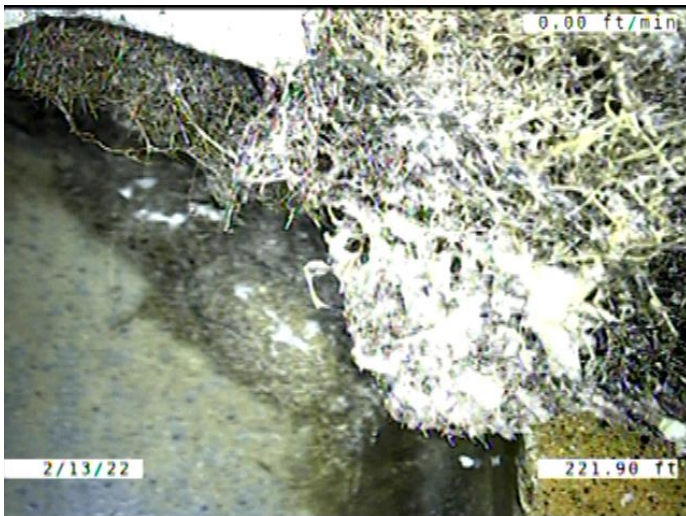
Code: **RML**
 Description: **Roots Medium Lateral**

Distance (ft): **221.9**
 Structural Grade: **0**
 O&M Grade: **3**
 Clock Start/From: **2**
 Clock To:
 1st Value:
 2nd Value:
 Value Percent: **5.000**
 Continuous Index:
 Within 8" of Joint: **NO**
 Remarks:

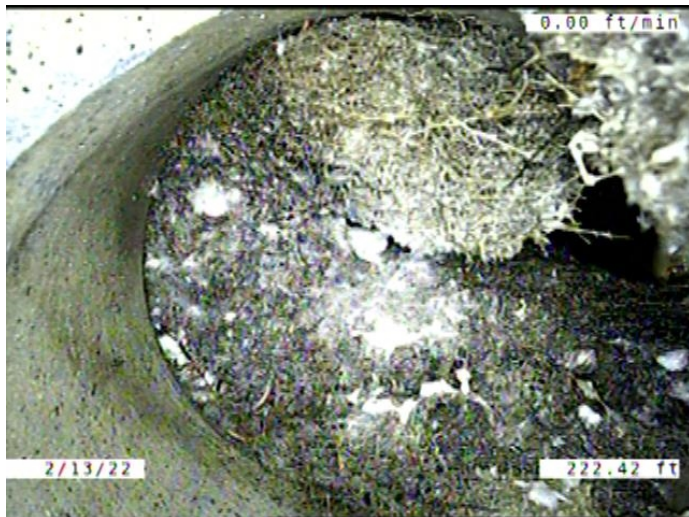
Code:	TF
Description:	Tap Factory
Distance (ft):	222.4
Structural Grade:	0
O&M Grade:	0
Clock Start/From:	2
Clock To:	
1st Value:	6.000
2nd Value:	
Value Percent:	
Continuous Index:	
Within 8" of Joint:	YES
Remarks:	ROOTS GROWING FROM THE SERVICE TO MAIN CONNECTION. LO

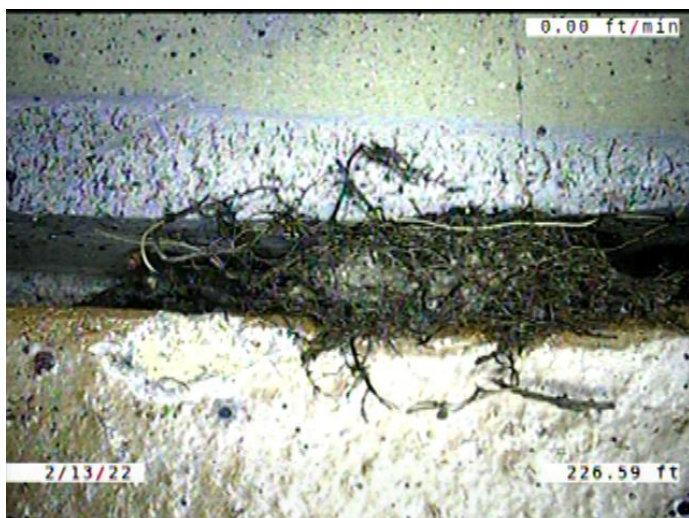
Code:	RFJ
Description:	Roots Fine Joint
Distance (ft):	226.6
Structural Grade:	0
O&M Grade:	1
Clock Start/From:	7
Clock To:	10
1st Value:	
2nd Value:	
Value Percent:	
Continuous Index:	
Within 8" of Joint:	YES
Remarks:

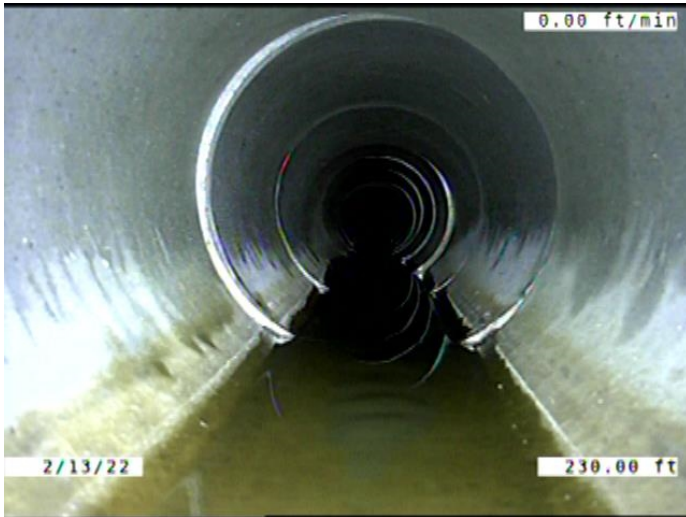
Code: **RFJ**
 Description: **Roots Fine Joint**

Distance (ft): **230.0**
 Structural Grade: **0**
 O&M Grade: **1**
 Clock Start/From: **12**
 Clock To: **4**
 1st Value:
 2nd Value:
 Value Percent:
 Continuous Index: **F03**
 Within 8" of Joint: **YES**
 Remarks:

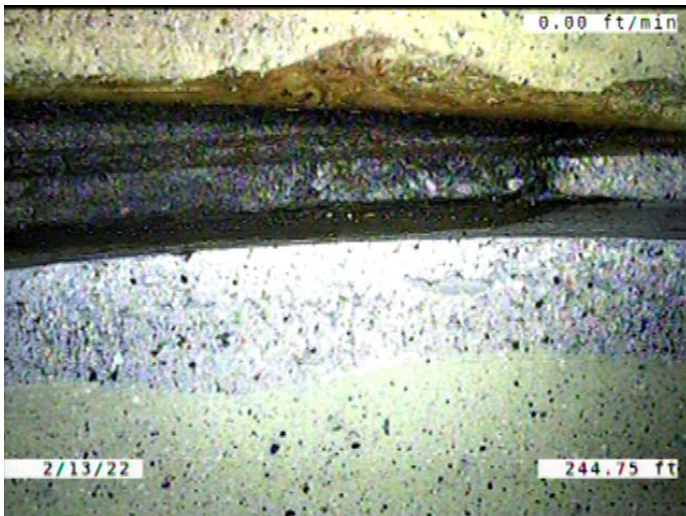
Code: **ISJ**
 Description: **Infiltration Stain Joint**

Distance (ft): **244.8**
 Structural Grade: **0**
 O&M Grade: **1**
 Clock Start/From: **8**
 Clock To: **11**
 1st Value:
 2nd Value:
 Value Percent:
 Continuous Index: **S04**
 Within 8" of Joint: **YES**
 Remarks:

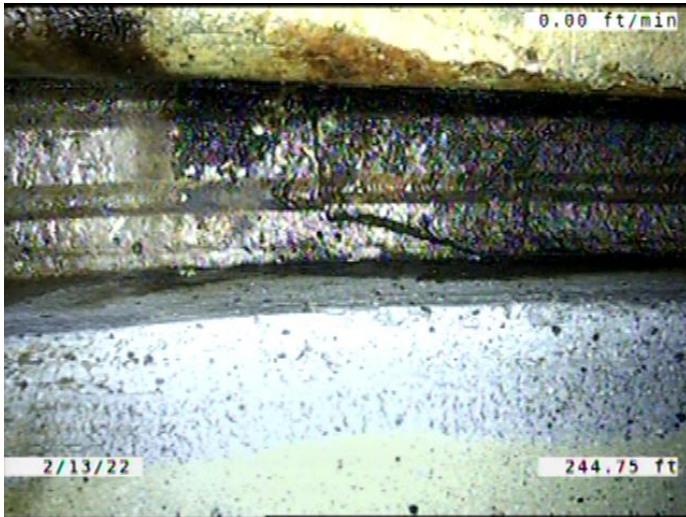
Code: **CM**
 Description: **Crack Multiple**

Distance (ft): **244.8**
 Structural Grade: **3**
 O&M Grade: **0**
 Clock Start/From: **9**
 Clock To: **11**
 1st Value:
 2nd Value:
 Value Percent:
 Continuous Index:
 Within 8" of Joint: **YES**
 Remarks:

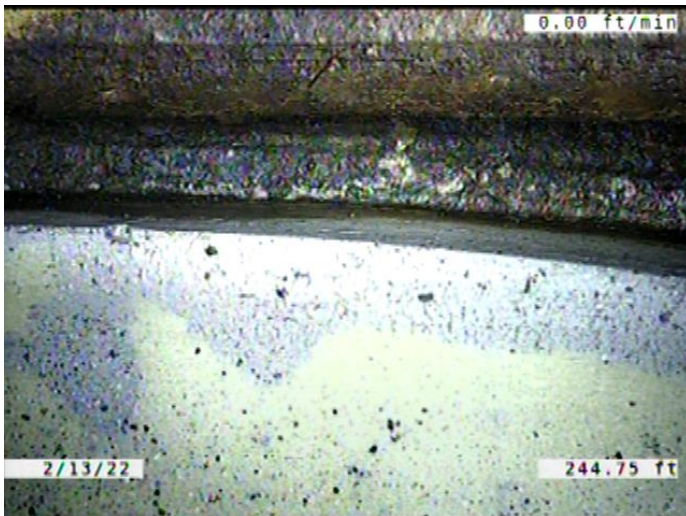
Code: **ISJ**
 Description: **Infiltration Stain Joint**

Distance (ft): **244.8**
 Structural Grade: **0**
 O&M Grade: **1**
 Clock Start/From: **1**
 Clock To: **4**
 1st Value:
 2nd Value:
 Value Percent:
 Continuous Index: **S05**
 Within 8" of Joint: **YES**
 Remarks:

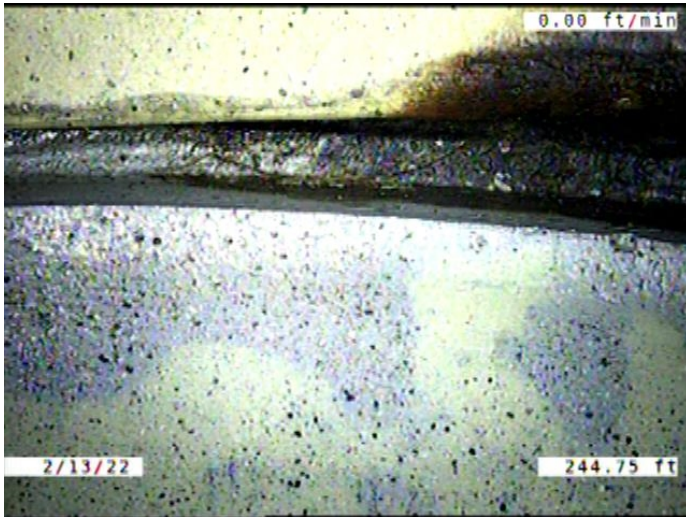
Code: **CM**
Description: **Crack Multiple**

Distance (ft): **244.8**
Structural Grade: **3**
O&M Grade: **0**
Clock Start/From: **1**
Clock To: **2**
1st Value:
2nd Value:
Value Percent:
Continuous Index:
Within 8" of Joint: **YES**
Remarks:

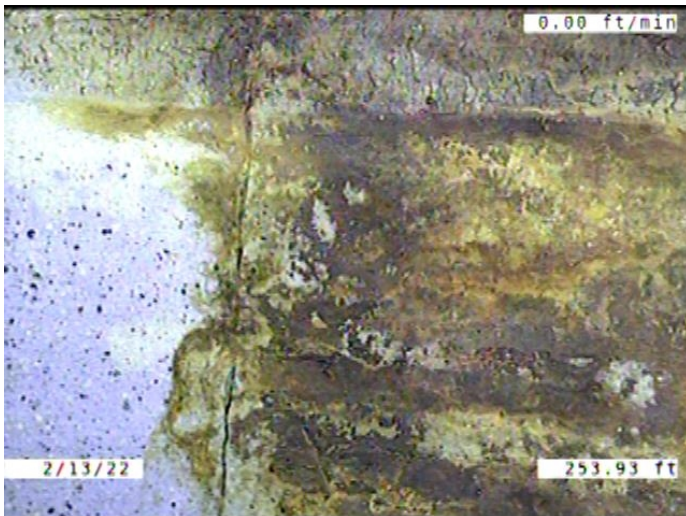
Code: **CL**
Description: **Crack Longitudinal**

Distance (ft): **253.9**
Structural Grade: **2**
O&M Grade: **0**
Clock Start/From: **3**
Clock To:
1st Value:
2nd Value:
Value Percent:
Continuous Index:
Within 8" of Joint: **YES**
Remarks:

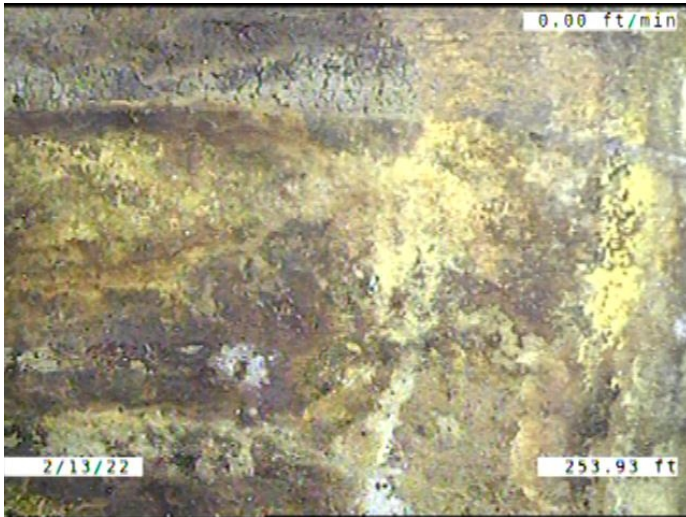
Code: **ISB**
 Description: **Infiltration Stain Barrel**

Distance (ft): **253.9**
 Structural Grade: **0**
 O&M Grade: **1**
 Clock Start/From: **3**
 Clock To: **5**
 1st Value:
 2nd Value:
 Value Percent:
 Continuous Index:
 Within 8" of Joint: **YES**
 Remarks:

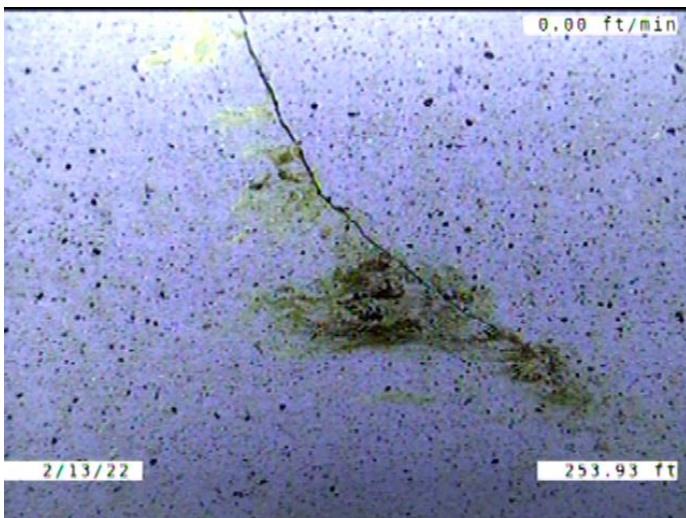
Code: **CS**
 Description: **Crack Spiral**

Distance (ft): **253.9**
 Structural Grade: **2**
 O&M Grade: **0**
 Clock Start/From: **10**
 Clock To: **11**
 1st Value:
 2nd Value:
 Value Percent:
 Continuous Index:
 Within 8" of Joint: **YES**
 Remarks:

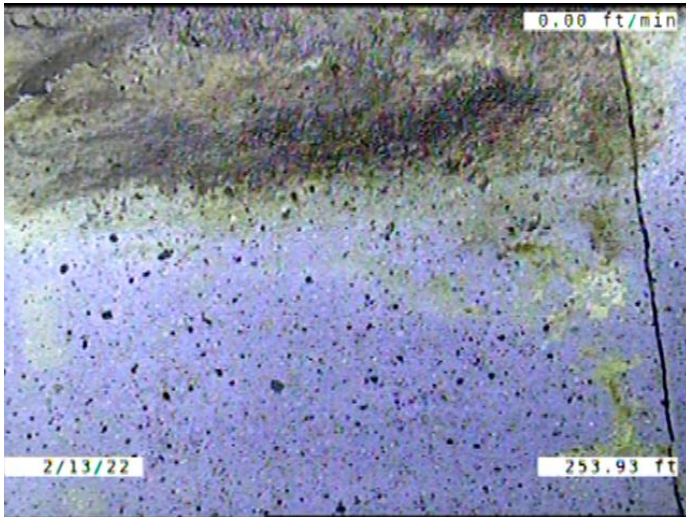
Code: **ISB**
 Description: **Infiltration Stain Barrel**

Distance (ft): **253.9**
 Structural Grade: **0**
 O&M Grade: **1**
 Clock Start/From: **9**
 Clock To: **11**
 1st Value:
 2nd Value:
 Value Percent:
 Continuous Index:
 Within 8" of Joint: **YES**
 Remarks:
