RedZone
ROBOTICS

Street:	East 13th Street	Flow Control:	Not Controlled
City:	Hobart, IN	Year Renewed:	
Location:	Local rural streets with light traffic, typical	Tape/Media #:	
Purpose:	Routine Assessment	Dia/Height:	12"
Use:	Sanitary Sewage Pipe	Material:	CP
Drain Area:		Lining:	None
Category:	NA		
Comment:			
Location Details:		Direction of Survey:	Downstream
US MH:	M-707-036	DS MH:	M-707-078
		Total Length Surveyed (ft):	282.0

Tuesday, April 25, 2023

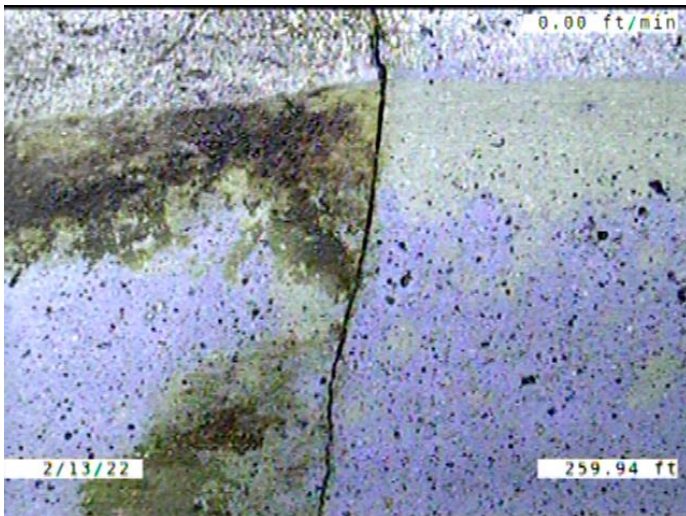
Code: **CS**
 Description: **Crack Spiral**

Distance (ft): **259.9**
 Structural Grade: **2**
 O&M Grade: **0**
 Clock Start/From: **10**
 Clock To: **11**
 1st Value:
 2nd Value:
 Value Percent:
 Continuous Index:
 Within 8" of Joint: **YES**
 Remarks:

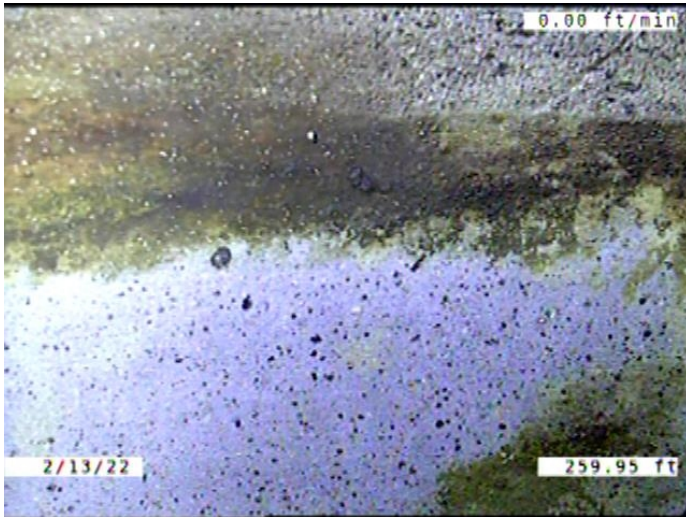
Code: **ISB**
 Description: **Infiltration Stain Barrel**

Distance (ft): **259.9**
 Structural Grade: **0**
 O&M Grade: **1**
 Clock Start/From: **8**
 Clock To: **11**
 1st Value:
 2nd Value:
 Value Percent:
 Continuous Index:
 Within 8" of Joint: **YES**
 Remarks:

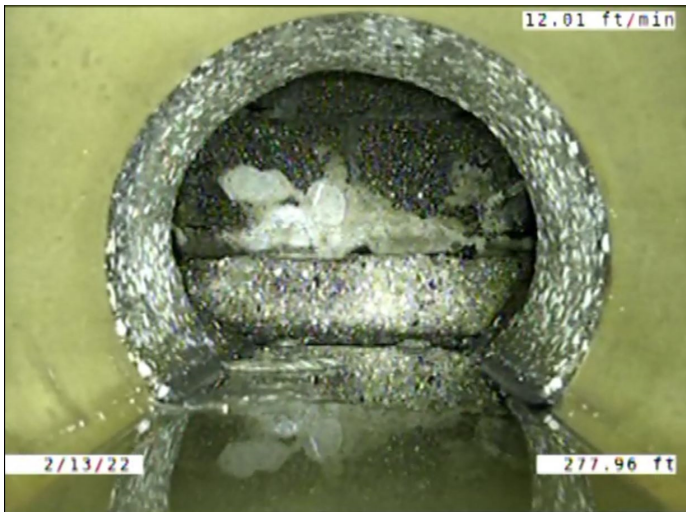
Code: **SAP**
 Description: **Surface Damage Aggregate Projecting**

Distance (ft): **278.0**
 Structural Grade: **3**
 O&M Grade: **0**
 Clock Start/From: **8**
 Clock To: **4**
 1st Value:
 2nd Value:
 Value Percent:
 Continuous Index:
 Within 8" of Joint: **NO**
 Remarks:

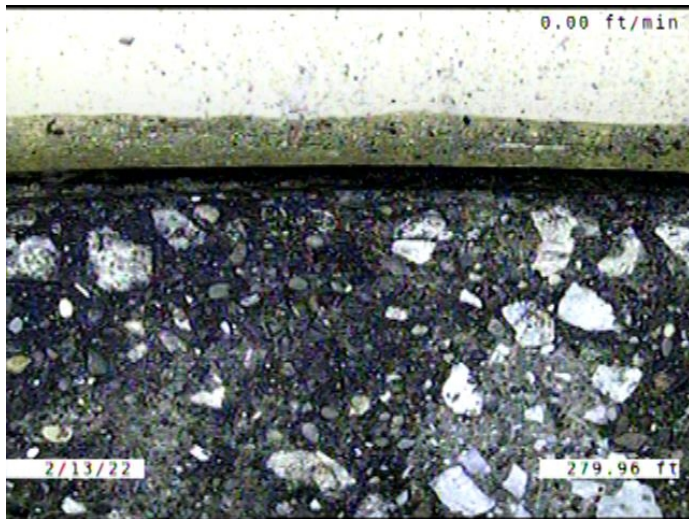
Code: **MMC**
 Description: **Miscellaneous Material Change**

Distance (ft): **280.0**
 Structural Grade: **0**
 O&M Grade: **0**
 Clock Start/From:
 Clock To:
 1st Value:
 2nd Value:
 Value Percent:
 Continuous Index:
 Within 8" of Joint: **NO**
 Remarks: **VCP TO CONCRETE**

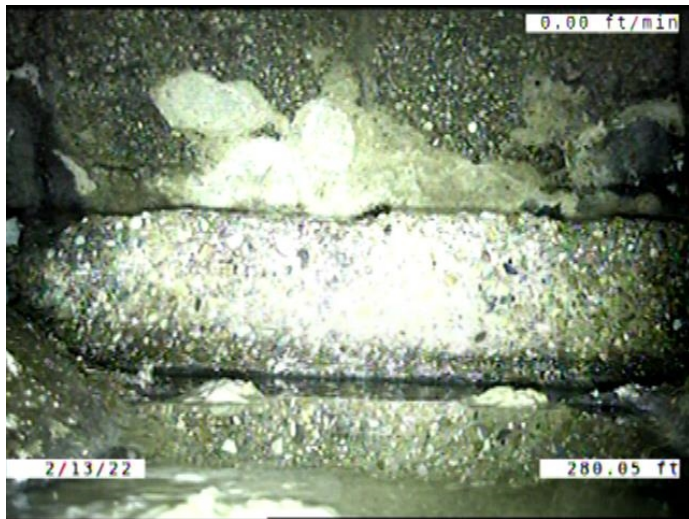
Code: **ISJ**
 Description: **Infiltration Stain Joint**

Distance (ft): **280.1**
 Structural Grade: **0**
 O&M Grade: **1**
 Clock Start/From: **8**
 Clock To: **11**
 1st Value:
 2nd Value:
 Value Percent:
 Continuous Index: **F04**
 Within 8" of Joint: **YES**
 Remarks:

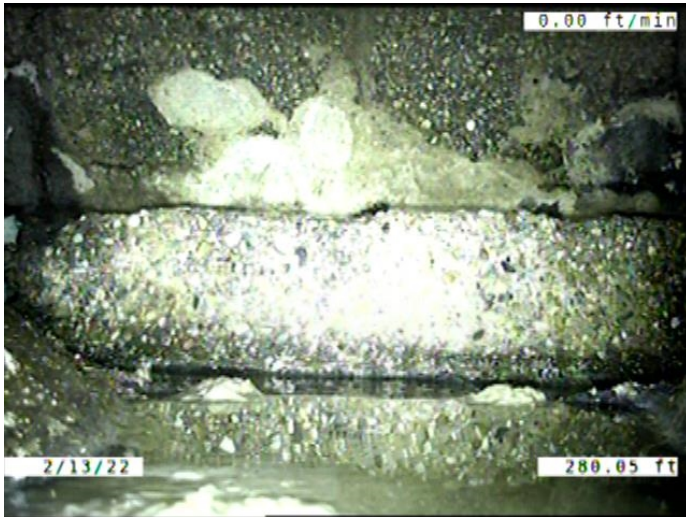
Code: **ISJ**
 Description: **Infiltration Stain Joint**

Distance (ft): **280.1**
 Structural Grade: **0**
 O&M Grade: **1**
 Clock Start/From: **1**
 Clock To: **4**
 1st Value:
 2nd Value:
 Value Percent:
 Continuous Index: **F05**
 Within 8" of Joint: **YES**
 Remarks:

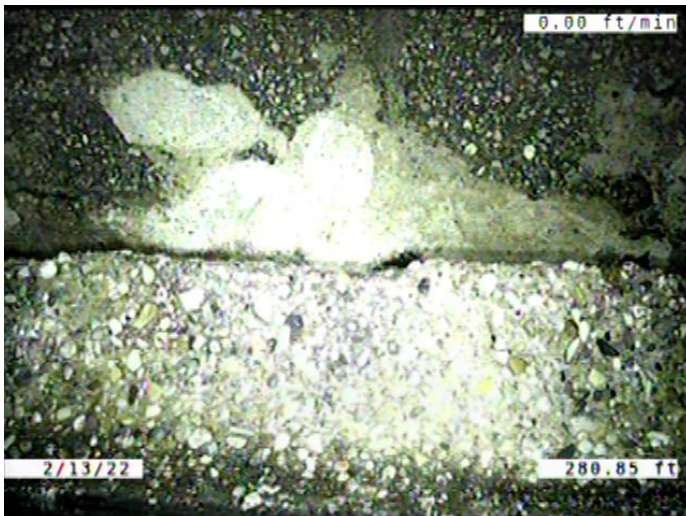
Code: **DSF**
 Description: **Deposits Settled Fine**

Distance (ft): **280.8**
 Structural Grade: **0**
 O&M Grade: **2**
 Clock Start/From: **5**
 Clock To: **7**
 1st Value:
 2nd Value:
 Value Percent: **5.000**
 Continuous Index: **F01**
 Within 8" of Joint: **YES**
 Remarks:

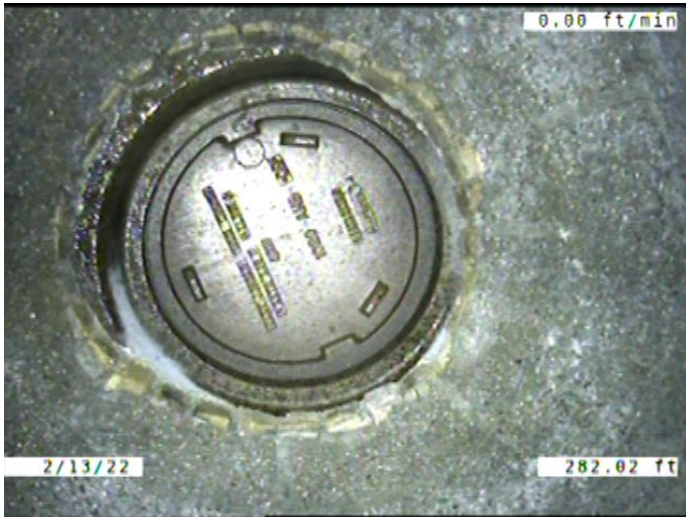
Code:	AMH
Description:	Manhole
Distance (ft):	282.0
Structural Grade:	0
O&M Grade:	0
Clock Start/From:	
Clock To:	
1st Value:	
2nd Value:	
Value Percent:	
Continuous Index:	
Within 8" of Joint:	NO
Remarks:	M-707-078
