Profile/Photo Observation Report

Date:	02/12/2022	Weather:		Coding:	PACP 7.0
Pipe Length (ft):	249.1	Owner:	City of Hobart	Pre Clean:	Heavy Cleaning
P.O.#:	YES502259	Surveyor:	S. Bucklin	PSR:	P-707-079-037
Customer:	City of Hobart	Clean Date:	02/10/2022	Shape:	C

Street:	South State Street	Flow Control:	Not Controlled
City:	Hobart, IN	Year Renewed:	
Location:	Local rural streets with light traffic, t	Tape/Media #:	
Purpose:	Routine Assessment	Dia/Height:	12"
Use:	Sanitary Sewage Pipe	Material:	VCP
Drain Area:		Lining:	None
Category:	NA		
Comment:			
Location Details:		Direction of Survey:	Downstream
US MH:	M-707-079	DS MH:	M-707-037
		Total Length Surveyed (ft):	249.0

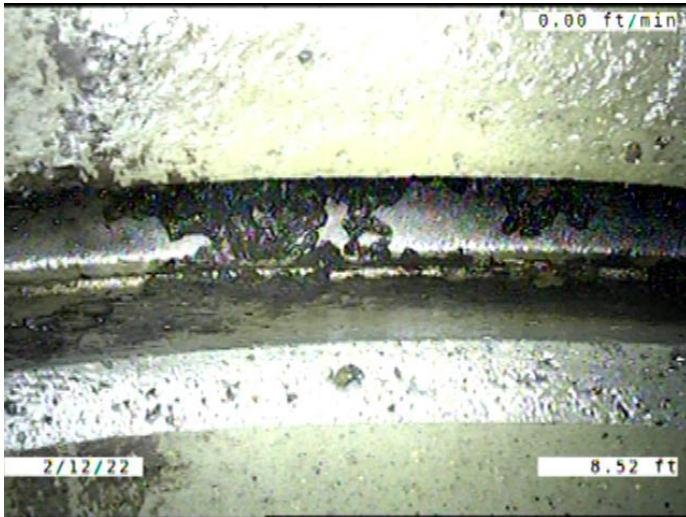
Code: **JAM**
 Description: **Joint Angular Medium**

Distance (ft): **8.5**
 Structural Grade: **3**
 O&M Grade: **0**
 Clock Start/From:
 Clock To:
 1st Value:
 2nd Value:
 Value Percent:
 Continuous Index:
 Within 8" of Joint: **NO**
 Remarks:

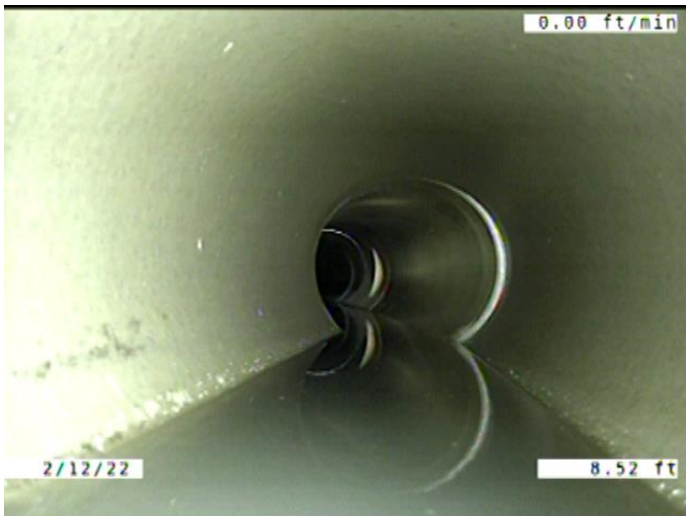
Code: **LR**
 Description: **Line Right**

Distance (ft): **8.5**
 Structural Grade: **0**
 O&M Grade: **1**
 Clock Start/From:
 Clock To:
 1st Value:
 2nd Value:
 Value Percent: **5.000**
 Continuous Index:
 Within 8" of Joint: **NO**
 Remarks:

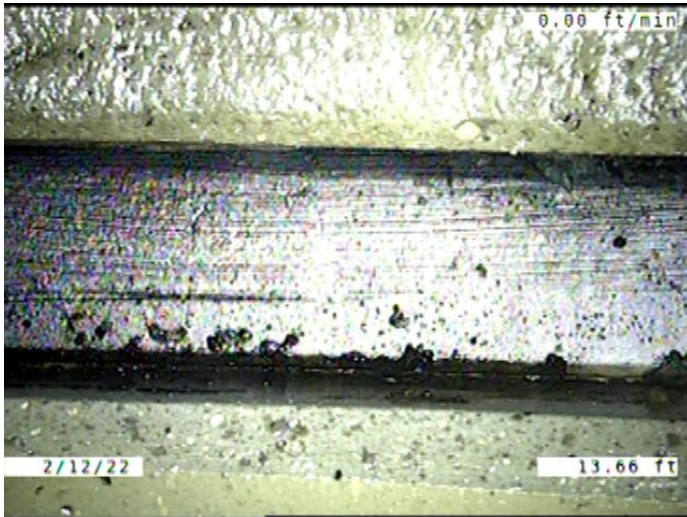
Code: **JAL**
 Description: **Joint Angular Large**

Distance (ft): **13.7**
 Structural Grade: **4**
 O&M Grade: **0**
 Clock Start/From:
 Clock To:
 1st Value:
 2nd Value:
 Value Percent:
 Continuous Index:
 Within 8" of Joint: **NO**
 Remarks:

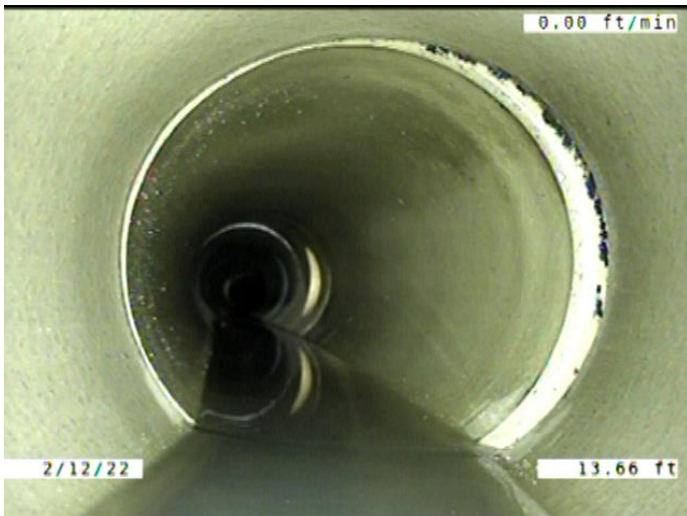
Code: **LL**
 Description: **Line Left**

Distance (ft): **13.7**
 Structural Grade: **0**
 O&M Grade: **1**
 Clock Start/From:
 Clock To:
 1st Value:
 2nd Value:
 Value Percent: **10.000**
 Continuous Index:
 Within 8" of Joint: **NO**
 Remarks:

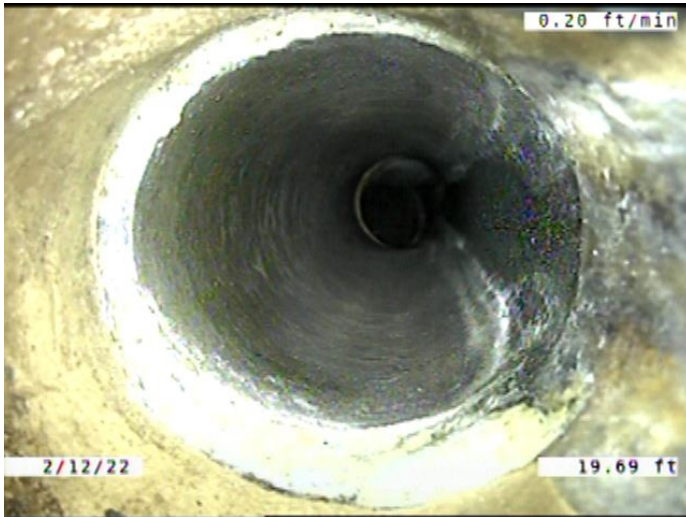
Code: **TF**
 Description: **Tap Factory**

Distance (ft): **19.7**
 Structural Grade: **0**
 O&M Grade: **0**
 Clock Start/From: **2**
 Clock To:
 1st Value: **6.000**

2nd Value:
 Value Percent:
 Continuous Index:
 Within 8" of Joint: **YES**
 Remarks: **ENCrustATION COMING FROM THE SERVICE TO MAIN CONNECTION.**

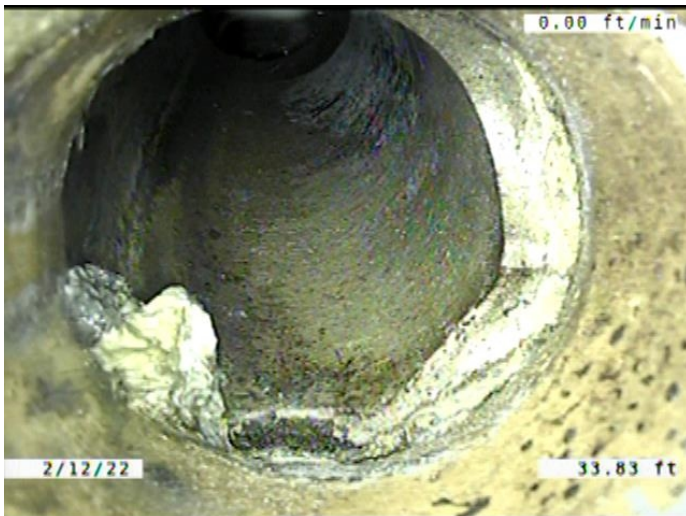
Code: **TFD**
 Description: **Tap Factory Defective**

Distance (ft): **33.8**
 Structural Grade: **0**
 O&M Grade: **3**
 Clock Start/From: **10**
 Clock To:
 1st Value: **6.000**

2nd Value:
 Value Percent:
 Continuous Index:
 Within 8" of Joint: **YES**
 Remarks: **ENCrustATION COMING TAP.**

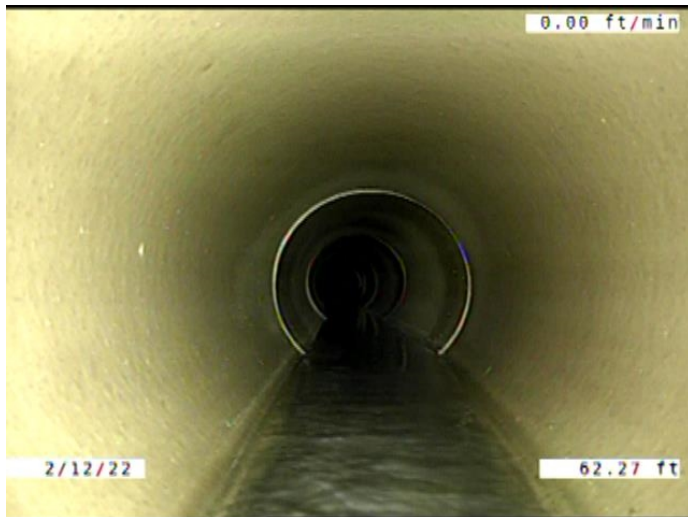
Code: **MWLS**
 Description: **Miscellaneous Water Level Sag**

Distance (ft): **62.3**
 Structural Grade: **2**
 O&M Grade: **0**
 Clock Start/From:
 Clock To:
 1st Value:
 2nd Value:
 Value Percent: **10.000**
 Continuous Index: **S01**
 Within 8" of Joint: **NO**
 Remarks:

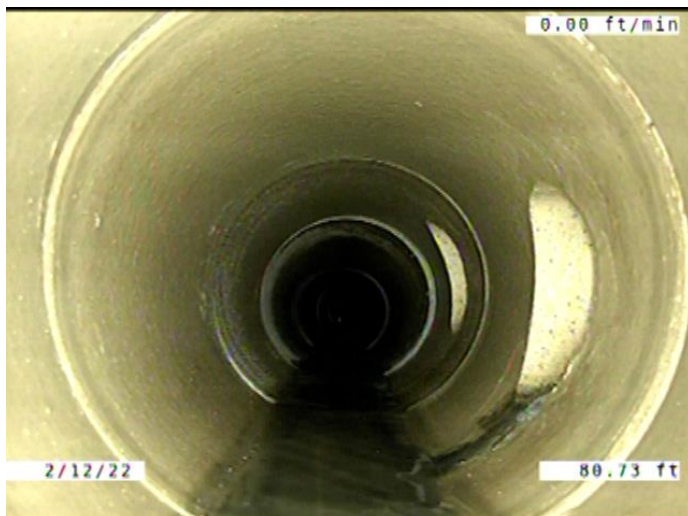
Code: **MWLS**
 Description: **Miscellaneous Water Level Sag**

Distance (ft): **80.7**
 Structural Grade: **2**
 O&M Grade: **0**
 Clock Start/From:
 Clock To:
 1st Value:
 2nd Value:
 Value Percent: **10.000**
 Continuous Index: **F01**
 Within 8" of Joint: **NO**
 Remarks:

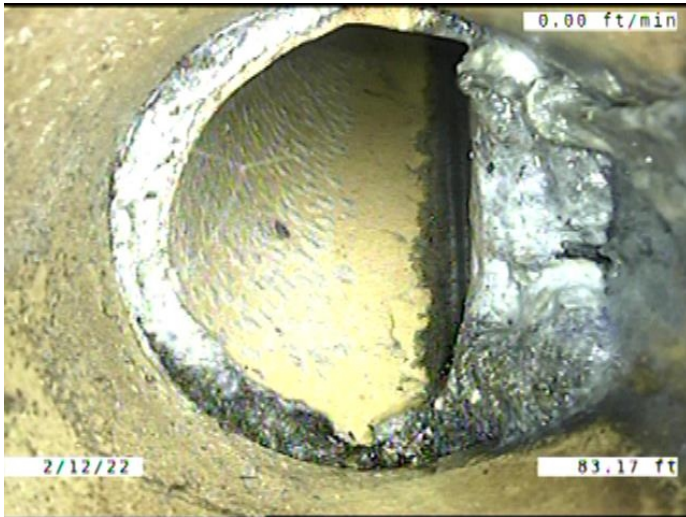
Code: **TF**
 Description: **Tap Factory**

Distance (ft): **83.2**
 Structural Grade: **0**
 O&M Grade: **0**
 Clock Start/From: **3**
 Clock To:
 1st Value: **6.000**

2nd Value:
 Value Percent:
 Continuous Index:
 Within 8" of Joint: **YES**
 Remarks: **ENCrustATION COMING FROM THE SERVICE TO MAIN CONNECTION.**

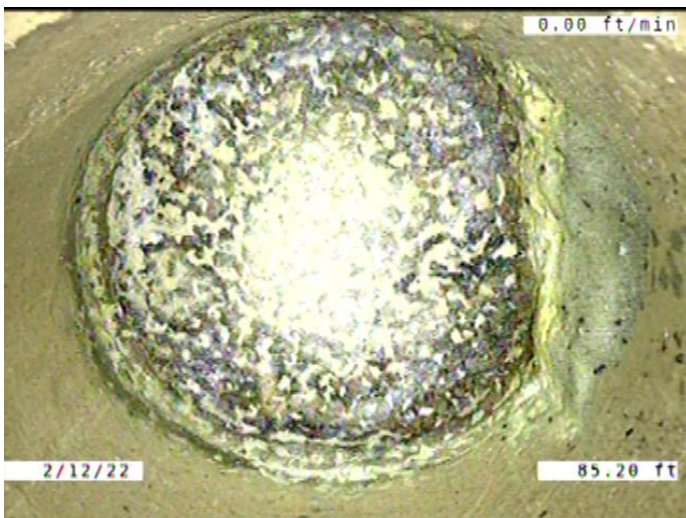
Code: **TFC**
 Description: **Tap Factory Capped**

Distance (ft): **85.2**
 Structural Grade: **0**
 O&M Grade: **0**
 Clock Start/From: **2**
 Clock To:
 1st Value: **4.000**

2nd Value:
 Value Percent:
 Continuous Index:
 Within 8" of Joint: **YES**
 Remarks: **ENCrustATION COMING FROM AROUND THE CAP**

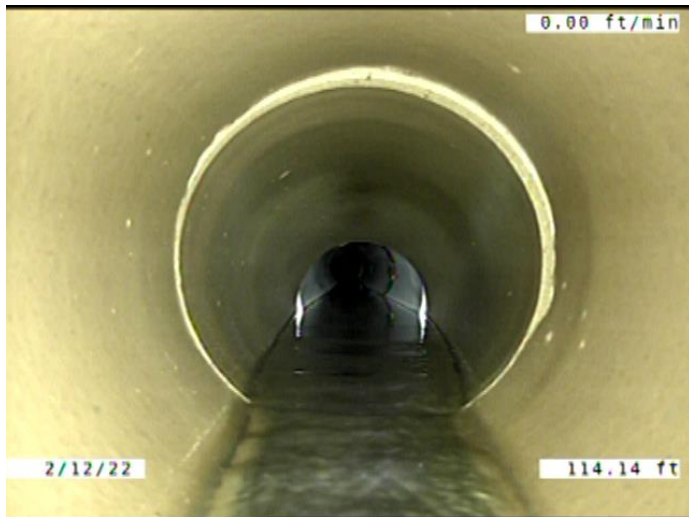
Code: **MWLS**
Description: **Miscellaneous Water Level Sag**

Distance (ft): **114.1**
Structural Grade: **2**
O&M Grade: **0**
Clock Start/From:
Clock To:
1st Value:
2nd Value:
Value Percent: **15.000**
Continuous Index: **S02**
Within 8" of Joint: **NO**
Remarks:

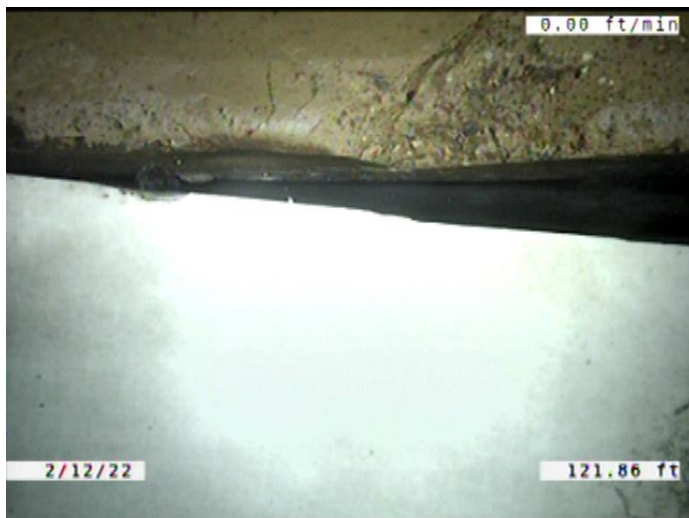
Code: **JAM**
Description: **Joint Angular Medium**

Distance (ft): **121.9**
Structural Grade: **3**
O&M Grade: **0**
Clock Start/From:
Clock To:
1st Value:
2nd Value:
Value Percent:
Continuous Index:
Within 8" of Joint: **NO**
Remarks:

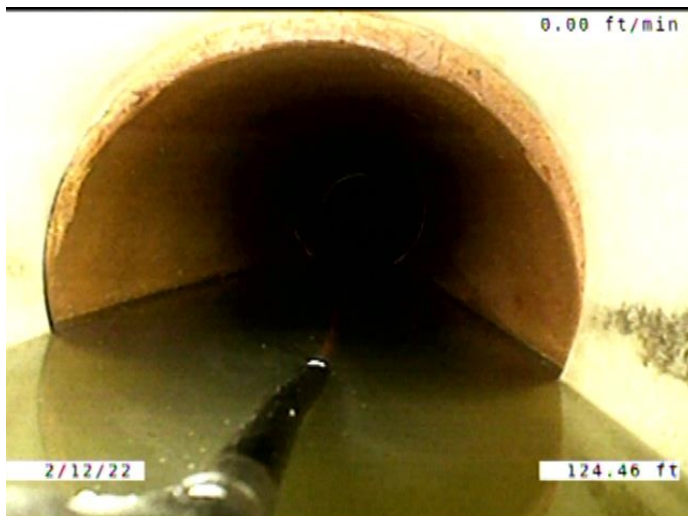
Code: **JOM**
Description: **Joint Offset Medium**

Distance (ft): **121.9**
Structural Grade: **3**
O&M Grade: **0**
Clock Start/From:
Clock To:
1st Value:
2nd Value:
Value Percent:
Continuous Index:
Within 8" of Joint: **NO**
Remarks:

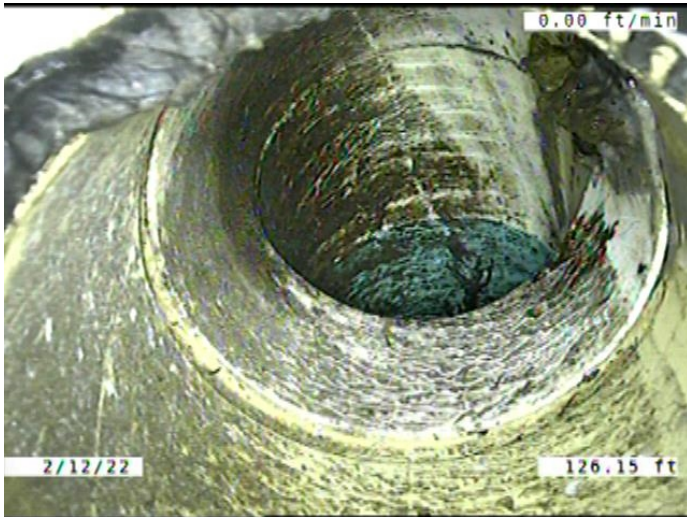
Code: **TB**
 Description: **Tap Break-in/Hammer**

Distance (ft): **126.1**
 Structural Grade: **0**
 O&M Grade: **0**
 Clock Start/From: **2**
 Clock To:
 1st Value: **6.000**
 2nd Value:
 Value Percent:
 Continuous Index:
 Within 8" of Joint: **NO**
 Remarks: **CONSTANTLY RUNNING WATER.**

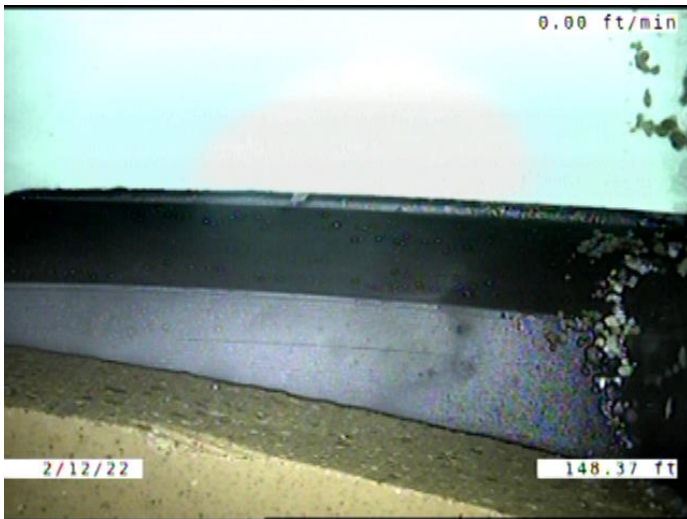
Code: **JAM**
 Description: **Joint Angular Medium**

Distance (ft): **148.4**
 Structural Grade: **3**
 O&M Grade: **0**
 Clock Start/From:
 Clock To:
 1st Value:
 2nd Value:
 Value Percent:
 Continuous Index:
 Within 8" of Joint: **NO**
 Remarks:

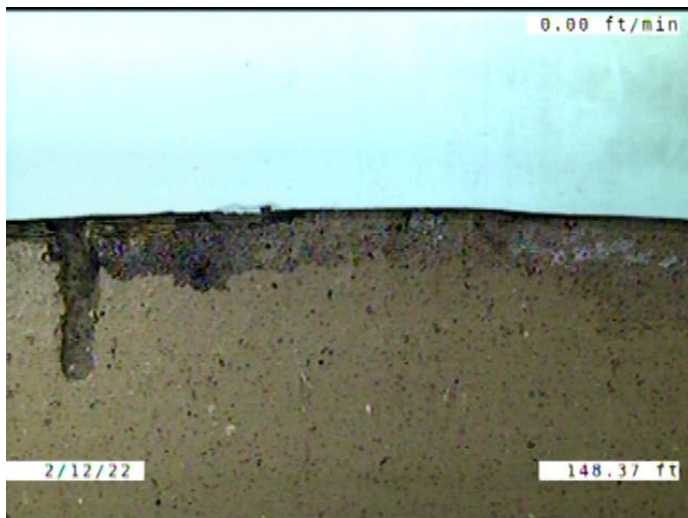
Code: **JOM**
Description: **Joint Offset Medium**

Distance (ft): **148.4**
Structural Grade: **3**
O&M Grade: **0**
Clock Start/From:
Clock To:
1st Value:
2nd Value:
Value Percent:
Continuous Index:
Within 8" of Joint: **NO**
Remarks:

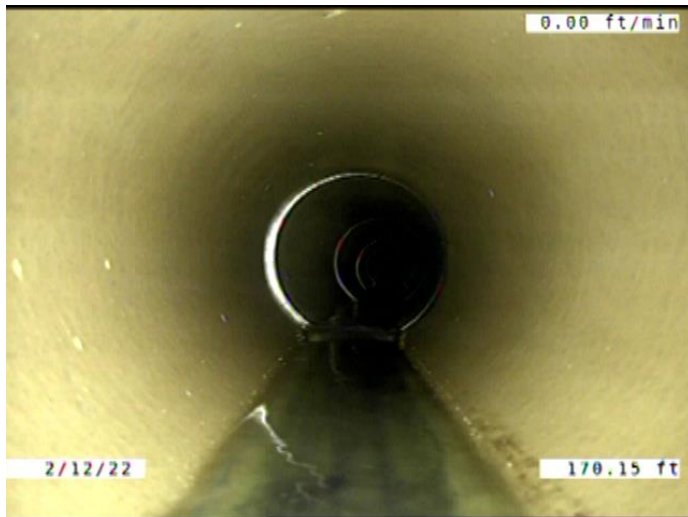
Code: **MWLS**
Description: **Miscellaneous Water Level Sag**

Distance (ft): **170.2**
Structural Grade: **2**
O&M Grade: **0**
Clock Start/From:
Clock To:
1st Value:
2nd Value:
Value Percent: **15.000**
Continuous Index: **F02**
Within 8" of Joint: **NO**
Remarks:

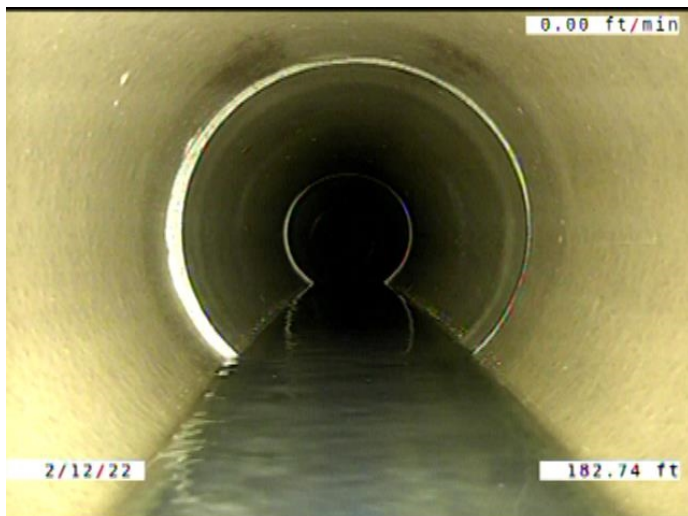
Code: **MWLS**
Description: **Miscellaneous Water Level Sag**

Distance (ft): **182.7**
Structural Grade: **2**
O&M Grade: **0**
Clock Start/From:
Clock To:
1st Value:
2nd Value:
Value Percent: **10.000**
Continuous Index: **S03**
Within 8" of Joint: **NO**
Remarks:

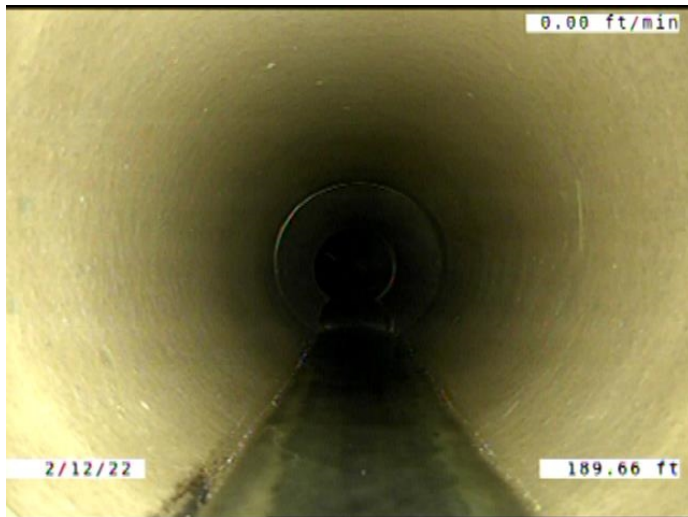
Code: **MWLS**
Description: **Miscellaneous Water Level Sag**

Distance (ft): **189.7**
Structural Grade: **2**
O&M Grade: **0**
Clock Start/From:
Clock To:
1st Value:
2nd Value:
Value Percent: **10.000**
Continuous Index: **F03**
Within 8" of Joint: **NO**
Remarks:

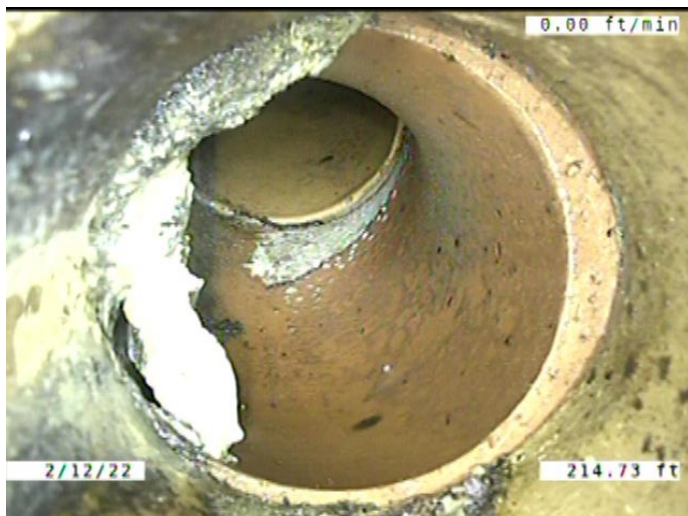
Code: **TF**
Description: **Tap Factory**

Distance (ft): **214.7**
Structural Grade: **0**
O&M Grade: **0**
Clock Start/From: **10**
Clock To:
1st Value: **6.000**
2nd Value:
Value Percent:
Continuous Index:
Within 8" of Joint: **YES**
Remarks: **ENCrustATION COMING FROM THE SERVICE TO MAIN CONNECTION.**

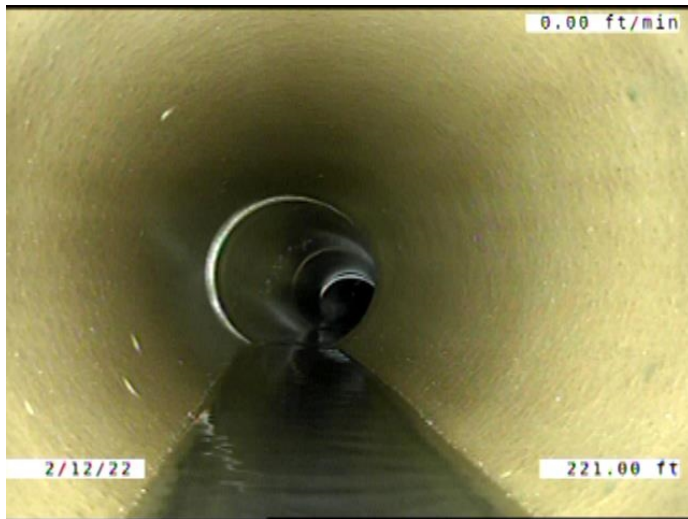
Code: **LL**
Description: **Line Left**

Distance (ft): **221.0**
Structural Grade: **0**
O&M Grade: **1**
Clock Start/From:
Clock To:
1st Value:
2nd Value:
Value Percent: **5.000**
Continuous Index:
Within 8" of Joint: **NO**
Remarks:

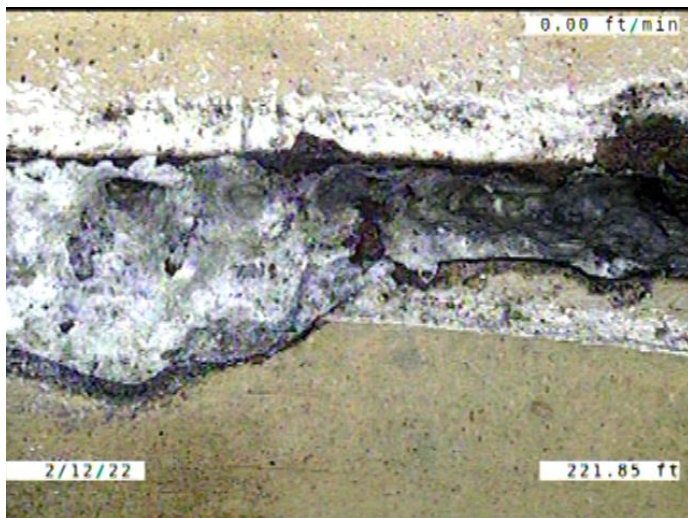
Code: **DAE**
Description: **Deposits Attached Encrustation**

Distance (ft): **221.8**
Structural Grade: **0**
O&M Grade: **2**
Clock Start/From: **8**
Clock To: **4**
1st Value:
2nd Value:
Value Percent: **5.000**
Continuous Index:
Within 8" of Joint: **YES**
Remarks:

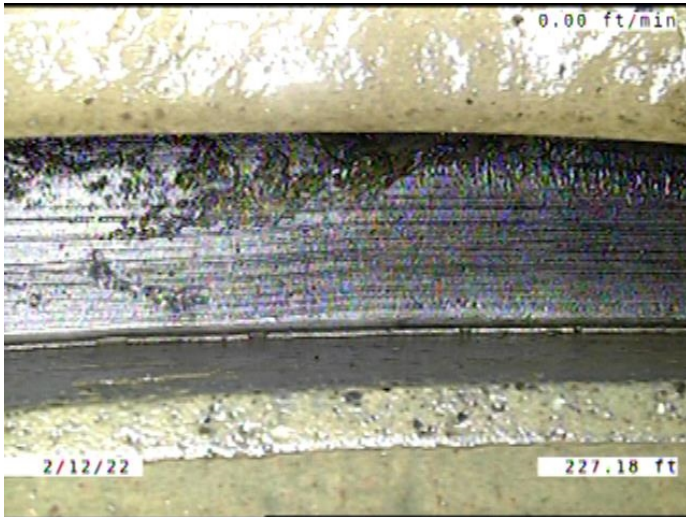
Code: **JAL**
Description: **Joint Angular Large**

Distance (ft): **227.2**
Structural Grade: **4**
O&M Grade: **0**
Clock Start/From:
Clock To:
1st Value:
2nd Value:
Value Percent:
Continuous Index:
Within 8" of Joint: **NO**
Remarks:

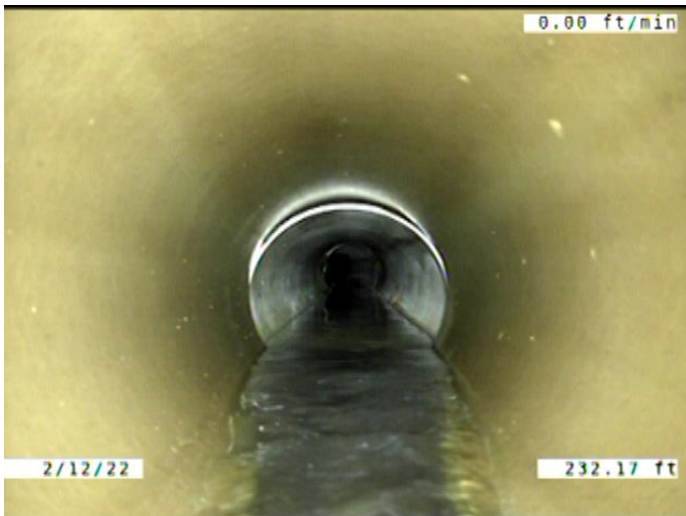
Code: **MWLS**
Description: **Miscellaneous Water Level Sag**

Distance (ft): **232.2**
Structural Grade: **2**
O&M Grade: **0**
Clock Start/From:
Clock To:
1st Value:
2nd Value:
Value Percent: **15.000**
Continuous Index: **S04**
Within 8" of Joint: **NO**
Remarks:

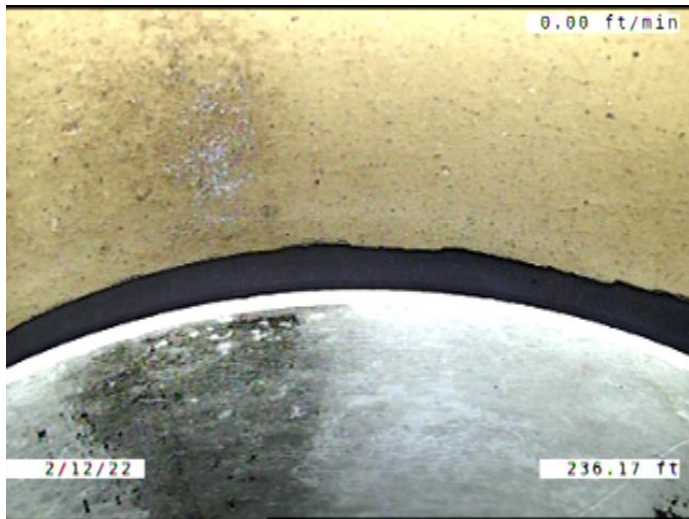
Code: **JOM**
Description: **Joint Offset Medium**

Distance (ft): **236.2**
Structural Grade: **3**
O&M Grade: **0**
Clock Start/From:
Clock To:
1st Value:
2nd Value:
Value Percent:
Continuous Index:
Within 8" of Joint: **NO**
Remarks:

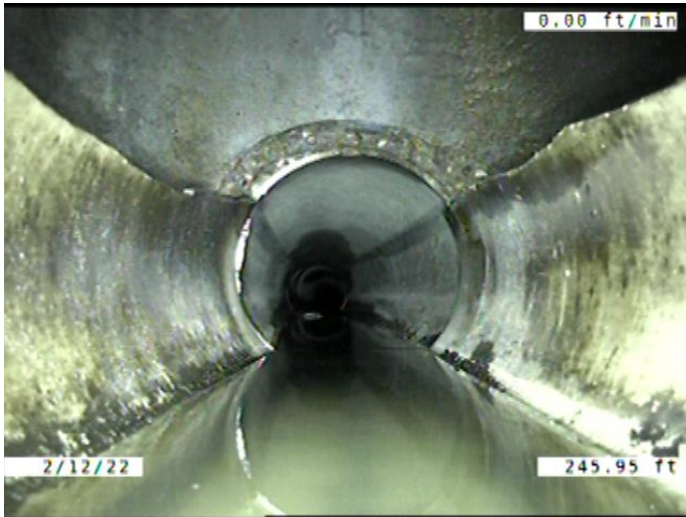
Code: **MWLS**
 Description: **Miscellaneous Water Level Sag**

Distance (ft): **245.9**
 Structural Grade: **2**
 O&M Grade: **0**
 Clock Start/From:
 Clock To:
 1st Value:
 2nd Value:
 Value Percent: **15.000**
 Continuous Index: **F04**
 Within 8" of Joint: **NO**
 Remarks:
