Profile/Photo Observation Report

Date:	04/11/2018	Weather:		Coding:	PACP 6.0
Pipe Length (ft):	364.1	Owner:	NA	Pre Clean:	Not Known
P.O.#:		Surveyor:	Jen Costello	PSR:	P-707-037-038
Customer:		Clean Date:	01/01/1900	Shape:	C

Street:	STATE ST & E 12TH ST	Flow Control:	Not Controlled
City:	Hobart, IN	Year Renewed:	
Location:	Light Highway	Tape/Media #:	
Purpose:	Maintenance Related	Dia/Height:	12"
Use:	Sanitary	Material:	VCP
Drain Area:	NA	Lining:	Cured in Place
Category:	NA		
Comment:	flow incorrect.

Location Details:		Direction of Survey:	Upstream
US MH:	M-707-038	DS MH:	M-707-037
		Total Length Surveyed (ft):	360.9

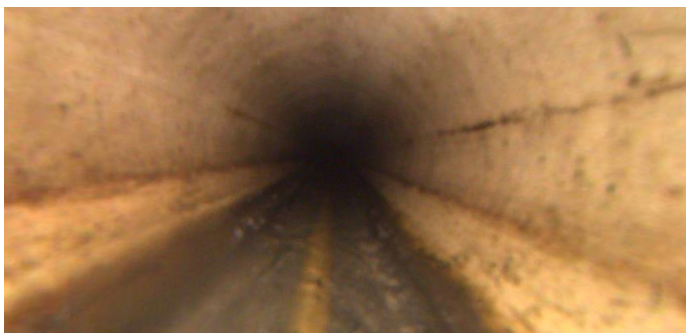
Code: **AMH**
Description: **Manhole**

Distance (ft): **.0**
Structural Grade: **0**
O&M Grade: **0**
Clock Start/From:
Clock To:
1st Value:
2nd Value:
Value Percent:
Continuous Index:
Within 8" of Joint: **NO**
Remarks: **M-707-037**

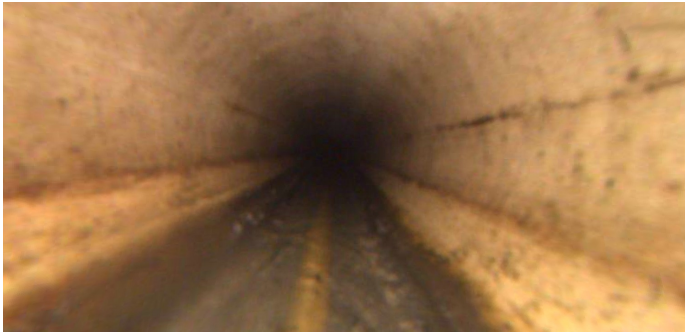
Code:	MWL
Description:	Water Level

Distance (ft):	.0
Structural Grade:	0
O&M Grade:	0
Clock Start/From:	
Clock To:	
1st Value:	
2nd Value:	
Value Percent:	5.000
Continuous Index:	
Within 8" of Joint:	NO
Remarks:

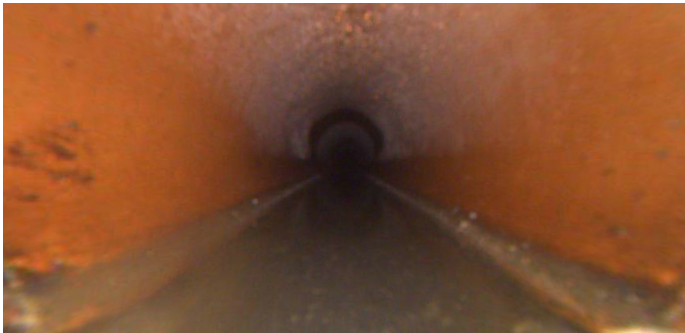
Code:	MMC
Description:	Material Change

Distance (ft):	10.7
Structural Grade:	0
O&M Grade:	0
Clock Start/From:	
Clock To:	
1st Value:	
2nd Value:	
Value Percent:	
Continuous Index:	
Within 8" of Joint:	NO
Remarks:	pvc

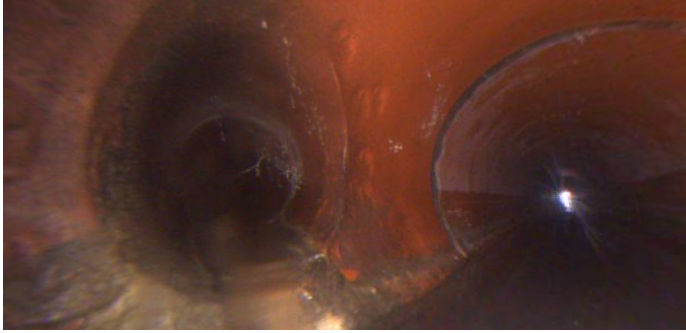
Code: **TFA**
Description: **Tap Factory Active**

Distance (ft): **64.4**
Structural Grade: **0**
O&M Grade: **0**
Clock Start/From: **3**
Clock To:
1st Value: **4.000**
2nd Value:
Value Percent:
Continuous Index:
Within 8" of Joint:
Remarks:

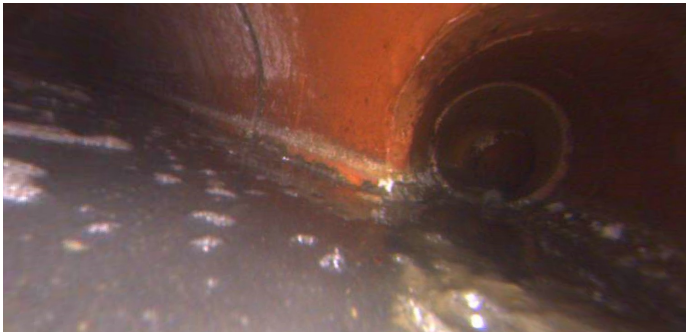
Code: **TFA**
Description: **Tap Factory Active**

Distance (ft): **138.9**
Structural Grade: **0**
O&M Grade: **0**
Clock Start/From: **9**
Clock To:
1st Value: **4.000**
2nd Value:
Value Percent:
Continuous Index:
Within 8" of Joint:
Remarks:

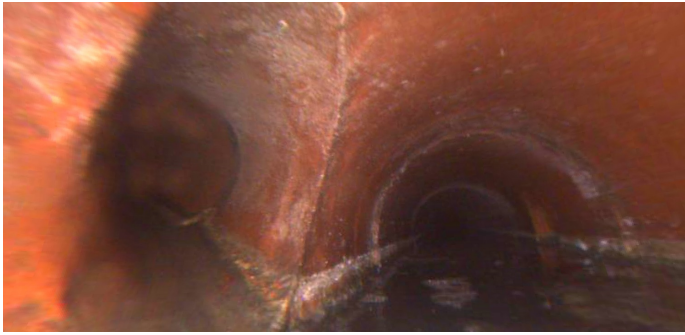
Code: **TFA**
Description: **Tap Factory Active**

Distance (ft): **141.3**
Structural Grade: **0**
O&M Grade: **0**
Clock Start/From: **3**
Clock To:
1st Value: **4.000**
2nd Value:
Value Percent:
Continuous Index:
Within 8" of Joint:
Remarks:

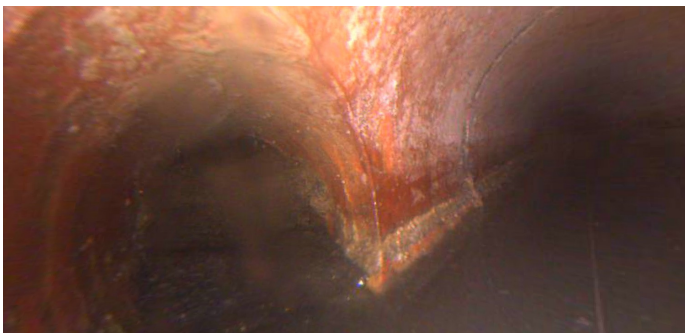
Code: **TFD**
Description: **Tap Factory Defective**

Distance (ft): **184.9**
Structural Grade: **0**
O&M Grade: **2**
Clock Start/From: **3**
Clock To:
1st Value: **4.000**
2nd Value:
Value Percent:
Continuous Index:
Within 8" of Joint:
Remarks: **deposits**

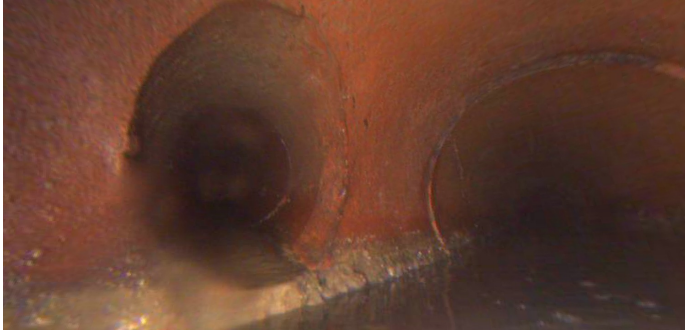
Code: **TFA**
Description: **Tap Factory Active**

Distance (ft): **217.5**
Structural Grade: **0**
O&M Grade: **0**
Clock Start/From: **3**
Clock To:
1st Value: **4.000**
2nd Value:
Value Percent:
Continuous Index:
Within 8" of Joint:
Remarks:

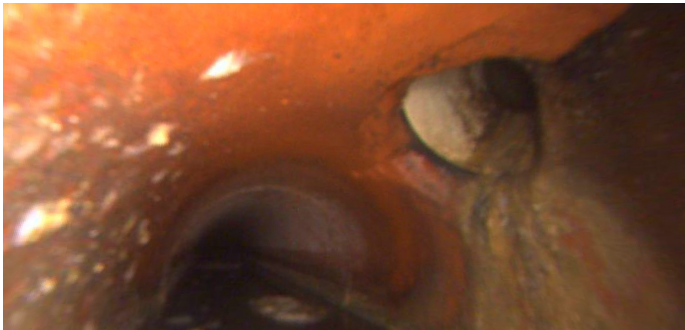
Code: **FL**
Description: **Fracture Longitudinal**

Distance (ft): **222.5**
Structural Grade: **3**
O&M Grade: **0**
Clock Start/From: **1**
Clock To:
1st Value:
2nd Value:
Value Percent:
Continuous Index:
Within 8" of Joint:
Remarks:

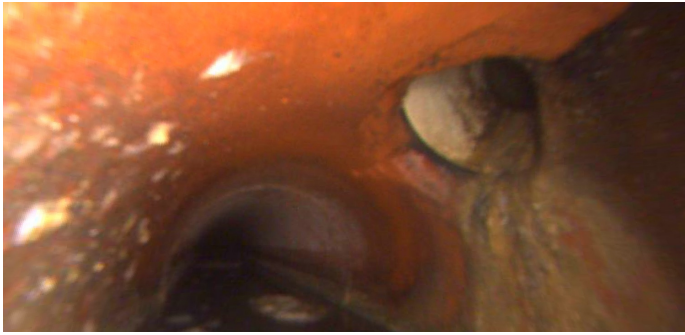
Code: **IW**
Description: **Infil Weeper**

Distance (ft): **222.5**
Structural Grade: **0**
O&M Grade: **2**
Clock Start/From: **1**
Clock To:
1st Value:
2nd Value:
Value Percent:
Continuous Index:
Within 8" of Joint:
Remarks:

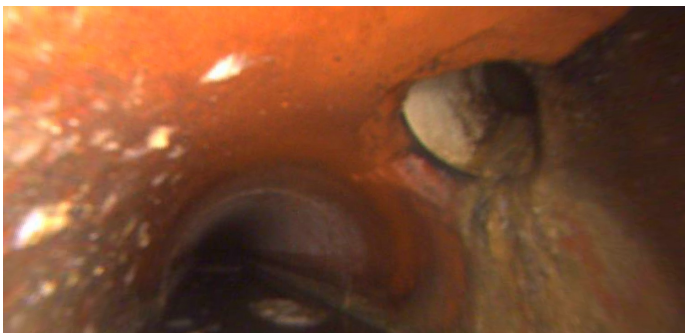
Code: **TBD**
Description: **Tap Break-in Defective**

Distance (ft): **222.5**
Structural Grade: **0**
O&M Grade: **3**
Clock Start/From: **1**
Clock To:
1st Value: **4.000**
2nd Value:
Value Percent:
Continuous Index:
Within 8" of Joint:
Remarks: **fractured**

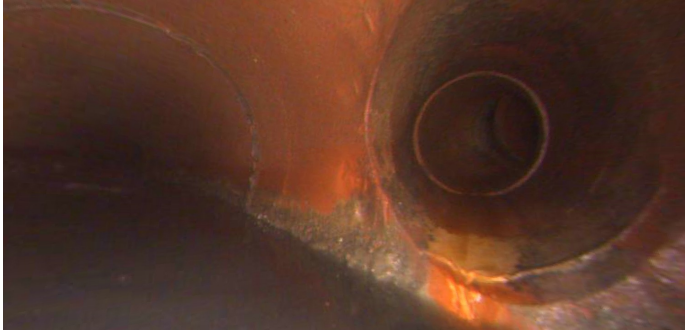
Code: **TFA**
Description: **Tap Factory Active**

Distance (ft): **243.6**
Structural Grade: **0**
O&M Grade: **0**
Clock Start/From: **9**
Clock To:
1st Value: **4.000**
2nd Value:
Value Percent:
Continuous Index:
Within 8" of Joint:
Remarks:

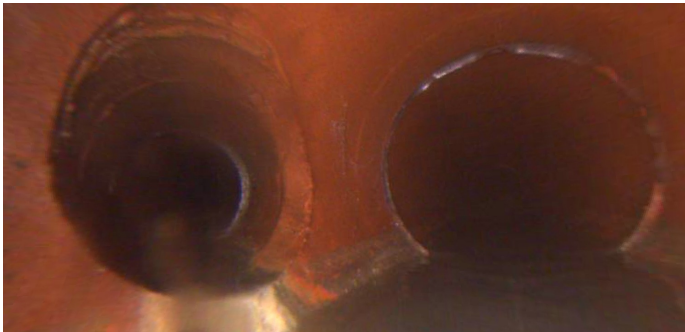
Code: **TFA**
Description: **Tap Factory Active**

Distance (ft): **335.7**
Structural Grade: **0**
O&M Grade: **0**
Clock Start/From: **3**
Clock To:
1st Value: **4.000**
2nd Value:
Value Percent:
Continuous Index:
Within 8" of Joint:
Remarks:

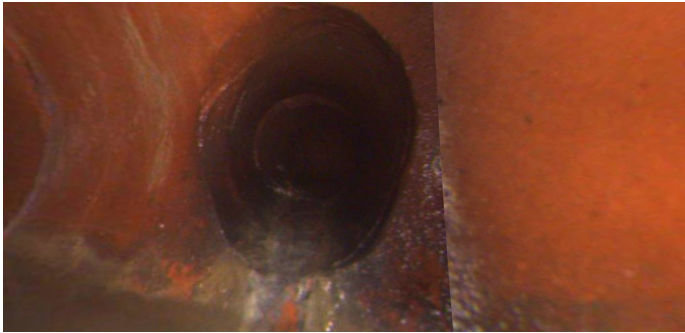
Code: **TFA**
Description: **Tap Factory Active**

Distance (ft): **337.8**
Structural Grade: **0**
O&M Grade: **0**
Clock Start/From: **9**
Clock To:
1st Value: **4.000**
2nd Value:
Value Percent:
Continuous Index:
Within 8" of Joint:
Remarks:

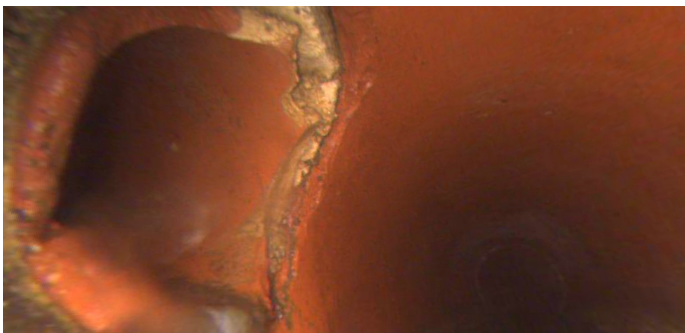
Code: **TBI**
Description: **Tap Break-in Intruding**

Distance (ft): **349.6**
Structural Grade: **0**
O&M Grade: **2**
Clock Start/From: **3**
Clock To:
1st Value: **4.000**
2nd Value: **1.000**
Value Percent:
Continuous Index:
Within 8" of Joint:
Remarks:

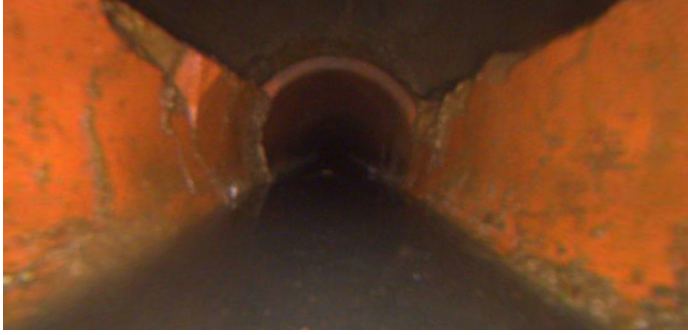
Code:	AMH
Description:	Manhole
Distance (ft):	360.9
Structural Grade:	0
O&M Grade:	0
Clock Start/From:	
Clock To:	
1st Value:	
2nd Value:	
Value Percent:	
Continuous Index:	
Within 8" of Joint:	NO
Remarks:	M-707-038
