Profile/Photo Observation Report

Date:	04/11/2018	Weather:		Coding:	PACP 6.0
Pipe Length (ft):	364.1	Owner:	NA	Pre Clean:	Not Known
P.O.#:		Surveyor:	Jen Costello	PSR:	P-707-037-038
Customer:		Clean Date:	01/01/1900	Shape:	C

Street:	Capitol	Flow Control:	Not Controlled
City:	Hobart, IN	Year Renewed:	
Location:	Light Highway	Tape/Media #:	
Purpose:	Maintenance Related	Dia/Height:	12"
Use:	Sanitary	Material:	VCP
Drain Area:	NA	Lining:	Cured in Place
Category:	NA		
Comment:	flow incorrect.

Location Details:		Direction of Survey:	Upstream
US MH:	M-707-038	DS MH:	M-707-037
		Total Length Surveyed (ft):	360.9

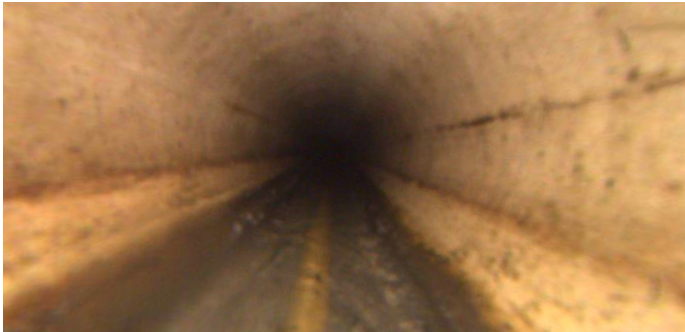
Code:	MWL
Description:	Water Level

Distance (ft):	.0
Structural Grade:	0
O&M Grade:	0
Clock Start/From:	
Clock To:	
1st Value:	
2nd Value:	
Value Percent:	5.000
Continuous Index:	
Within 8" of Joint:	NO
Remarks:

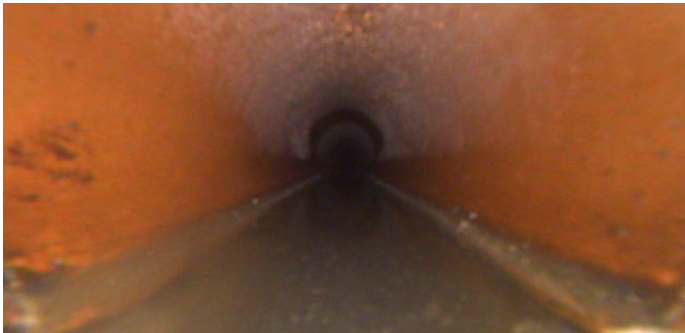
Code:	MMC
Description:	Material Change

Distance (ft):	10.7
Structural Grade:	0
O&M Grade:	0
Clock Start/From:	
Clock To:	
1st Value:	
2nd Value:	
Value Percent:	
Continuous Index:	
Within 8" of Joint:	NO
Remarks:	pvc

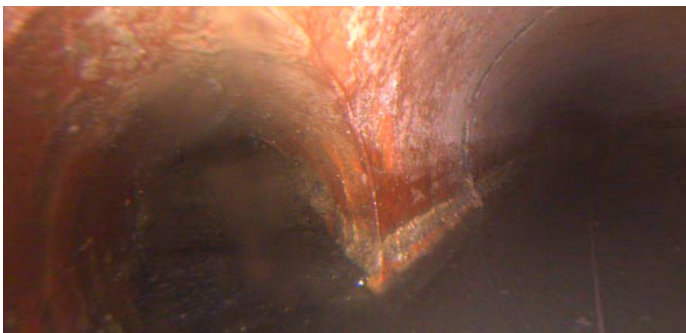
Code: **TFD**
Description: **Tap Factory Defective**

Distance (ft): **184.9**
Structural Grade: **0**
O&M Grade: **2**
Clock Start/From: **3**
Clock To:
1st Value: **4.000**
2nd Value:
Value Percent:
Continuous Index:
Within 8" of Joint:
Remarks: **deposits**

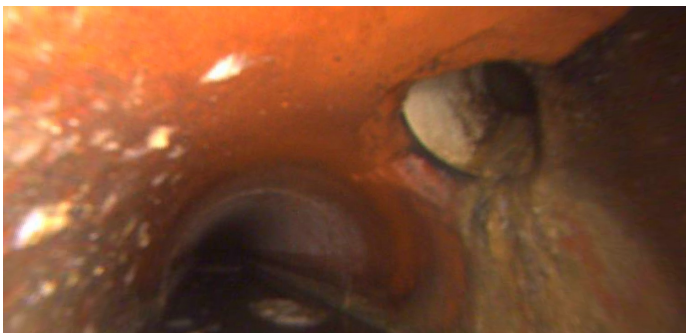
Code: **FL**
Description: **Fracture Longitudinal**

Distance (ft): **222.5**
Structural Grade: **3**
O&M Grade: **0**
Clock Start/From: **1**
Clock To:
1st Value:
2nd Value:
Value Percent:
Continuous Index:
Within 8" of Joint:
Remarks:

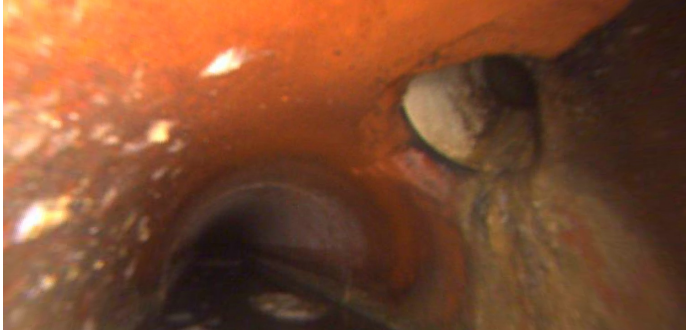
Code: **IW**
Description: **Infil Weeper**

Distance (ft): **222.5**
Structural Grade: **0**
O&M Grade: **2**
Clock Start/From: **1**
Clock To:
1st Value:
2nd Value:
Value Percent:
Continuous Index:
Within 8" of Joint:
Remarks:

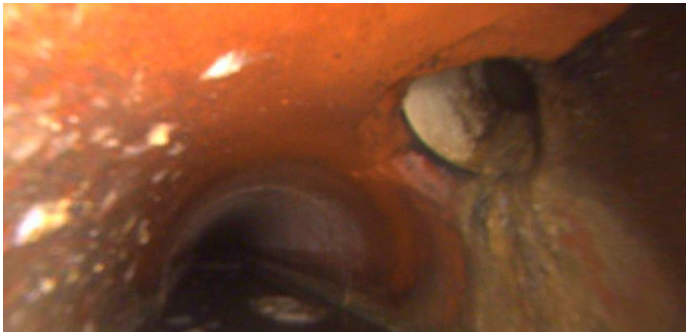
Code: **TBD**
Description: **Tap Break-in Defective**

Distance (ft): **222.5**
Structural Grade: **0**
O&M Grade: **3**
Clock Start/From: **1**
Clock To:
1st Value: **4.000**
2nd Value:
Value Percent:
Continuous Index:
Within 8" of Joint:
Remarks: **fractured**

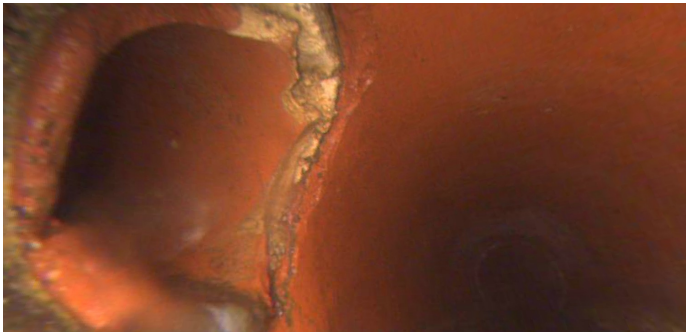
Code: **TBI**
Description: **Tap Break-in Intruding**

Distance (ft): **349.6**
Structural Grade: **0**
O&M Grade: **2**
Clock Start/From: **3**
Clock To:
1st Value: **4.000**
2nd Value: **1.000**
Value Percent:
Continuous Index:
Within 8" of Joint:
Remarks:
