Profile/Photo Observation Report

Date:	04/15/2018	Weather:		Coding:	PACP 6.0
Pipe Length (ft):	390.0	Owner:	NA	Pre Clean:	Not Known
P.O.#:		Surveyor:	Selasie Honu	PSR:	P-707-063-039
Customer:		Clean Date:	01/01/1900	Shape:	C

Street:	E 11TH ST	Flow Control:	Not Controlled
City:	Hobart, IN	Year Renewed:	
Location:	Light Highway	Tape/Media #:	
Purpose:	Maintenance Related	Dia/Height:	12"
Use:	Sanitary	Material:	VCP
Drain Area:	NA	Lining:	Cured in Place
Category:	NA		
Comment:	Reverse setup. heavy silt and pipe change at 117'. flow reversed.		
Location Details:		Direction of Survey:	Upstream
US MH:	M-707-039	DS MH:	M-707-063
		Total Length Surveyed (ft):	118.1

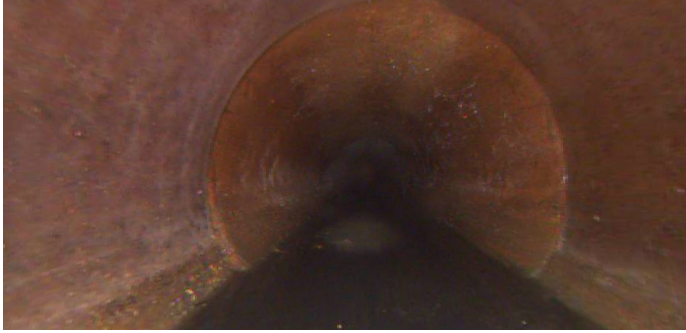
Code: **AMH**
Description: **Manhole**

Distance (ft): **.0**
Structural Grade: **0**
O&M Grade: **0**
Clock Start/From:
Clock To:
1st Value:
2nd Value:
Value Percent:
Continuous Index:
Within 8" of Joint: **NO**
Remarks: **M-707-063**

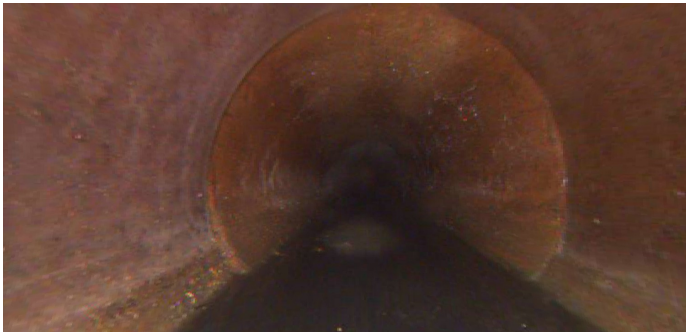
Code: **MWL**
Description: **Water Level**

Distance (ft): **.0**
Structural Grade: **0**
O&M Grade: **0**
Clock Start/From:
Clock To:
1st Value:
2nd Value:
Value Percent: **5.000**
Continuous Index:
Within 8" of Joint: **NO**
Remarks:

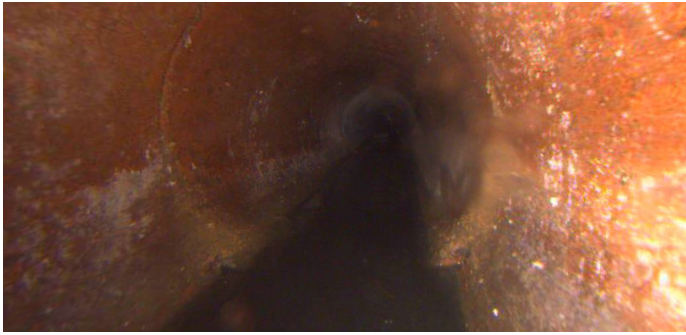
Code: **DAE**
Description: **Deposits Attached Encrustation**

Distance (ft): **13.1**
Structural Grade: **0**
O&M Grade: **2**
Clock Start/From: **8**
Clock To: **4**
1st Value:
2nd Value:
Value Percent: **5.000**
Continuous Index: **S02**
Within 8" of Joint: **YES**
Remarks:

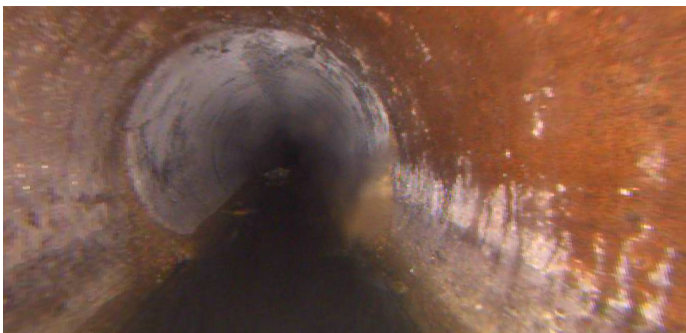
Code: **RFJ**
Description: **Roots Fine Joint**

Distance (ft): **15.7**
Structural Grade: **0**
O&M Grade: **1**
Clock Start/From: **7**
Clock To: **5**
1st Value:
2nd Value:
Value Percent:
Continuous Index:
Within 8" of Joint: **YES**
Remarks:

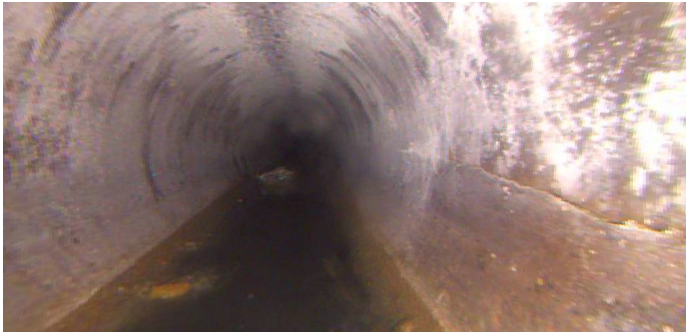
Code: **FL**
Description: **Fracture Longitudinal**

Distance (ft): **16.8**
Structural Grade: **3**
O&M Grade: **0**
Clock Start/From: **3**
Clock To:
1st Value:
2nd Value:
Value Percent:
Continuous Index:
Within 8" of Joint: **YES**
Remarks:

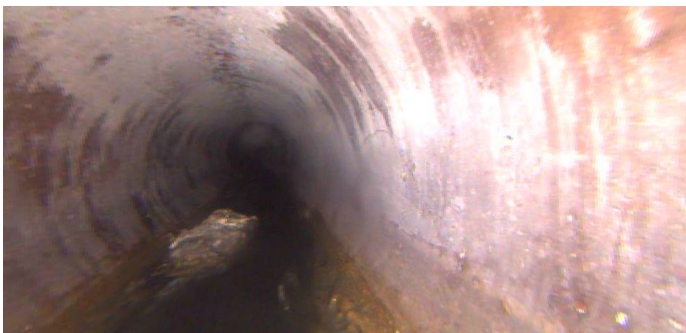
Code: **FL**
Description: **Fracture Longitudinal**

Distance (ft): **18.2**
Structural Grade: **3**
O&M Grade: **0**
Clock Start/From: **4**
Clock To:
1st Value:
2nd Value:
Value Percent:
Continuous Index:
Within 8" of Joint: **NO**
Remarks:

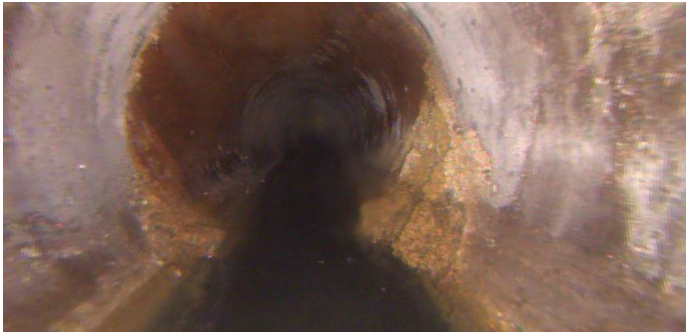
Code: **RFJ**
Description: **Roots Fine Joint**

Distance (ft): **22.0**
Structural Grade: **0**
O&M Grade: **1**
Clock Start/From: **7**
Clock To: **5**
1st Value:
2nd Value:
Value Percent:
Continuous Index: **S01**
Within 8" of Joint: **YES**
Remarks:

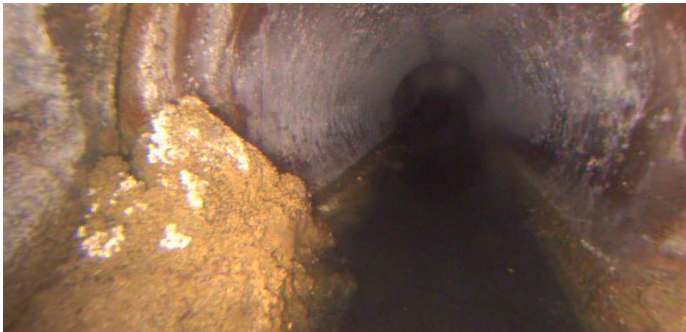
Code: **DAE**
Description: **Deposits Attached Encrustation**

Distance (ft): **28.6**
Structural Grade: **0**
O&M Grade: **2**
Clock Start/From: **7**
Clock To: **9**
1st Value:
2nd Value:
Value Percent: **10.000**
Continuous Index:
Within 8" of Joint: **YES**
Remarks:

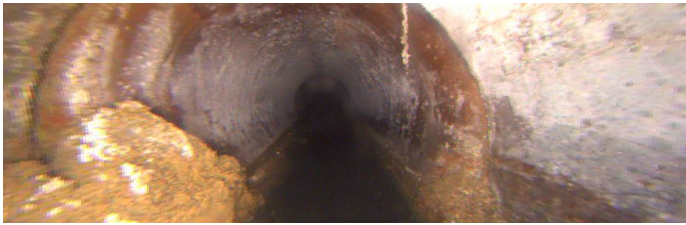
Code: **RFJ**
Description: **Roots Fine Joint**

Distance (ft): **28.6**
Structural Grade: **0**
O&M Grade: **1**
Clock Start/From: **7**
Clock To: **5**
1st Value:
2nd Value:
Value Percent:
Continuous Index: **F01**
Within 8" of Joint: **YES**
Remarks:

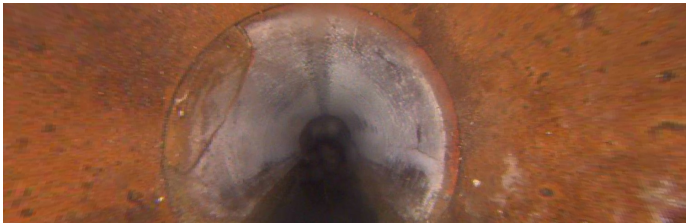
Code: **FS**
Description: **Fracture Spiral**

Distance (ft): **34.5**
Structural Grade: **3**
O&M Grade: **0**
Clock Start/From: **8**
Clock To: **11**
1st Value:
2nd Value:
Value Percent:
Continuous Index:
Within 8" of Joint: **YES**
Remarks:

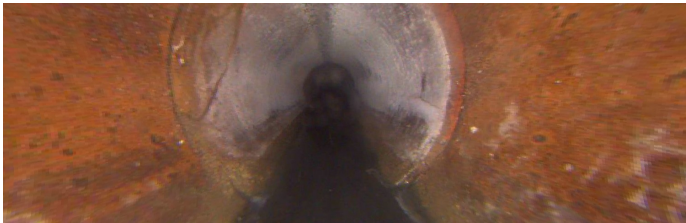
Code: **RFJ**
Description: **Roots Fine Joint**

Distance (ft): **34.5**
Structural Grade: **0**
O&M Grade: **1**
Clock Start/From: **7**
Clock To: **8**
1st Value:
2nd Value:
Value Percent:
Continuous Index:
Within 8" of Joint: **YES**
Remarks:

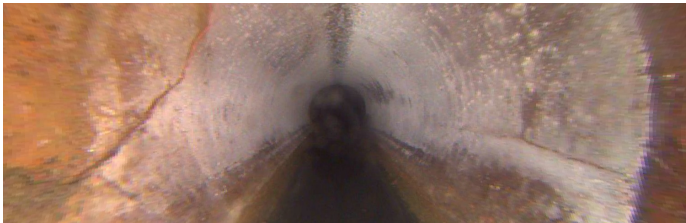
Code: **FL**
Description: **Fracture Longitudinal**

Distance (ft): **34.9**
Structural Grade: **3**
O&M Grade: **0**
Clock Start/From: **3**
Clock To:
1st Value:
2nd Value:
Value Percent:
Continuous Index:
Within 8" of Joint: **YES**
Remarks:

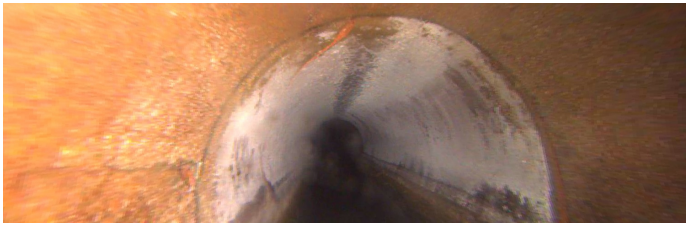
Code: **FC**
Description: **Fracture Circumferential**

Distance (ft): **40.7**
Structural Grade: **2**
O&M Grade: **0**
Clock Start/From: **7**
Clock To: **12**
1st Value:
2nd Value:
Value Percent:
Continuous Index:
Within 8" of Joint: **YES**
Remarks:

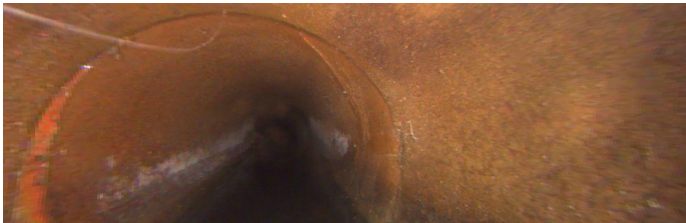
Code: **FM**
Description: **Fracture Multiple**

Distance (ft): **46.7**
Structural Grade: **4**
O&M Grade: **0**
Clock Start/From: **1**
Clock To: **5**
1st Value:
2nd Value:
Value Percent:
Continuous Index:
Within 8" of Joint: **YES**
Remarks:

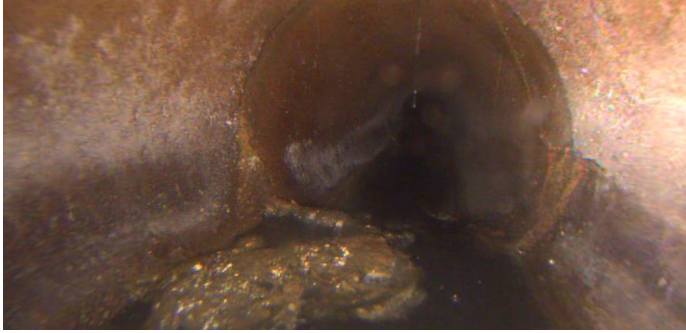
Code: **DSC**
Description: **Deposits Settled Compacted**

Distance (ft): **49.6**
Structural Grade: **0**
O&M Grade: **2**
Clock Start/From: **6**
Clock To: **7**
1st Value:
2nd Value:
Value Percent: **10.000**
Continuous Index:
Within 8" of Joint: **NO**
Remarks:

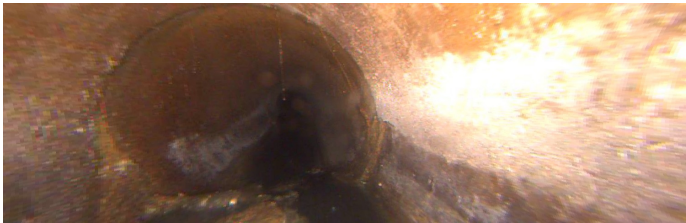
Code: **RFJ**
Description: **Roots Fine Joint**

Distance (ft): **49.6**
Structural Grade: **0**
O&M Grade: **1**
Clock Start/From: **7**
Clock To: **5**
1st Value:
2nd Value:
Value Percent:
Continuous Index:
Within 8" of Joint: **YES**
Remarks:

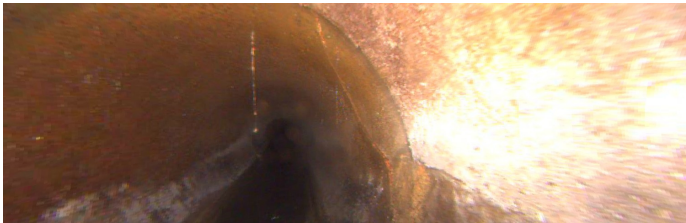
Code: **FC**
Description: **Fracture Circumferential**

Distance (ft): **50.0**
Structural Grade: **2**
O&M Grade: **0**
Clock Start/From: **2**
Clock To: **5**
1st Value:
2nd Value:
Value Percent:
Continuous Index:
Within 8" of Joint: **YES**
Remarks:

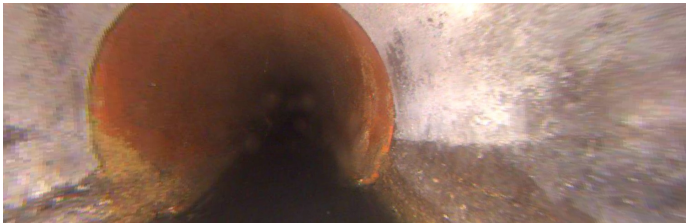
Code: **RFJ**
Description: **Roots Fine Joint**

Distance (ft): **55.7**
Structural Grade: **0**
O&M Grade: **1**
Clock Start/From: **7**
Clock To: **8**
1st Value:
2nd Value:
Value Percent:
Continuous Index:
Within 8" of Joint: **YES**
Remarks:

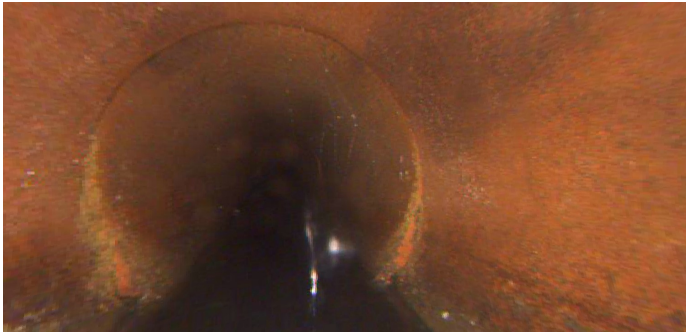
Code: **RFJ**
Description: **Roots Fine Joint**

Distance (ft): **58.7**
Structural Grade: **0**
O&M Grade: **1**
Clock Start/From: **7**
Clock To: **5**
1st Value:
2nd Value:
Value Percent:
Continuous Index:
Within 8" of Joint: **YES**
Remarks:

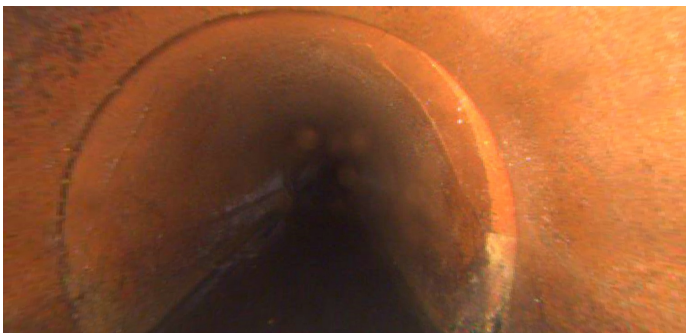
Code: **FC**
Description: **Fracture Circumferential**

Distance (ft): **62.1**
Structural Grade: **2**
O&M Grade: **0**
Clock Start/From: **9**
Clock To: **3**
1st Value:
2nd Value:
Value Percent:
Continuous Index:
Within 8" of Joint: **YES**
Remarks:

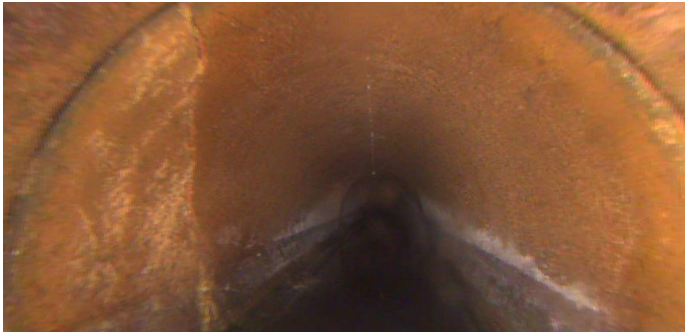
Code: **FS**
Description: **Fracture Spiral**

Distance (ft): **65.3**
Structural Grade: **3**
O&M Grade: **0**
Clock Start/From: **7**
Clock To: **11**
1st Value:
2nd Value:
Value Percent:
Continuous Index:
Within 8" of Joint: **YES**
Remarks:

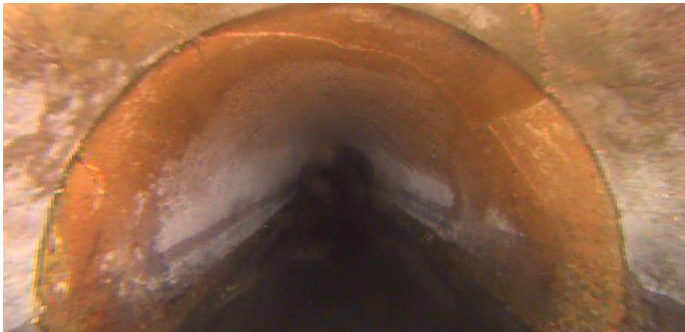
Code: **FM**
Description: **Fracture Multiple**

Distance (ft): **68.3**
Structural Grade: **4**
O&M Grade: **0**
Clock Start/From: **7**
Clock To: **5**
1st Value:
2nd Value:
Value Percent:
Continuous Index:
Within 8" of Joint: **YES**
Remarks:

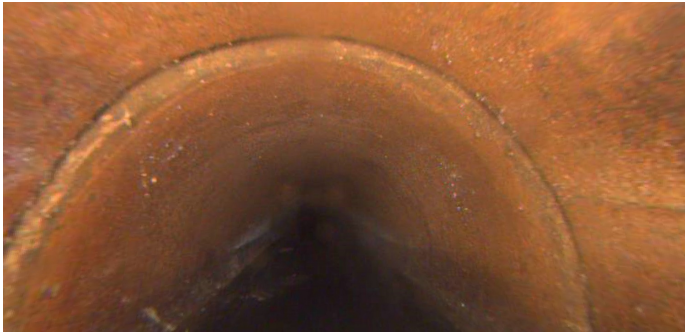
Code: **DAE**
Description: **Deposits Attached Encrustation**

Distance (ft): **74.5**
Structural Grade: **0**
O&M Grade: **2**
Clock Start/From: **8**
Clock To: **4**
1st Value:
2nd Value:
Value Percent: **5.000**
Continuous Index: **F02**
Within 8" of Joint: **YES**
Remarks:

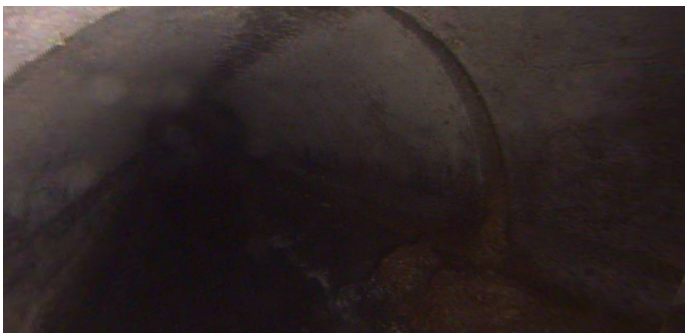
Code: **DAE**
Description: **Deposits Attached Encrustation**

Distance (ft): **80.7**
Structural Grade: **0**
O&M Grade: **2**
Clock Start/From: **3**
Clock To: **5**
1st Value:
2nd Value:
Value Percent: **5.000**
Continuous Index:
Within 8" of Joint: **YES**
Remarks:

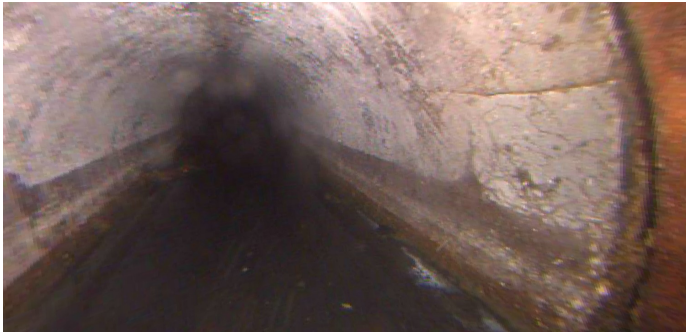
Code: **FL**
Description: **Fracture Longitudinal**

Distance (ft): **87.2**
Structural Grade: **3**
O&M Grade: **0**
Clock Start/From: **3**
Clock To:
1st Value:
2nd Value:
Value Percent:
Continuous Index:
Within 8" of Joint: **YES**
Remarks:

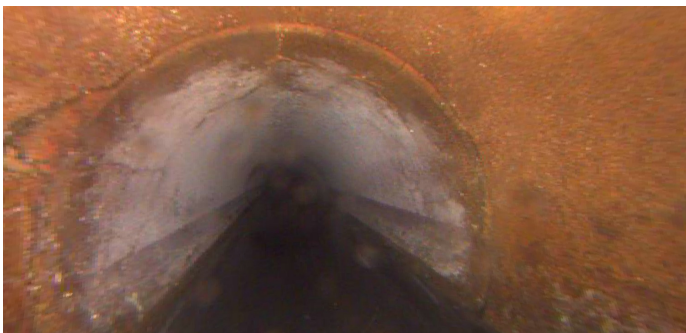
Code: **FM**
Description: **Fracture Multiple**

Distance (ft): **92.8**
Structural Grade: **4**
O&M Grade: **0**
Clock Start/From: **7**
Clock To: **5**
1st Value:
2nd Value:
Value Percent:
Continuous Index:
Within 8" of Joint: **YES**
Remarks:

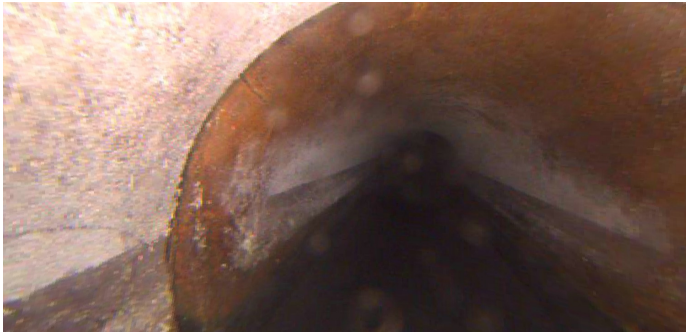
Code: **FS**
Description: **Fracture Spiral**

Distance (ft): **96.1**
Structural Grade: **3**
O&M Grade: **0**
Clock Start/From: **8**
Clock To: **10**
1st Value:
2nd Value:
Value Percent:
Continuous Index:
Within 8" of Joint: **YES**
Remarks:

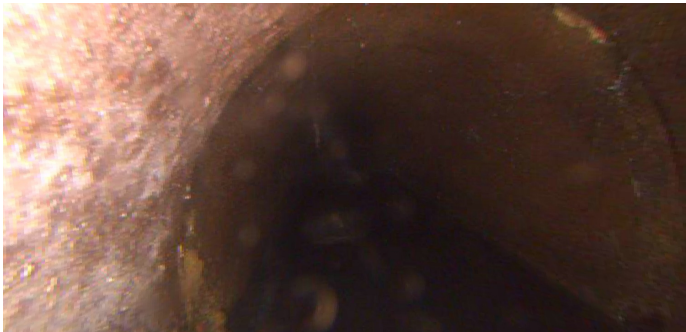
Code: **RFJ**
Description: **Roots Fine Joint**

Distance (ft): **102.2**
Structural Grade: **0**
O&M Grade: **1**
Clock Start/From: **7**
Clock To: **1**
1st Value:
2nd Value:
Value Percent:
Continuous Index:
Within 8" of Joint: **YES**
Remarks:

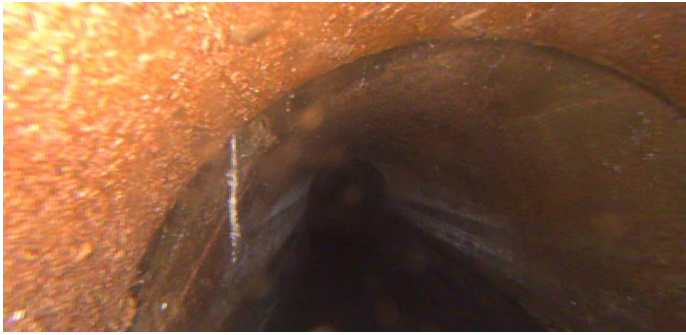
Code: **RFJ**
Description: **Roots Fine Joint**

Distance (ft): **105.3**
Structural Grade: **0**
O&M Grade: **1**
Clock Start/From: **10**
Clock To:
1st Value:
2nd Value:
Value Percent:
Continuous Index:
Within 8" of Joint: **YES**
Remarks:

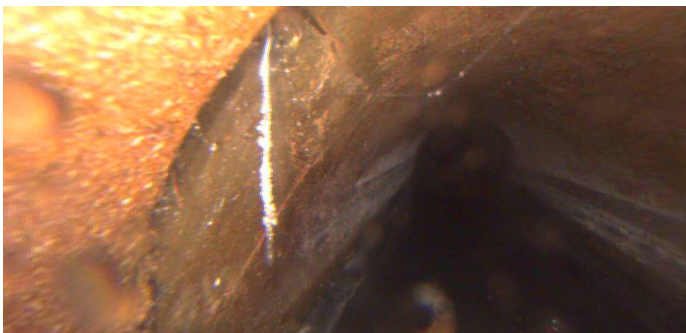
Code: **FS**
Description: **Fracture Spiral**

Distance (ft): **105.5**
Structural Grade: **3**
O&M Grade: **0**
Clock Start/From: **8**
Clock To: **10**
1st Value:
2nd Value:
Value Percent:
Continuous Index:
Within 8" of Joint: **YES**
Remarks:

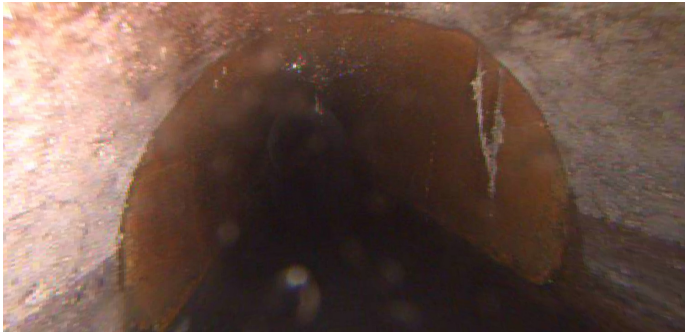
Code: **RFJ**
Description: **Roots Fine Joint**

Distance (ft): **108.2**
Structural Grade: **0**
O&M Grade: **1**
Clock Start/From: **2**
Clock To:
1st Value:
2nd Value:
Value Percent:
Continuous Index:
Within 8" of Joint: **YES**
Remarks:

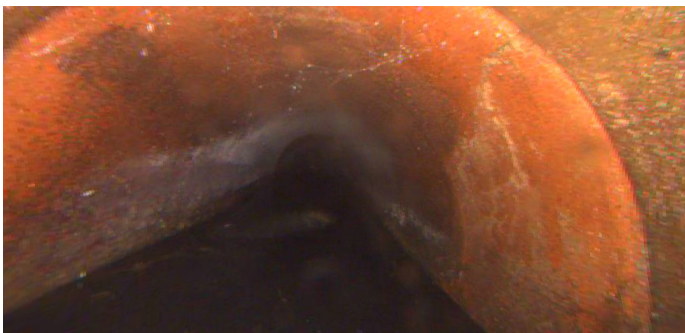
Code: **FS**
Description: **Fracture Spiral**

Distance (ft): **117.8**
Structural Grade: **3**
O&M Grade: **0**
Clock Start/From: **2**
Clock To: **3**
1st Value:
2nd Value:
Value Percent:
Continuous Index:
Within 8" of Joint: **YES**
Remarks:

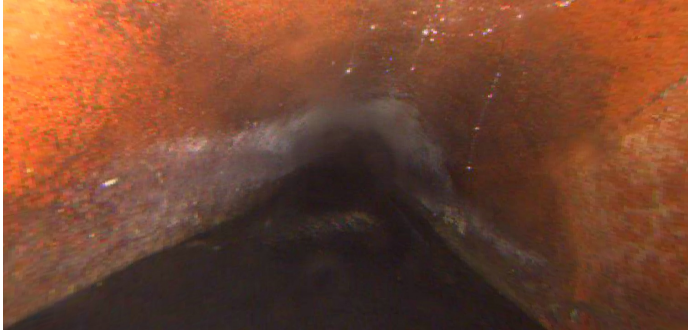
Code:	MSA
Description:	Abandoned Survey
Distance (ft):	118.1
Structural Grade:	0
O&M Grade:	0
Clock Start/From:	
Clock To:	
1st Value:	
2nd Value:	
Value Percent:	
Continuous Index:	
Within 8" of Joint:	NO
Remarks:	debris under water
