Profile/Photo Observation Report

Date:	04/15/2018	Weather:		Coding:	PACP 6.0
Pipe Length (ft):	390.0	Owner:	NA	Pre Clean:	Not Known
P.O.#:		Surveyor:	Selasie Honu	PSR:	P-707-063-039
Customer:		Clean Date:	01/01/1900	Shape:	C

Street:	Capitol	Flow Control:	Not Controlled
City:	Hobart, IN	Year Renewed:	
Location:	Light Highway	Tape/Media #:	
Purpose:	Maintenance Related	Dia/Height:	12"
Use:	Sanitary	Material:	VCP
Drain Area:	NA	Lining:	Cured in Place
Category:	NA		
Comment:	Reverse setup. heavy silt and pipe change at 117'. flow reversed.		
Location Details:		Direction of Survey:	Upstream
US MH:	M-707-039	DS MH:	M-707-063
		Total Length Surveyed (ft):	118.1

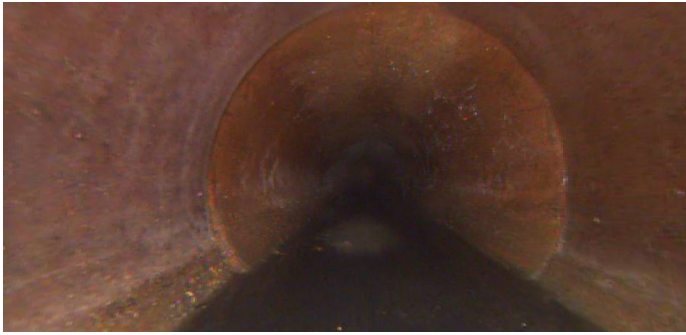
Code: **AMH**
Description: **Manhole**

Distance (ft): **.0**
Structural Grade: **0**
O&M Grade: **0**
Clock Start/From:
Clock To:
1st Value:
2nd Value:
Value Percent:
Continuous Index:
Within 8" of Joint: **NO**
Remarks: **M-707-063**

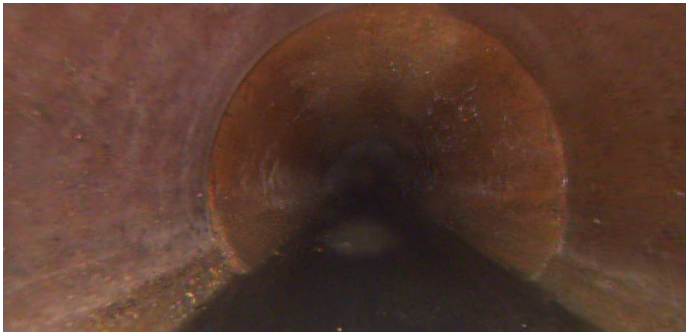
Code: **MWL**
Description: **Water Level**

Distance (ft): **.0**
Structural Grade: **0**
O&M Grade: **0**
Clock Start/From:
Clock To:
1st Value:
2nd Value:
Value Percent: **5.000**
Continuous Index:
Within 8" of Joint: **NO**
Remarks:

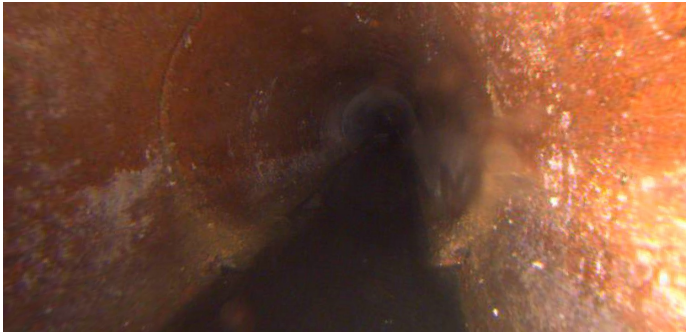
Code: **DAE**
Description: **Deposits Attached Encrustation**

Distance (ft): **13.1**
Structural Grade: **0**
O&M Grade: **2**
Clock Start/From: **8**
Clock To: **4**
1st Value:
2nd Value:
Value Percent: **5.000**
Continuous Index: **S02**
Within 8" of Joint: **YES**
Remarks:

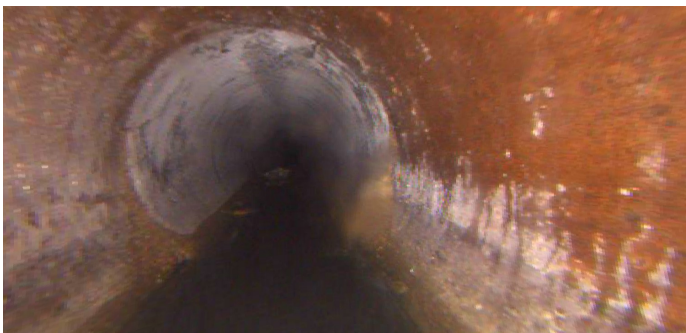
Code: **RFJ**
Description: **Roots Fine Joint**

Distance (ft): **15.7**
Structural Grade: **0**
O&M Grade: **1**
Clock Start/From: **7**
Clock To: **5**
1st Value:
2nd Value:
Value Percent:
Continuous Index:
Within 8" of Joint: **YES**
Remarks:

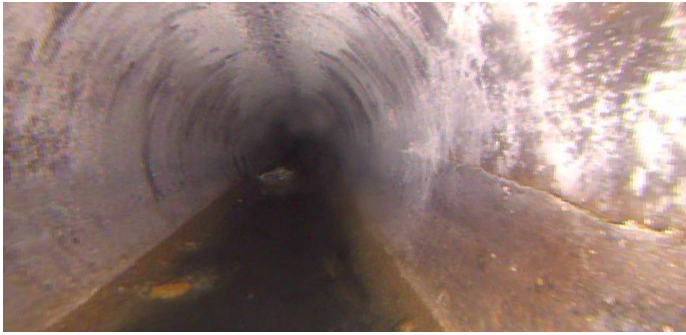
Code: **FL**
Description: **Fracture Longitudinal**

Distance (ft): **16.8**
Structural Grade: **3**
O&M Grade: **0**
Clock Start/From: **3**
Clock To:
1st Value:
2nd Value:
Value Percent:
Continuous Index:
Within 8" of Joint: **YES**
Remarks:

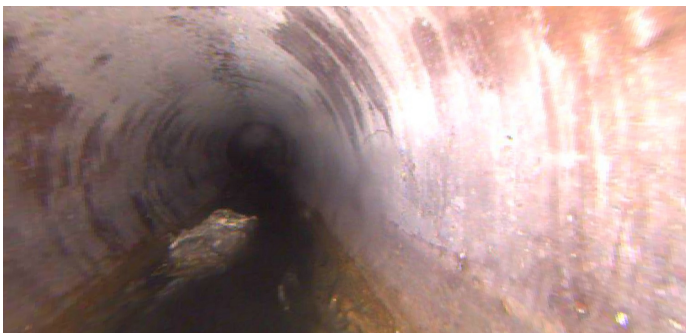
Code: **FL**
Description: **Fracture Longitudinal**

Distance (ft): **18.2**
Structural Grade: **3**
O&M Grade: **0**
Clock Start/From: **4**
Clock To:
1st Value:
2nd Value:
Value Percent:
Continuous Index:
Within 8" of Joint: **NO**
Remarks:

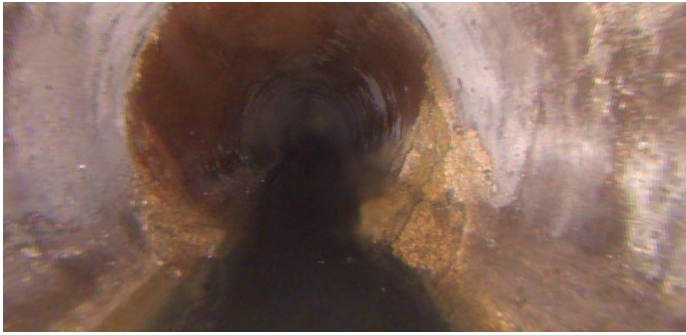
Code: **RFJ**
Description: **Roots Fine Joint**

Distance (ft): **22.0**
Structural Grade: **0**
O&M Grade: **1**
Clock Start/From: **7**
Clock To: **5**
1st Value:
2nd Value:
Value Percent:
Continuous Index: **S01**
Within 8" of Joint: **YES**
Remarks:

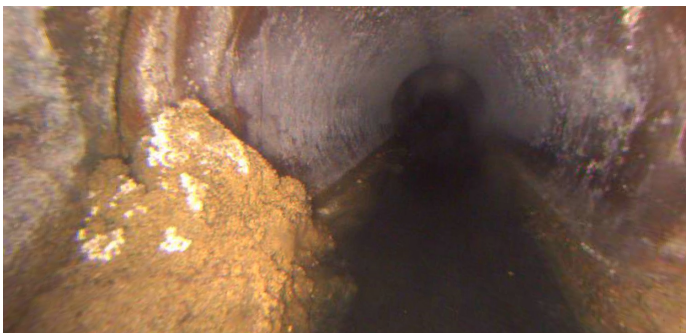
Code: **DAE**
Description: **Deposits Attached Encrustation**

Distance (ft): **28.6**
Structural Grade: **0**
O&M Grade: **2**
Clock Start/From: **7**
Clock To: **9**
1st Value:
2nd Value:
Value Percent: **10.000**
Continuous Index:
Within 8" of Joint: **YES**
Remarks:

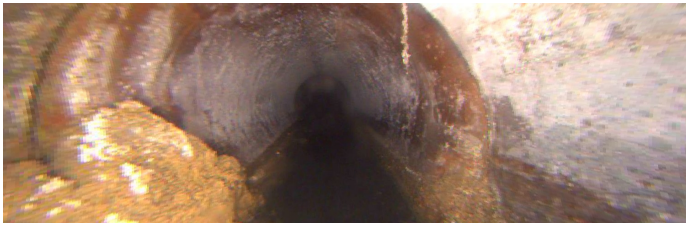
Code: **RFJ**
Description: **Roots Fine Joint**

Distance (ft): **28.6**
Structural Grade: **0**
O&M Grade: **1**
Clock Start/From: **7**
Clock To: **5**
1st Value:
2nd Value:
Value Percent:
Continuous Index: **F01**
Within 8" of Joint: **YES**
Remarks:

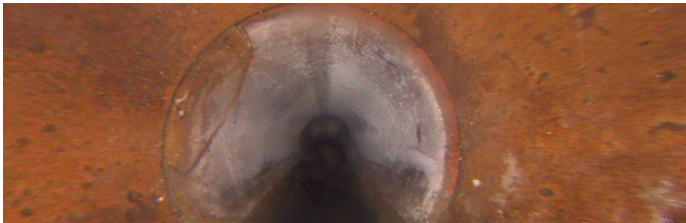
Code: **FS**
Description: **Fracture Spiral**

Distance (ft): **34.5**
Structural Grade: **3**
O&M Grade: **0**
Clock Start/From: **8**
Clock To: **11**
1st Value:
2nd Value:
Value Percent:
Continuous Index:
Within 8" of Joint: **YES**
Remarks:

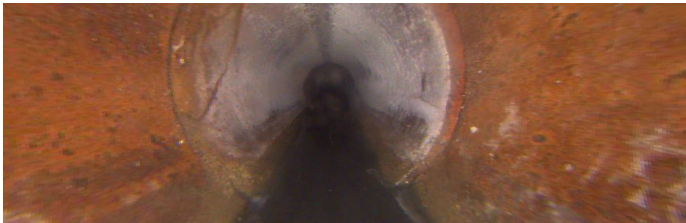
Code: **RFJ**
Description: **Roots Fine Joint**

Distance (ft): **34.5**
Structural Grade: **0**
O&M Grade: **1**
Clock Start/From: **7**
Clock To: **8**
1st Value:
2nd Value:
Value Percent:
Continuous Index:
Within 8" of Joint: **YES**
Remarks:

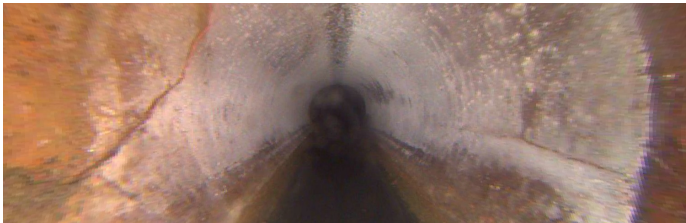
Code: **FL**
Description: **Fracture Longitudinal**

Distance (ft): **34.9**
Structural Grade: **3**
O&M Grade: **0**
Clock Start/From: **3**
Clock To:
1st Value:
2nd Value:
Value Percent:
Continuous Index:
Within 8" of Joint: **YES**
Remarks:

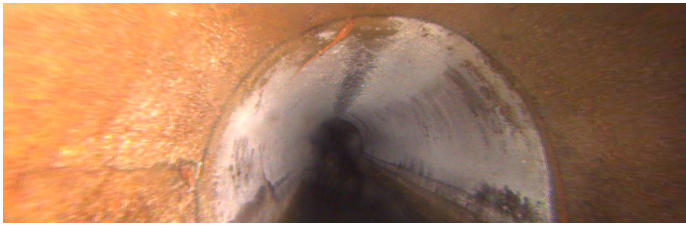
Code: **FC**
Description: **Fracture Circumferential**

Distance (ft): **40.7**
Structural Grade: **2**
O&M Grade: **0**
Clock Start/From: **7**
Clock To: **12**
1st Value:
2nd Value:
Value Percent:
Continuous Index:
Within 8" of Joint: **YES**
Remarks:

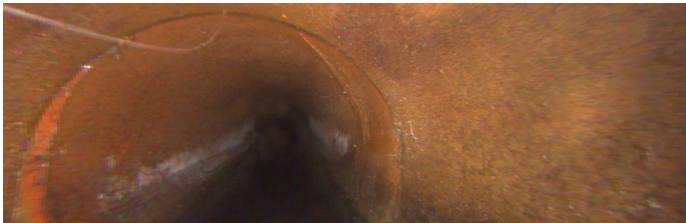
Code: **FM**
Description: **Fracture Multiple**

Distance (ft): **46.7**
Structural Grade: **4**
O&M Grade: **0**
Clock Start/From: **1**
Clock To: **5**
1st Value:
2nd Value:
Value Percent:
Continuous Index:
Within 8" of Joint: **YES**
Remarks:

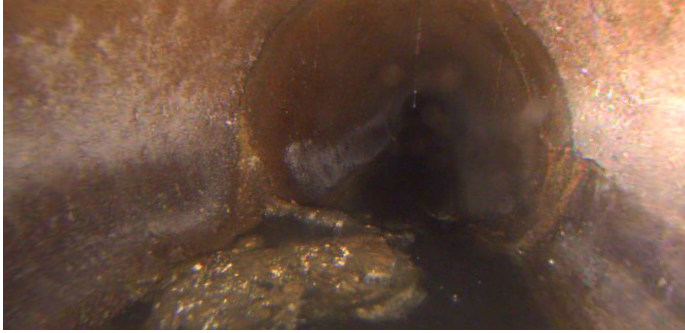
Code: **DSC**
Description: **Deposits Settled Compacted**

Distance (ft): **49.6**
Structural Grade: **0**
O&M Grade: **2**
Clock Start/From: **6**
Clock To: **7**
1st Value:
2nd Value:
Value Percent: **10.000**
Continuous Index:
Within 8" of Joint: **NO**
Remarks:

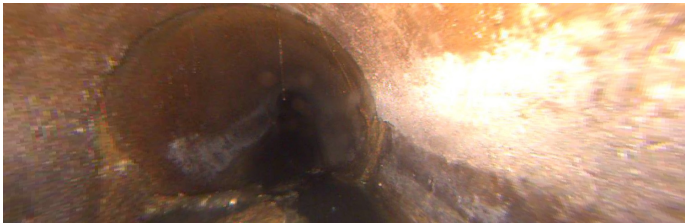
Code: **RFJ**
Description: **Roots Fine Joint**

Distance (ft): **49.6**
Structural Grade: **0**
O&M Grade: **1**
Clock Start/From: **7**
Clock To: **5**
1st Value:
2nd Value:
Value Percent:
Continuous Index:
Within 8" of Joint: **YES**
Remarks:

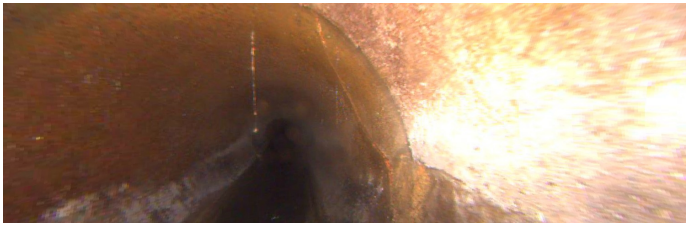
Code: **FC**
Description: **Fracture Circumferential**

Distance (ft): **50.0**
Structural Grade: **2**
O&M Grade: **0**
Clock Start/From: **2**
Clock To: **5**
1st Value:
2nd Value:
Value Percent:
Continuous Index:
Within 8" of Joint: **YES**
Remarks:

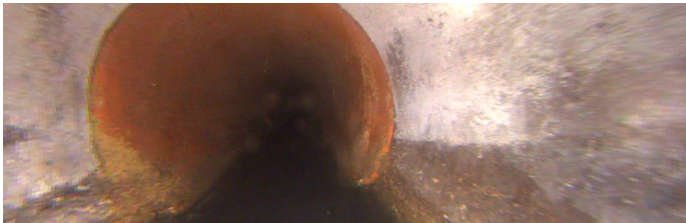
Code: **RFJ**
Description: **Roots Fine Joint**

Distance (ft): **55.7**
Structural Grade: **0**
O&M Grade: **1**
Clock Start/From: **7**
Clock To: **8**
1st Value:
2nd Value:
Value Percent:
Continuous Index:
Within 8" of Joint: **YES**
Remarks:

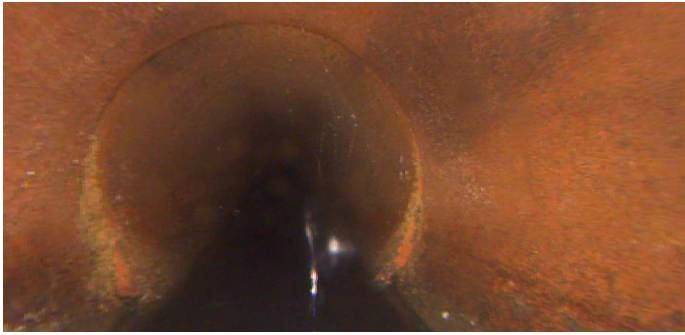
Code: **RFJ**
Description: **Roots Fine Joint**

Distance (ft): **58.7**
Structural Grade: **0**
O&M Grade: **1**
Clock Start/From: **7**
Clock To: **5**
1st Value:
2nd Value:
Value Percent:
Continuous Index:
Within 8" of Joint: **YES**
Remarks:

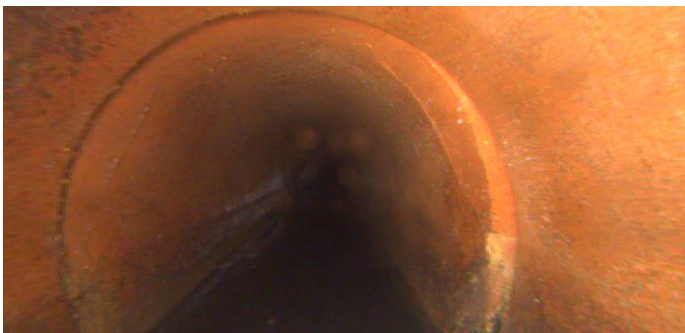
Code: **FC**
Description: **Fracture Circumferential**

Distance (ft): **62.1**
Structural Grade: **2**
O&M Grade: **0**
Clock Start/From: **9**
Clock To: **3**
1st Value:
2nd Value:
Value Percent:
Continuous Index:
Within 8" of Joint: **YES**
Remarks:

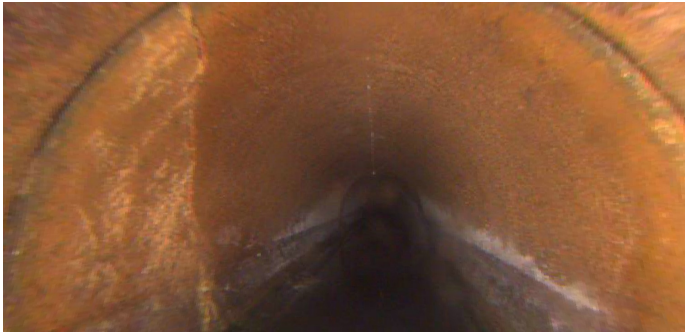
Code: **FS**
Description: **Fracture Spiral**

Distance (ft): **65.3**
Structural Grade: **3**
O&M Grade: **0**
Clock Start/From: **7**
Clock To: **11**
1st Value:
2nd Value:
Value Percent:
Continuous Index:
Within 8" of Joint: **YES**
Remarks:

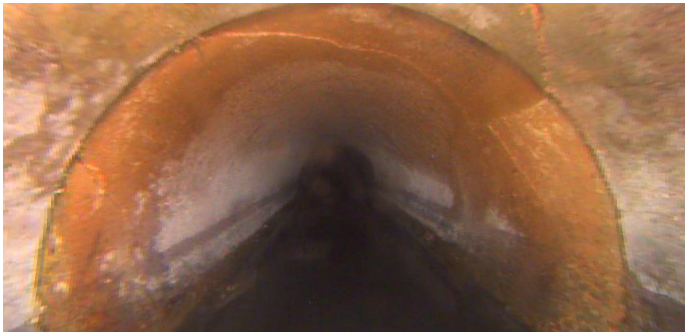
Code: **FM**
Description: **Fracture Multiple**

Distance (ft): **68.3**
Structural Grade: **4**
O&M Grade: **0**
Clock Start/From: **7**
Clock To: **5**
1st Value:
2nd Value:
Value Percent:
Continuous Index:
Within 8" of Joint: **YES**
Remarks:

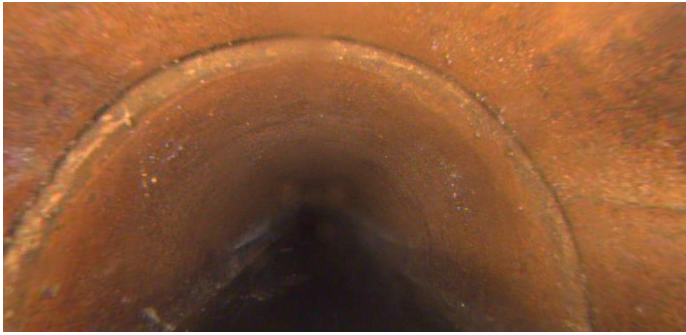
Code: **DAE**
Description: **Deposits Attached Encrustation**

Distance (ft): **74.5**
Structural Grade: **0**
O&M Grade: **2**
Clock Start/From: **8**
Clock To: **4**
1st Value:
2nd Value:
Value Percent: **5.000**
Continuous Index: **F02**
Within 8" of Joint: **YES**
Remarks:

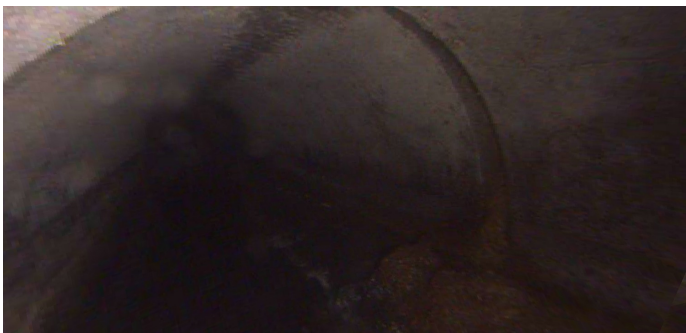
Code: **DAE**
Description: **Deposits Attached Encrustation**

Distance (ft): **80.7**
Structural Grade: **0**
O&M Grade: **2**
Clock Start/From: **3**
Clock To: **5**
1st Value:
2nd Value:
Value Percent: **5.000**
Continuous Index:
Within 8" of Joint: **YES**
Remarks:

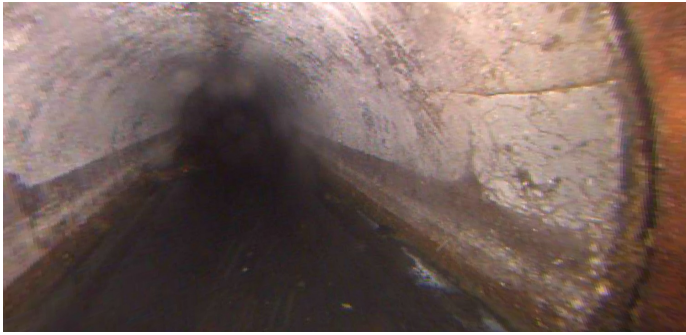
Code: **FL**
Description: **Fracture Longitudinal**

Distance (ft): **87.2**
Structural Grade: **3**
O&M Grade: **0**
Clock Start/From: **3**
Clock To:
1st Value:
2nd Value:
Value Percent:
Continuous Index:
Within 8" of Joint: **YES**
Remarks:

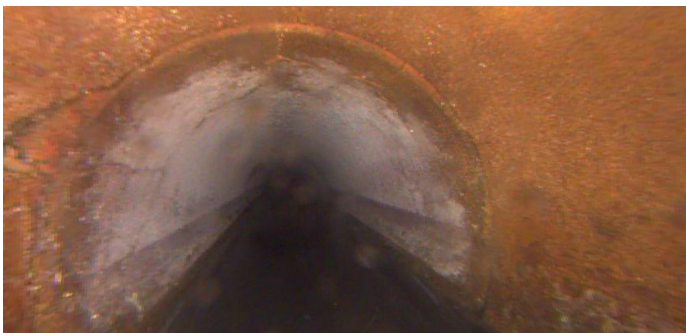
Code: **FM**
Description: **Fracture Multiple**

Distance (ft): **92.8**
Structural Grade: **4**
O&M Grade: **0**
Clock Start/From: **7**
Clock To: **5**
1st Value:
2nd Value:
Value Percent:
Continuous Index:
Within 8" of Joint: **YES**
Remarks:

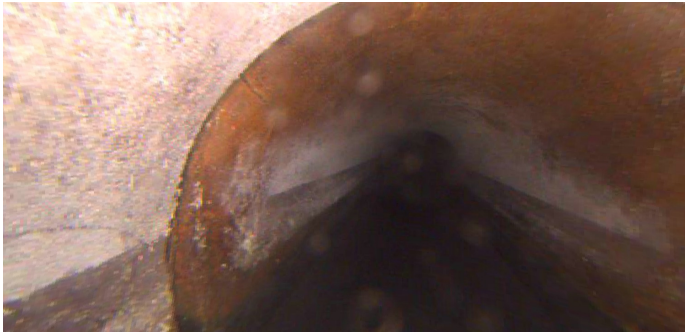
Code: **FS**
Description: **Fracture Spiral**

Distance (ft): **96.1**
Structural Grade: **3**
O&M Grade: **0**
Clock Start/From: **8**
Clock To: **10**
1st Value:
2nd Value:
Value Percent:
Continuous Index:
Within 8" of Joint: **YES**
Remarks:

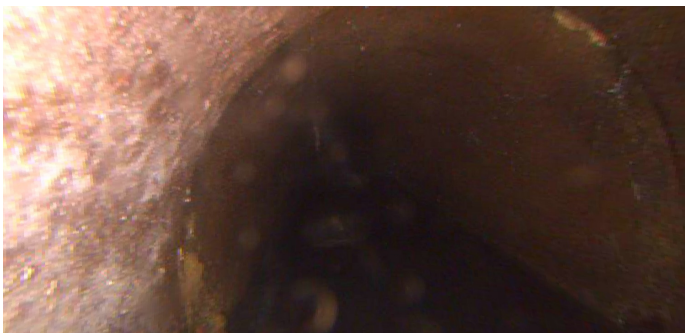
Code: **RFJ**
Description: **Roots Fine Joint**

Distance (ft): **102.2**
Structural Grade: **0**
O&M Grade: **1**
Clock Start/From: **7**
Clock To: **1**
1st Value:
2nd Value:
Value Percent:
Continuous Index:
Within 8" of Joint: **YES**
Remarks:

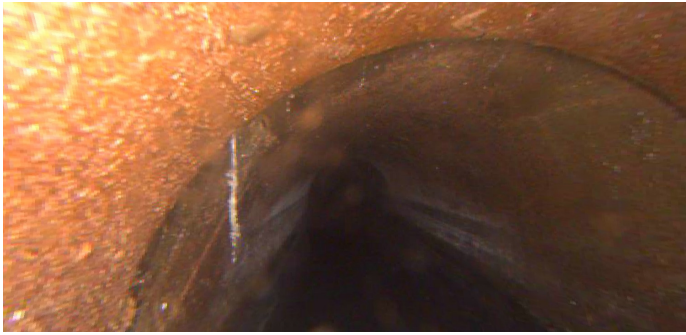
Code: **RFJ**
Description: **Roots Fine Joint**

Distance (ft): **105.3**
Structural Grade: **0**
O&M Grade: **1**
Clock Start/From: **10**
Clock To:
1st Value:
2nd Value:
Value Percent:
Continuous Index:
Within 8" of Joint: **YES**
Remarks:

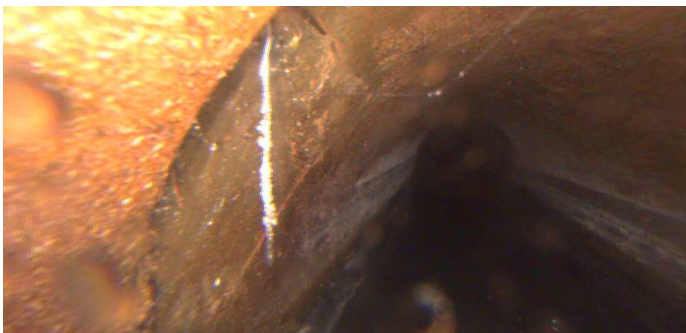
Code: **FS**
Description: **Fracture Spiral**

Distance (ft): **105.5**
Structural Grade: **3**
O&M Grade: **0**
Clock Start/From: **8**
Clock To: **10**
1st Value:
2nd Value:
Value Percent:
Continuous Index:
Within 8" of Joint: **YES**
Remarks:

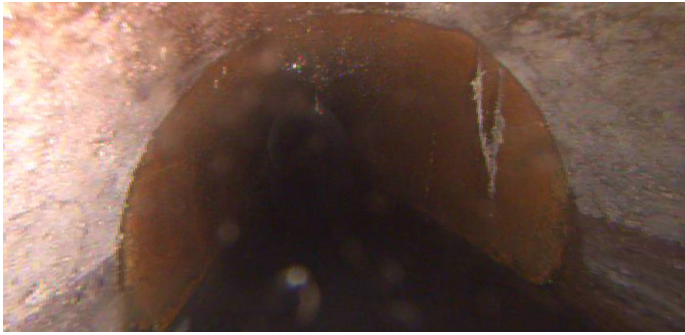
Code: **RFJ**
Description: **Roots Fine Joint**

Distance (ft): **108.2**
Structural Grade: **0**
O&M Grade: **1**
Clock Start/From: **2**
Clock To:
1st Value:
2nd Value:
Value Percent:
Continuous Index:
Within 8" of Joint: **YES**
Remarks:

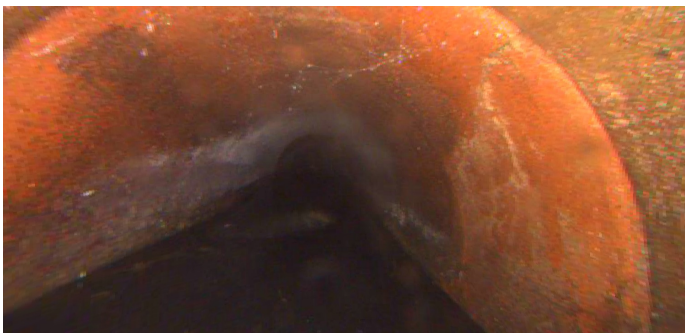
Code: **FS**
Description: **Fracture Spiral**

Distance (ft): **117.8**
Structural Grade: **3**
O&M Grade: **0**
Clock Start/From: **2**
Clock To: **3**
1st Value:
2nd Value:
Value Percent:
Continuous Index:
Within 8" of Joint: **YES**
Remarks:

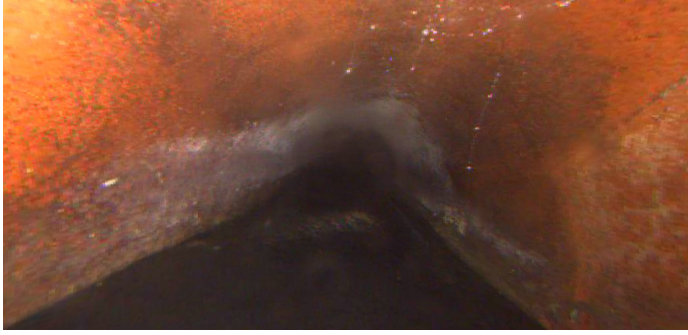
Code:	MSA
Description:	Abandoned Survey
Distance (ft):	118.1
Structural Grade:	0
O&M Grade:	0
Clock Start/From:	
Clock To:	
1st Value:	
2nd Value:	
Value Percent:	
Continuous Index:	
Within 8" of Joint:	NO
Remarks:	debris under water
