Profile/Photo Observation Report

Street:	E 11TH ST	Flow Control:	Not Controlled
City:	Hobart, IN	Year Renewed:	
Location:	Light Highway	Tape/Media #:	
Purpose:	Maintenance Related	Dia/Height:	12"
Use:	Sanitary	Material:	VCP
Drain Area:	NA	Lining:	Cured in Place
Category:	NA		
Comment:	heavy blk silt at 6'.

Location Details:		Direction of Survey:	Downstream
US MH:	M-707-039	DS MH:	M-707-063
		Total Length Surveyed (ft):	7.5

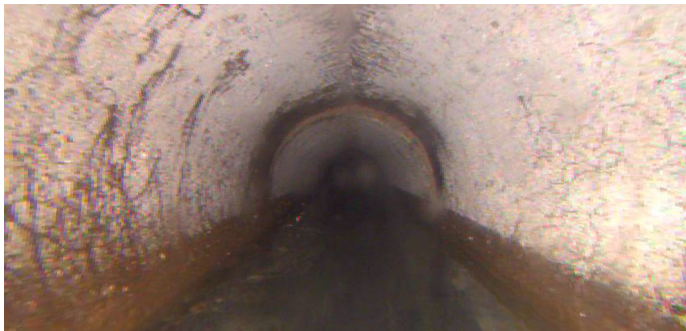
Code: **AMH**
Description: **Manhole**

Distance (ft): **.0**
Structural Grade: **0**
O&M Grade: **0**
Clock Start/From:
Clock To:
1st Value:
2nd Value:
Value Percent:
Continuous Index:
Within 8" of Joint: **NO**
Remarks: **M-707-039**

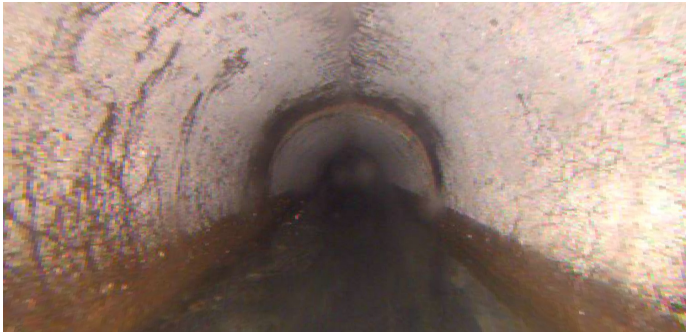
Code:	MWL
Description:	Water Level

Distance (ft):	.0
Structural Grade:	0
O&M Grade:	0
Clock Start/From:	
Clock To:	
1st Value:	
2nd Value:	
Value Percent:	5.000
Continuous Index:	
Within 8" of Joint:	NO
Remarks:

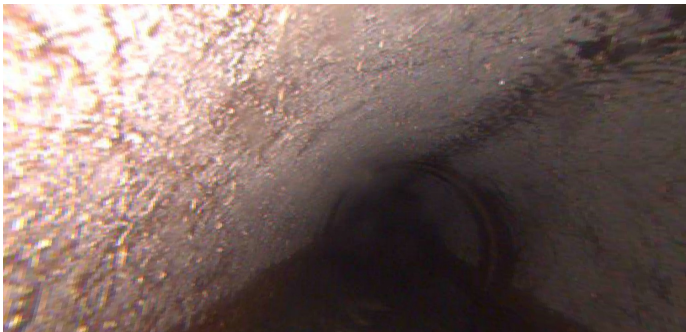
Code:	MSA
Description:	Abandoned Survey

Distance (ft):	7.5
Structural Grade:	0
O&M Grade:	0
Clock Start/From:	
Clock To:	
1st Value:	
2nd Value:	
Value Percent:	
Continuous Index:	
Within 8" of Joint:	NO
Remarks:	debris under water
