Profile/Photo Observation Report

Date:	04/15/2018	Weather:		Coding:	PACP 6.0
Pipe Length (ft):	390.0	Owner:	NA	Pre Clean:	Not Known
P.O.#:		Surveyor:	Selasie Honu	PSR:	P-707-063-039
Customer:		Clean Date:	01/01/1900	Shape:	C

Location Details:		Direction of Survey:	Downstream
US MH:	M-707-039	DS MH:	M-707-063
		Total Length Surveyed (ft):	7.5

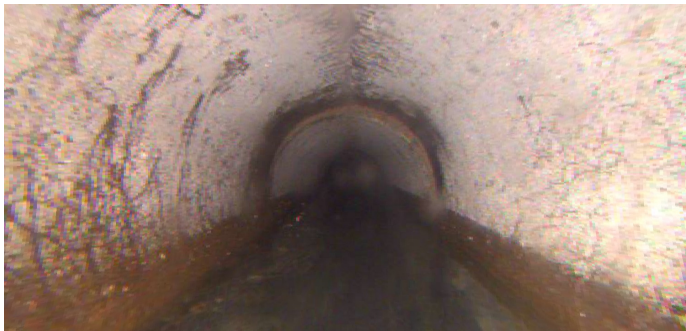
Code: **AMH**
Description: **Manhole**

Distance (ft): **.0**
Structural Grade: **0**
O&M Grade: **0**
Clock Start/From:
Clock To:
1st Value:
2nd Value:
Value Percent:
Continuous Index:
Within 8" of Joint: **NO**
Remarks: **M-707-039**

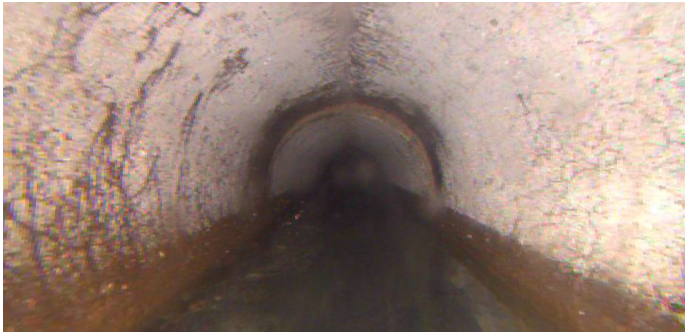
Code:	MWL
Description:	Water Level

Distance (ft):	.0
Structural Grade:	0
O&M Grade:	0
Clock Start/From:	
Clock To:	
1st Value:	
2nd Value:	
Value Percent:	5.000
Continuous Index:	
Within 8" of Joint:	NO
Remarks:

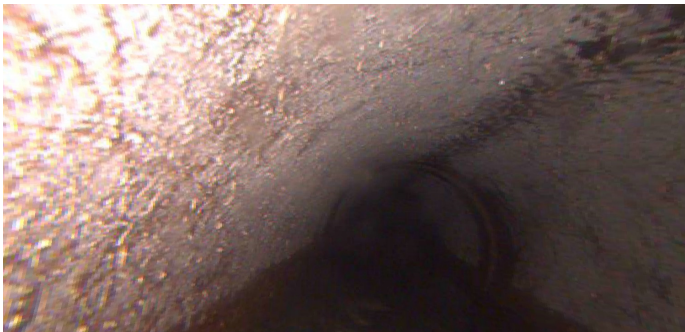
Code:	MSA
Description:	Abandoned Survey

Distance (ft):	7.5
Structural Grade:	0
O&M Grade:	0
Clock Start/From:	
Clock To:	
1st Value:	
2nd Value:	
Value Percent:	
Continuous Index:	
Within 8" of Joint:	NO
Remarks:	debris under water
