Profile/Photo Observation Report

Date:	02/18/2022	Weather:		Coding:	PACP 7.0
Pipe Length (ft):	390.0	Owner:	City of Hobart	Pre Clean:	Heavy Cleaning
P.O.#:	YES502259	Surveyor:	S. Bucklin	PSR:	P-707-063-039
Customer:	City of Hobart	Clean Date:	02/16/2022	Shape:	C

Street:	East 11th Street	Flow Control:	Not Controlled
City:	Hobart, IN	Year Renewed:	
Location:	Local rural streets with light traffic, t	Tape/Media #:	
Purpose:	Routine Assessment	Dia/Height:	12"
Use:	Sanitary Sewage Pipe	Material:	VCP
Drain Area:		Lining:	None
Category:	NA		
Comment:			
Location Details:		Direction of Survey:	Downstream
US MH:	M-707-039	DS MH:	M-707-063
		Total Length Surveyed (ft):	197.4

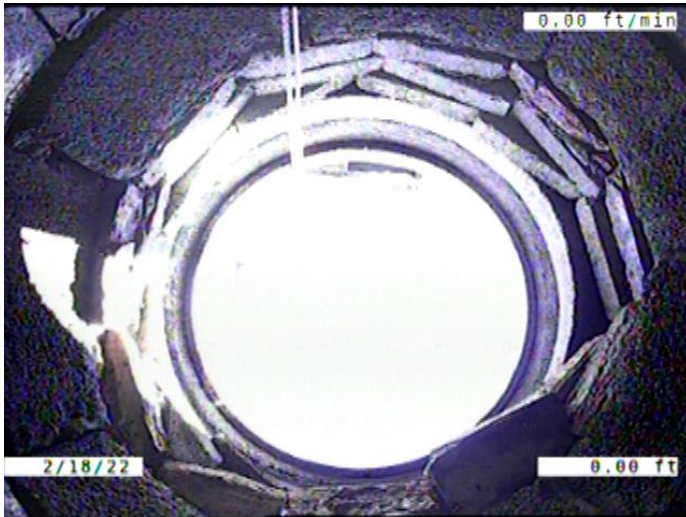
Code: **AMH**
 Description: **Manhole**

Distance (ft): **.0**
 Structural Grade: **0**
 O&M Grade: **0**
 Clock Start/From:
 Clock To:
 1st Value:
 2nd Value:
 Value Percent:
 Continuous Index:
 Within 8" of Joint: **NO**
 Remarks: **M-707-039**

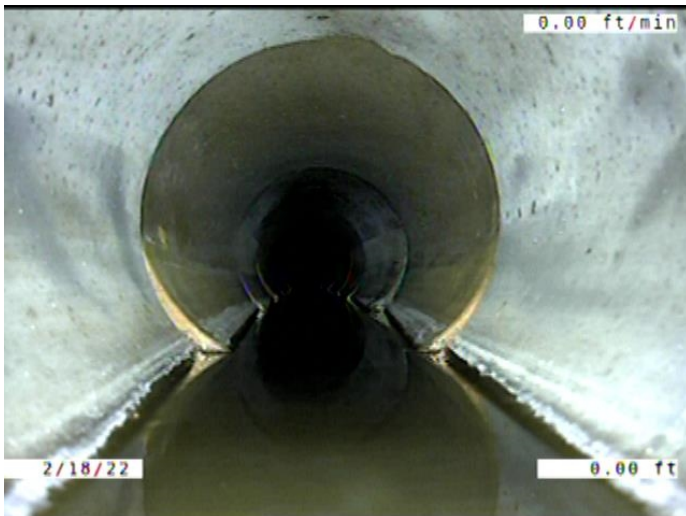
Code: **MWL**
 Description: **Miscellaneous Water Level**

Distance (ft): **.0**
 Structural Grade: **0**
 O&M Grade: **0**
 Clock Start/From:
 Clock To:
 1st Value:
 2nd Value:
 Value Percent: **5.000**
 Continuous Index:
 Within 8" of Joint: **NO**
 Remarks:

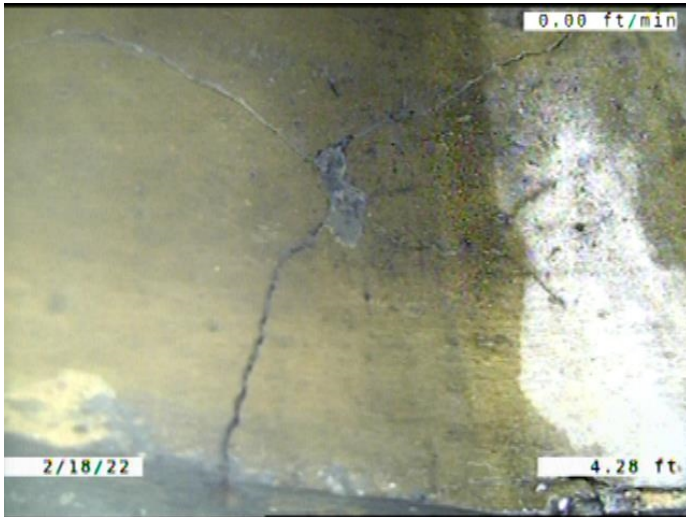
Code: **CM**
 Description: **Crack Multiple**

Distance (ft): **4.3**
 Structural Grade: **3**
 O&M Grade: **0**
 Clock Start/From: **12**
 Clock To: **12**
 1st Value:
 2nd Value:
 Value Percent:
 Continuous Index: **S01**
 Within 8" of Joint: **YES**
 Remarks:

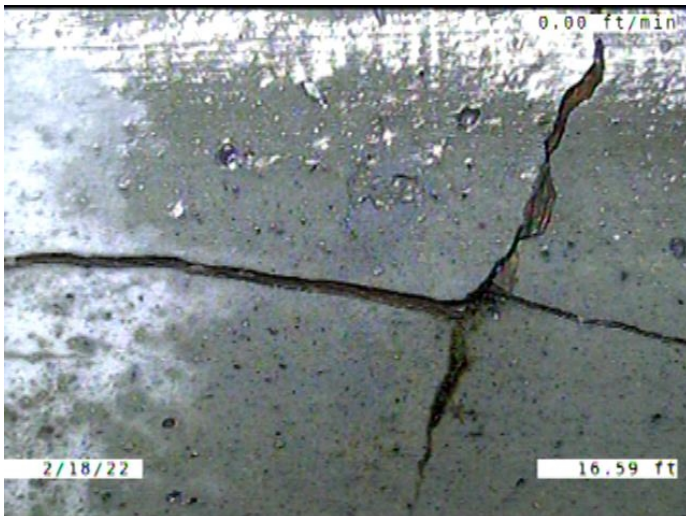
Code: **B**
 Description: **Broken**

Distance (ft): **16.6**
 Structural Grade: **4**
 O&M Grade: **0**
 Clock Start/From: **10**
 Clock To: **3**
 1st Value:
 2nd Value:
 Value Percent:
 Continuous Index:
 Within 8" of Joint: **YES**
 Remarks:

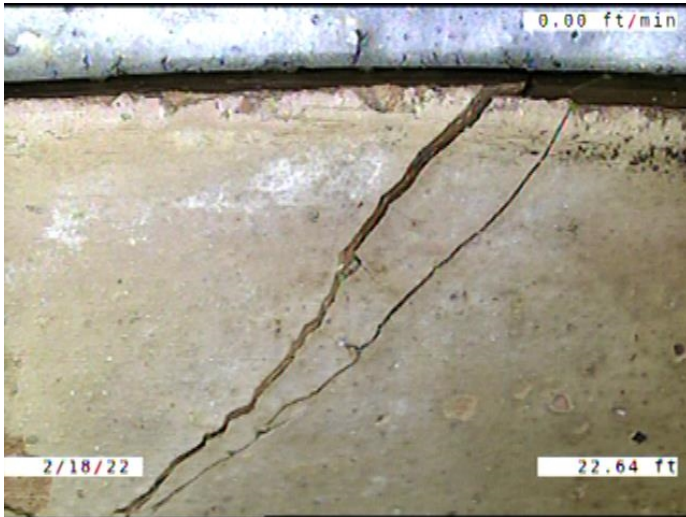
Code: **B**
Description: **Broken**

Distance (ft): **22.6**
Structural Grade: **4**
O&M Grade: **0**
Clock Start/From: **8**
Clock To: **10**
1st Value:
2nd Value:
Value Percent:
Continuous Index:
Within 8" of Joint: **YES**
Remarks:

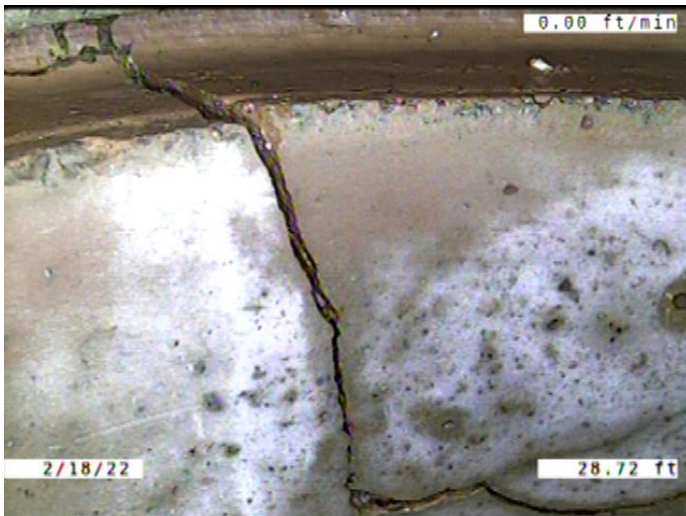
Code: **B**
Description: **Broken**

Distance (ft): **28.7**
Structural Grade: **4**
O&M Grade: **0**
Clock Start/From: **12**
Clock To: **12**
1st Value:
2nd Value:
Value Percent:
Continuous Index: **S02**
Within 8" of Joint: **YES**
Remarks:

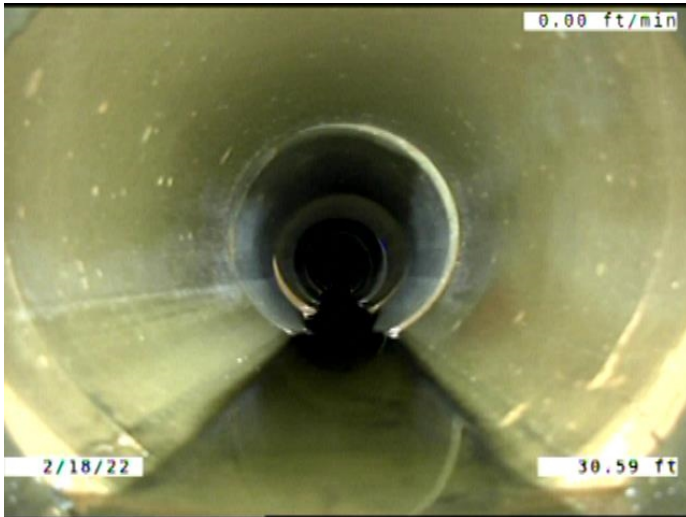
Code: **CM**
Description: **Crack Multiple**

Distance (ft): **30.6**
Structural Grade: **3**
O&M Grade: **0**
Clock Start/From: **12**
Clock To: **12**
1st Value:
2nd Value:
Value Percent:
Continuous Index: **F01**
Within 8" of Joint: **YES**
Remarks:

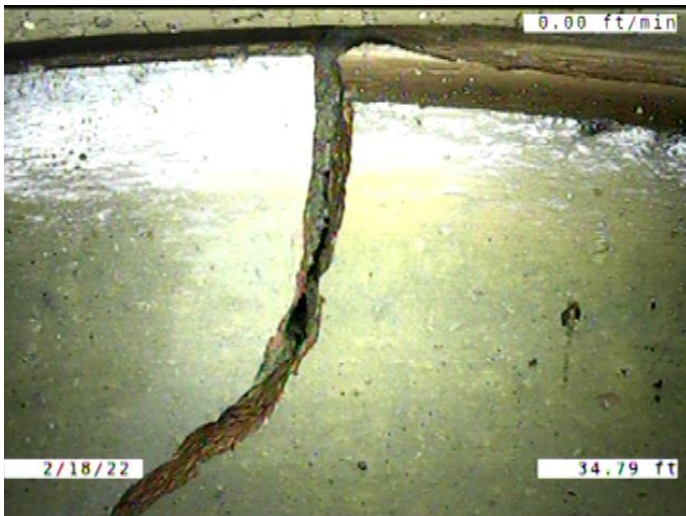
Code: **BSV**
Description: **Broken Soil Visible**

Distance (ft): **34.8**
Structural Grade: **5**
O&M Grade: **0**
Clock Start/From: **8**
Clock To: **11**
1st Value:
2nd Value:
Value Percent:
Continuous Index:
Within 8" of Joint: **YES**
Remarks:

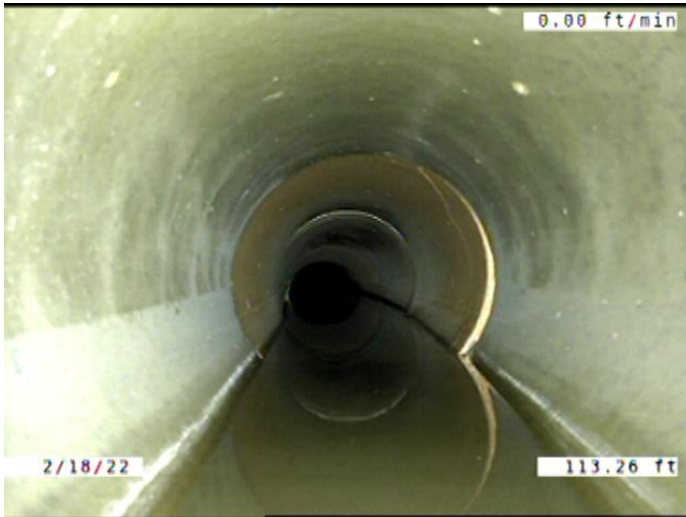
Code: **MWLS**
Description: **Miscellaneous Water Level Sag**

Distance (ft): **113.3**
Structural Grade: **3**
O&M Grade: **0**
Clock Start/From:
Clock To:
1st Value:
2nd Value:
Value Percent: **50.000**
Continuous Index: **S03**
Within 8" of Joint: **NO**
Remarks:

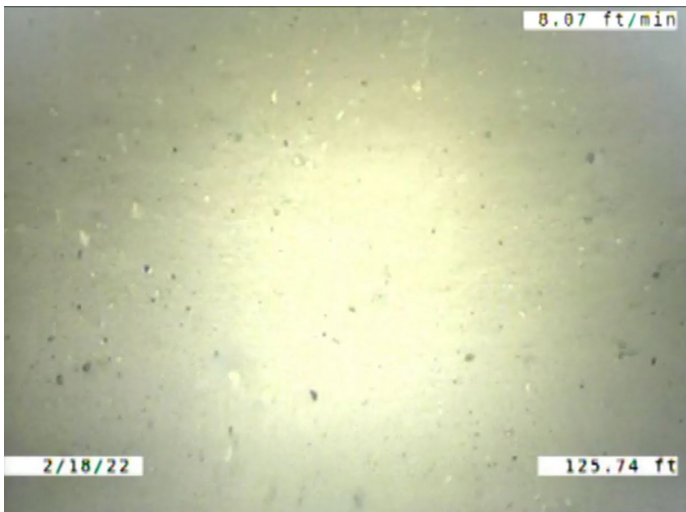
Code: **B**
Description: **Broken**

Distance (ft): **125.7**
Structural Grade: **4**
O&M Grade: **0**
Clock Start/From: **12**
Clock To: **12**
1st Value:
2nd Value:
Value Percent:
Continuous Index: **F02**
Within 8" of Joint: **YES**
Remarks:

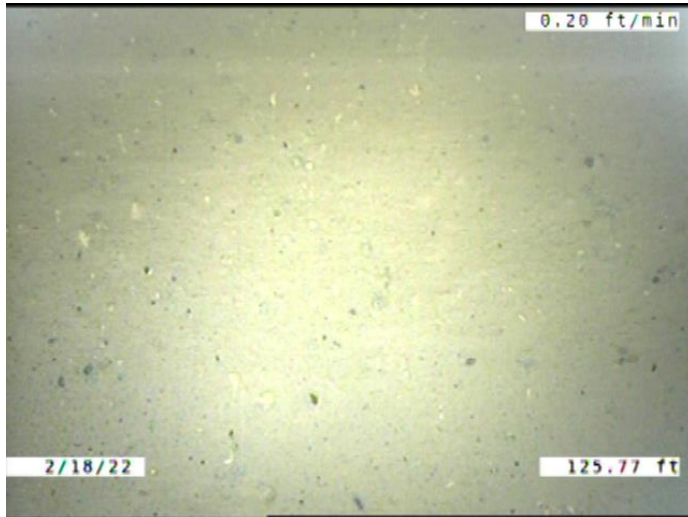
Code: **MCU**
Description: **Miscellaneous Camera Underwater**

Distance (ft): **125.8**
Structural Grade: **0**
O&M Grade: **4**
Clock Start/From:
Clock To:
1st Value:
2nd Value:
Value Percent:
Continuous Index:
Within 8" of Joint: **NO**
Remarks:

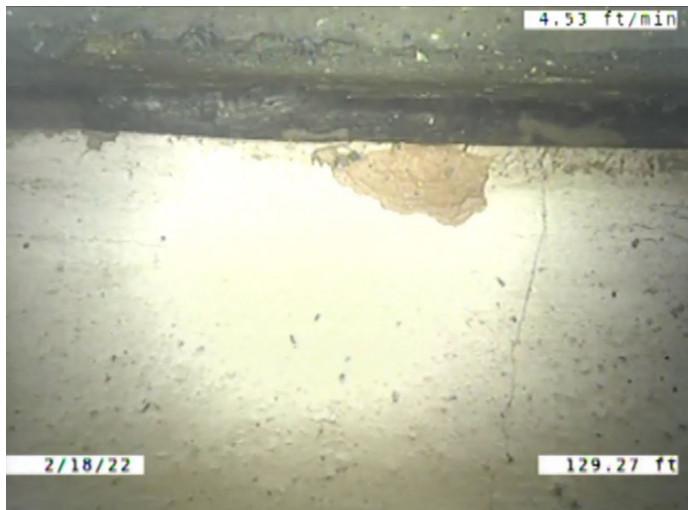
Code: **SSS**
Description: **Surface Damage Surface Spalling**

Distance (ft): **129.3**
Structural Grade: **2**
O&M Grade: **0**
Clock Start/From: **12**
Clock To:
1st Value:
2nd Value:
Value Percent:
Continuous Index:
Within 8" of Joint: **YES**
Remarks: **Visible through water**

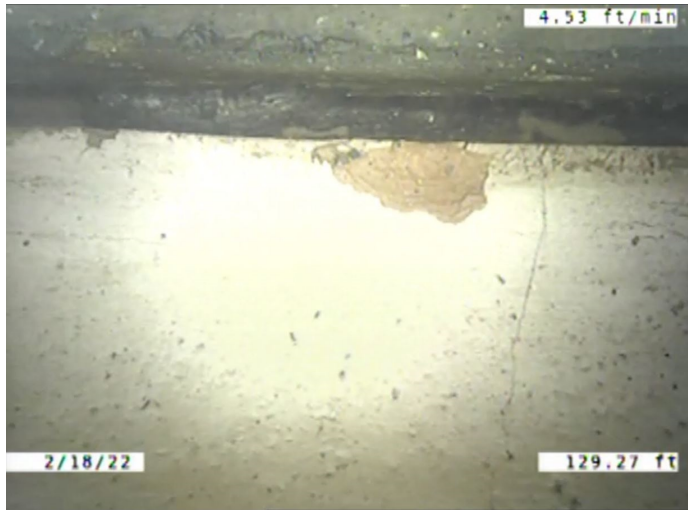
Code: **CL**
Description: **Crack Longitudinal**

Distance (ft): **129.3**
Structural Grade: **2**
O&M Grade: **0**
Clock Start/From: **12**
Clock To:
1st Value:
2nd Value:
Value Percent:
Continuous Index:
Within 8" of Joint: **YES**
Remarks: **Visible through water**

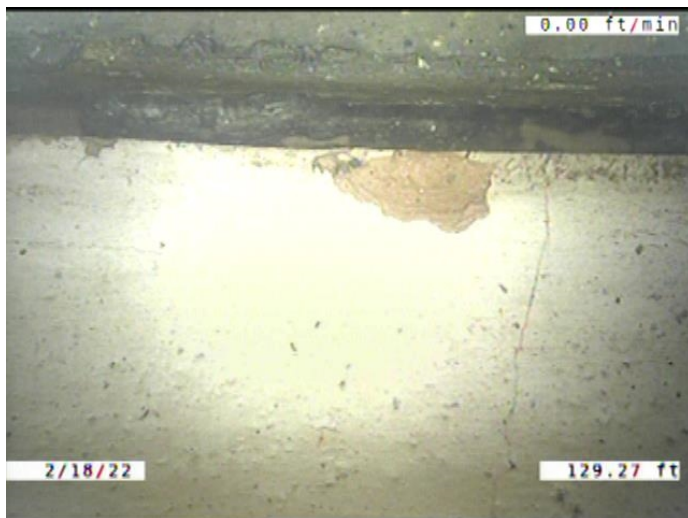
Code: **MCU**
Description: **Miscellaneous Camera Underwater**

Distance (ft): **129.3**
Structural Grade: **0**
O&M Grade: **4**
Clock Start/From:
Clock To:
1st Value:
2nd Value:
Value Percent:
Continuous Index: **S04**
Within 8" of Joint: **NO**
Remarks:

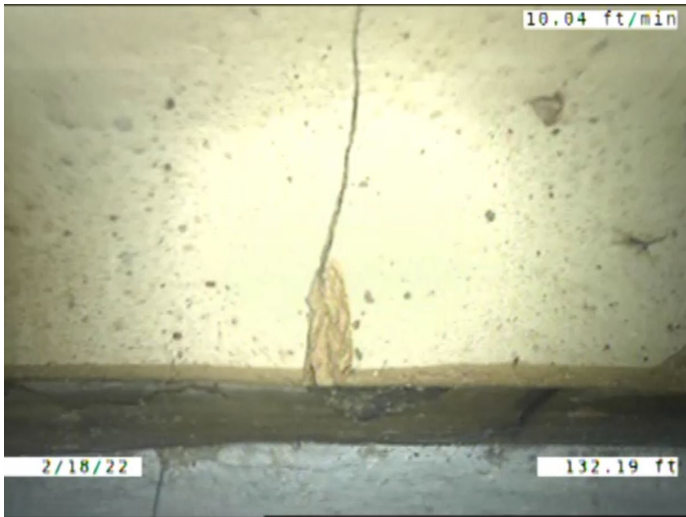
Code: **SSS**
Description: **Surface Damage Surface Spalling**

Distance (ft): **132.2**
Structural Grade: **2**
O&M Grade: **0**
Clock Start/From: **12**
Clock To:
1st Value:
2nd Value:
Value Percent:
Continuous Index:
Within 8" of Joint: **YES**
Remarks: **Visible through water**

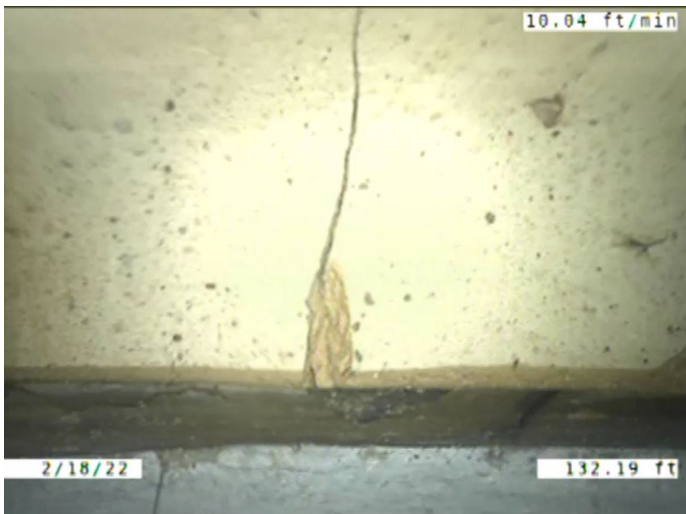
Code: **FM**
Description: **Fracture Multiple**

Distance (ft): **132.2**
Structural Grade: **4**
O&M Grade: **0**
Clock Start/From: **11**
Clock To: **12**
1st Value:
2nd Value:
Value Percent:
Continuous Index:
Within 8" of Joint: **YES**
Remarks: **Visible through water**

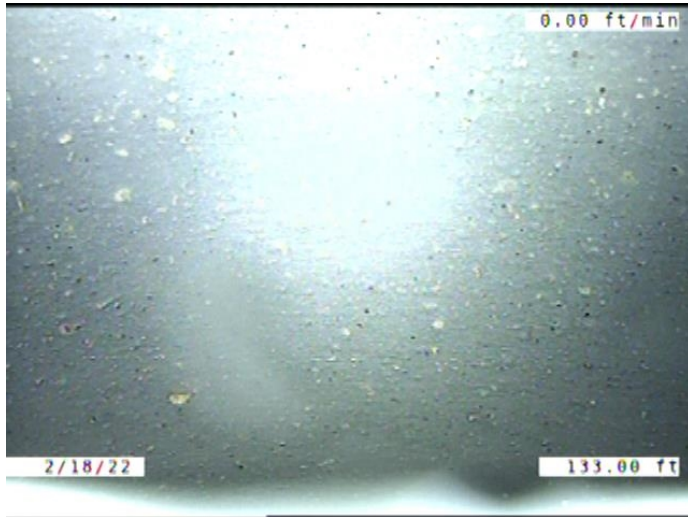
Code:	MCU
Description:	Miscellaneous Camera Underwater
Distance (ft):	133.0
Structural Grade:	0
O&M Grade:	4
Clock Start/From:	
Clock To:	
1st Value:	
2nd Value:	
Value Percent:	
Continuous Index:	F04
Within 8" of Joint:	NO
Remarks:

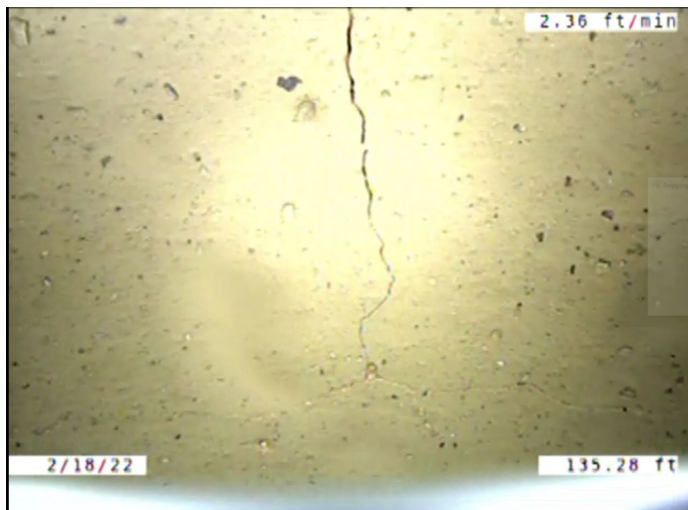
Code:	FM
Description:	Fracture Multiple
Distance (ft):	135.3
Structural Grade:	4
O&M Grade:	0
Clock Start/From:	11
Clock To:	1
1st Value:	
2nd Value:	
Value Percent:	
Continuous Index:	
Within 8" of Joint:	YES
Remarks:

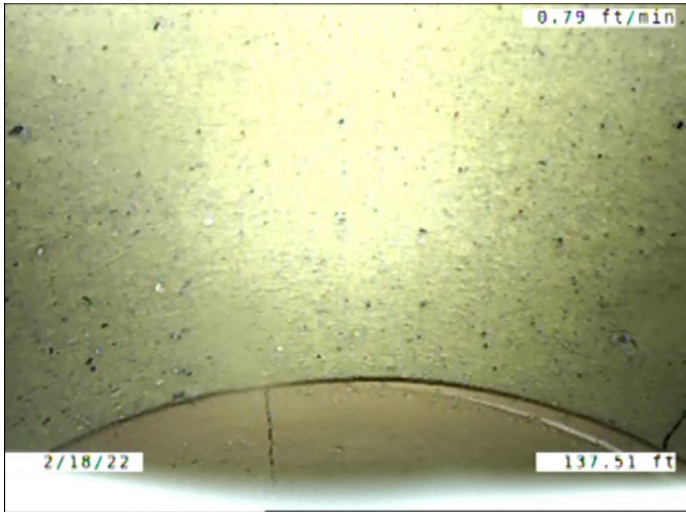
Code: **FM**
Description: **Fracture Multiple**

Distance (ft): **137.5**
Structural Grade: **4**
O&M Grade: **0**
Clock Start/From: **12**
Clock To: **1**
1st Value:
2nd Value:
Value Percent:
Continuous Index:
Within 8" of Joint: **YES**
Remarks:

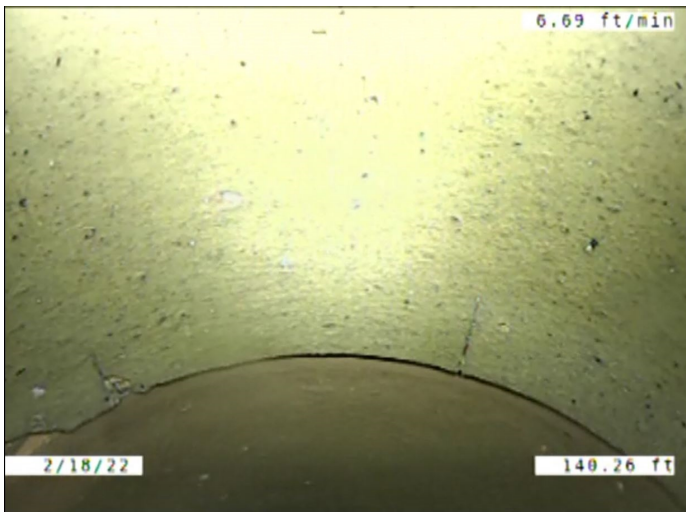
Code: **FM**
Description: **Fracture Multiple**

Distance (ft): **140.3**
Structural Grade: **4**
O&M Grade: **0**
Clock Start/From: **11**
Clock To: **12**
1st Value:
2nd Value:
Value Percent:
Continuous Index:
Within 8" of Joint: **YES**
Remarks:

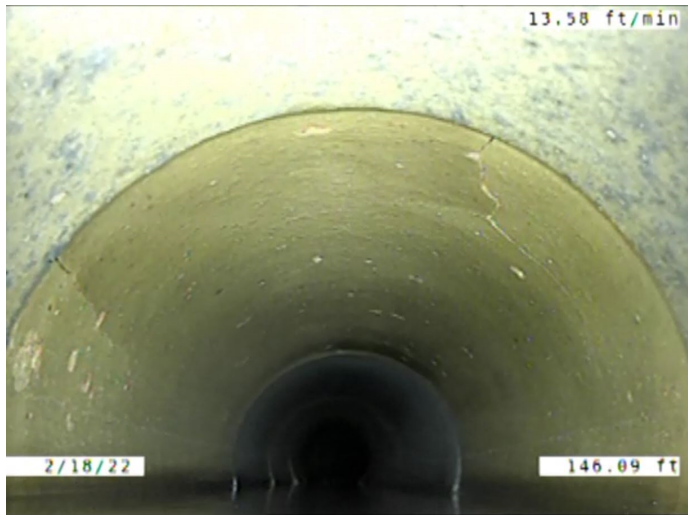
Code: **B**
 Description: **Broken**

Distance (ft): **146.1**
 Structural Grade: **4**
 O&M Grade: **0**
 Clock Start/From: **10**
 Clock To: **2**
 1st Value:
 2nd Value:
 Value Percent:
 Continuous Index:
 Within 8" of Joint: **YES**
 Remarks:

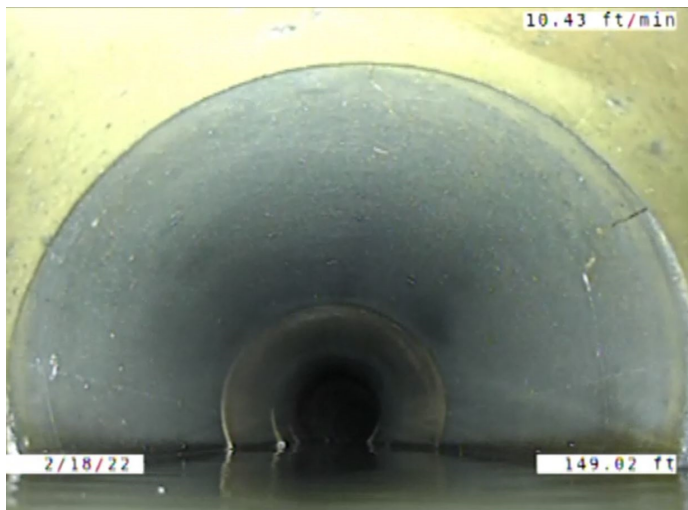
Code: **FM**
 Description: **Fracture Multiple**

Distance (ft): **149.0**
 Structural Grade: **4**
 O&M Grade: **0**
 Clock Start/From: **8**
 Clock To: **4**
 1st Value:
 2nd Value:
 Value Percent:
 Continuous Index: **S05**
 Within 8" of Joint: **YES**
 Remarks: **Wandering**

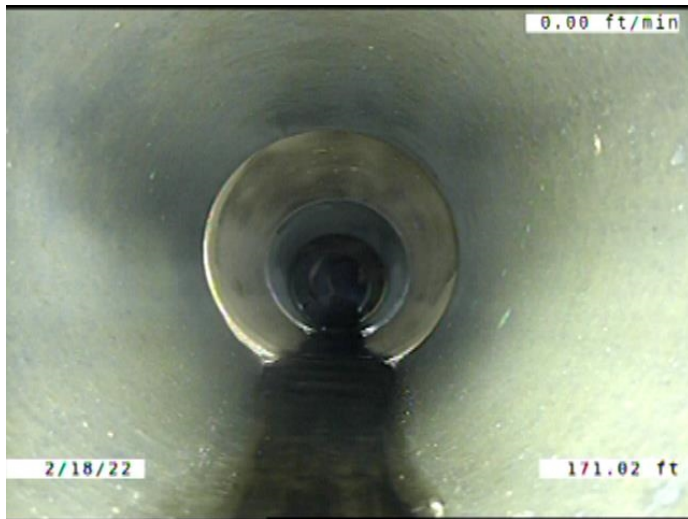
Code: **MWLS**
 Description: **Miscellaneous Water Level Sag**

Distance (ft): **171.0**
 Structural Grade: **3**
 O&M Grade: **0**
 Clock Start/From:
 Clock To:
 1st Value:
 2nd Value:
 Value Percent: **50.000**
 Continuous Index: **F03**
 Within 8" of Joint: **NO**
 Remarks:

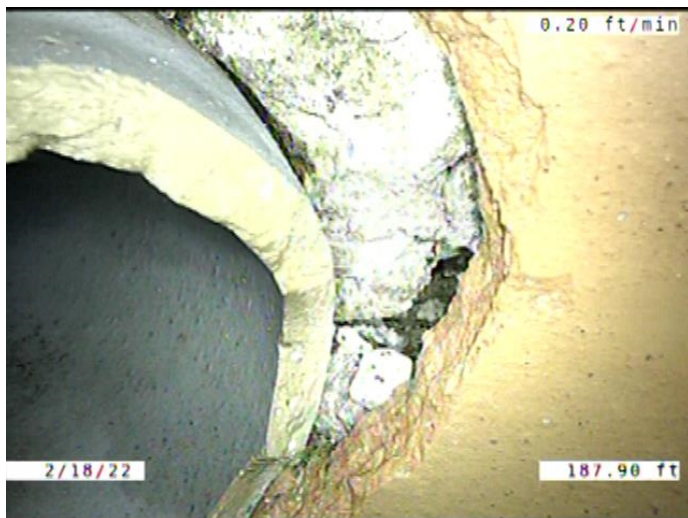
Code: **SSS**
 Description: **Surface Damage Surface Spalling**

Distance (ft): **187.9**
 Structural Grade: **2**
 O&M Grade: **0**
 Clock Start/From: **9**
 Clock To: **12**
 1st Value:
 2nd Value:
 Value Percent:
 Continuous Index:
 Within 8" of Joint: **NO**
 Remarks:

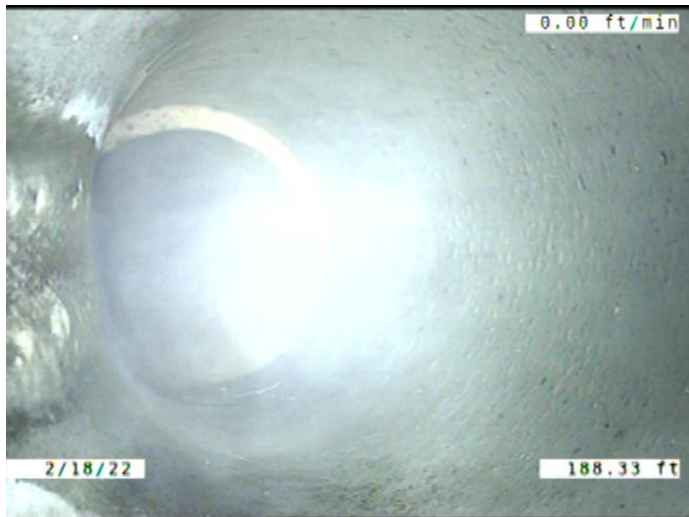
Code: **TBI**
Description: **Tap Break-in Intruding**

Distance (ft): **188.3**
Structural Grade: **0**
O&M Grade: **2**
Clock Start/From: **10**
Clock To:
1st Value: **6.000**
2nd Value: **1.000**
Value Percent:
Continuous Index:
Within 8" of Joint: **NO**
Remarks: **CONSTANTLY RUNNING WATER.**

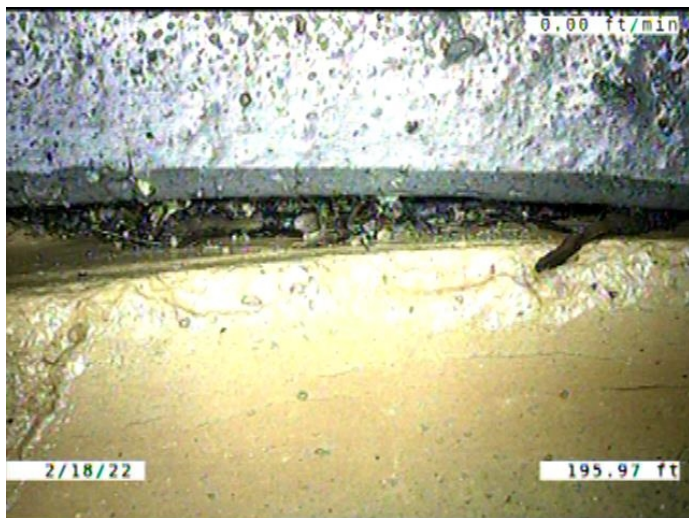
Code: **RFJ**
Description: **Roots Fine Joint**

Distance (ft): **196.0**
Structural Grade: **0**
O&M Grade: **1**
Clock Start/From: **8**
Clock To: **10**
1st Value:
2nd Value:
Value Percent:
Continuous Index:
Within 8" of Joint: **YES**
Remarks:

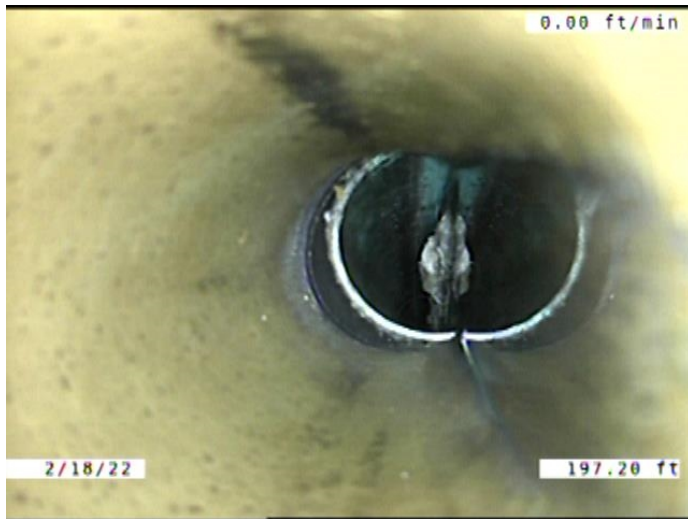
Code: **TBI**
 Description: **Tap Break-in Intruding**

Distance (ft): **197.2**
 Structural Grade: **0**
 O&M Grade: **2**
 Clock Start/From: **3**
 Clock To:
 1st Value: **6.000**
 2nd Value: **3.000**
 Value Percent:
 Continuous Index:
 Within 8" of Joint: **YES**
 Remarks:

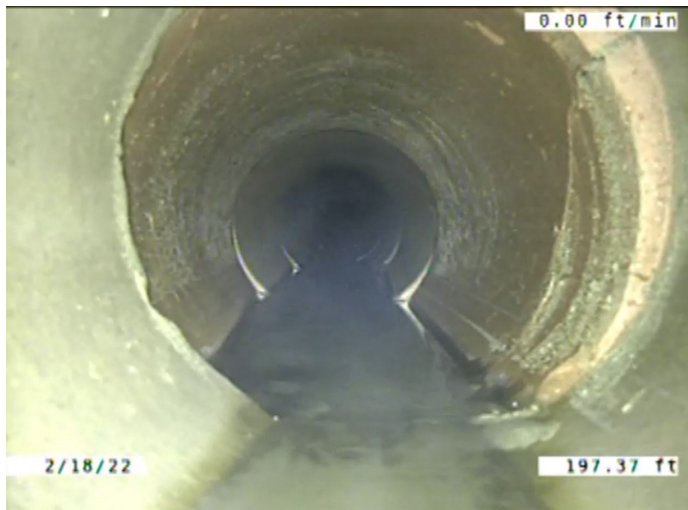
Code: **FM**
 Description: **Fracture Multiple**

Distance (ft): **197.4**
 Structural Grade: **4**
 O&M Grade: **0**
 Clock Start/From: **8**
 Clock To: **4**
 1st Value:
 2nd Value:
 Value Percent:
 Continuous Index: **F05**
 Within 8" of Joint: **YES**
 Remarks: **Wandering**

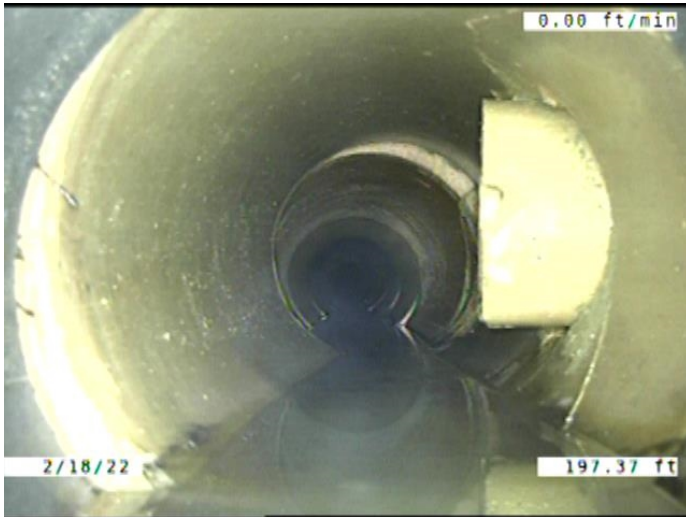
Code: **MSA**
Description: **Miscellaneous Survey Abandoned**

Distance (ft): **197.4**
Structural Grade: **0**
O&M Grade: **0**
Clock Start/From:
Clock To:
1st Value:
2nd Value:
Value Percent:
Continuous Index:
Within 8" of Joint: **NO**
Remarks: **CAMERA CANT MAKE IT PAST PROTRUDING TAP.**
