# Profile/Photo Observation Report

Date:	02/18/2022	Weather:		Coding:	PACP 7.0
Pipe Length (ft):	390.0	Owner:	City of Hobart	Pre Clean:	Heavy Cleaning
P.O.#:	YES502259	Surveyor:	S. Bucklin	PSR:	P-707-063-039
Customer:	City of Hobart	Clean Date:	02/16/2022	Shape:	C

Street:	East 11th Street	Flow Control:	Not Controlled
City:	Hobart, IN	Year Renewed:	
Location:	Local rural streets with light traffic, t	Tape/Media #:	
Purpose:	Routine Assessment	Dia/Height:	12"
Use:	Sanitary Sewage Pipe	Material:	VCP
Drain Area:		Lining:	None
Category:	NA		
Comment:			
Location Details:		Direction of Survey:	Upstream
US MH:	M-707-039	DS MH:	M-707-063
		Total Length Surveyed (ft):	189.0

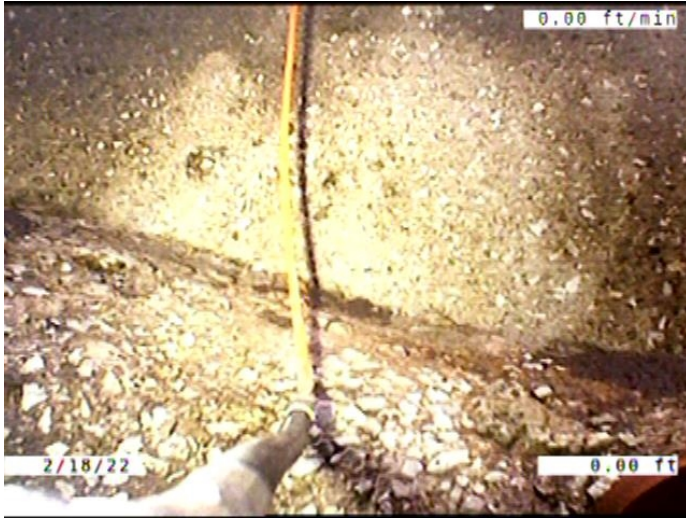
Code: **AMH**  
 Description: **Manhole**

Distance (ft): **.0**  
 Structural Grade: **0**  
 O&M Grade: **0**  
 Clock Start/From:  
 Clock To:  
 1st Value:  
 2nd Value:  
 Value Percent:  
 Continuous Index:  
 Within 8" of Joint: **NO**  
 Remarks: **M-707-063**

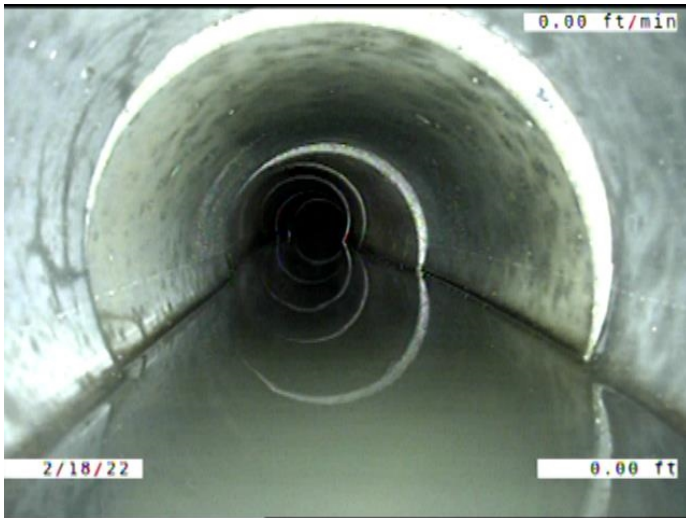
Code: **MWL**  
 Description: **Miscellaneous Water Level**

Distance (ft): **.0**  
 Structural Grade: **0**  
 O&M Grade: **0**  
 Clock Start/From:  
 Clock To:  
 1st Value:  
 2nd Value:  
 Value Percent: **25.000**  
 Continuous Index:  
 Within 8" of Joint: **NO**  
 Remarks:

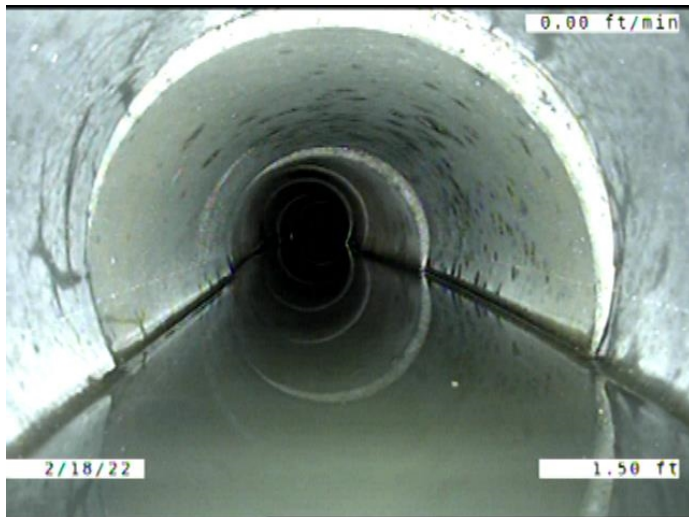
Code: **MGO**  
 Description: **Miscellaneous General Observation**

Distance (ft): **1.5**  
 Structural Grade: **0**  
 O&M Grade: **0**  
 Clock Start/From:  
 Clock To:  
 1st Value:  
 2nd Value:  
 Value Percent:  
 Continuous Index:  
 Within 8" of Joint: **NO**  
 Remarks: **DROP INTO THE MANHOLE. HAD TO START IN THE PIPE.**

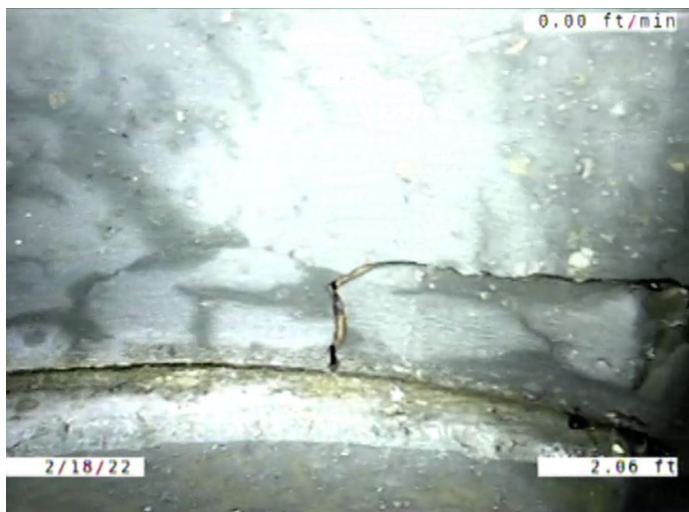
Code: **B**  
 Description: **Broken**

Distance (ft): **2.1**  
 Structural Grade: **4**  
 O&M Grade: **0**  
 Clock Start/From: **3**  
 Clock To: **4**  
 1st Value:  
 2nd Value:  
 Value Percent:  
 Continuous Index:  
 Within 8" of Joint: **YES**  
 Remarks:

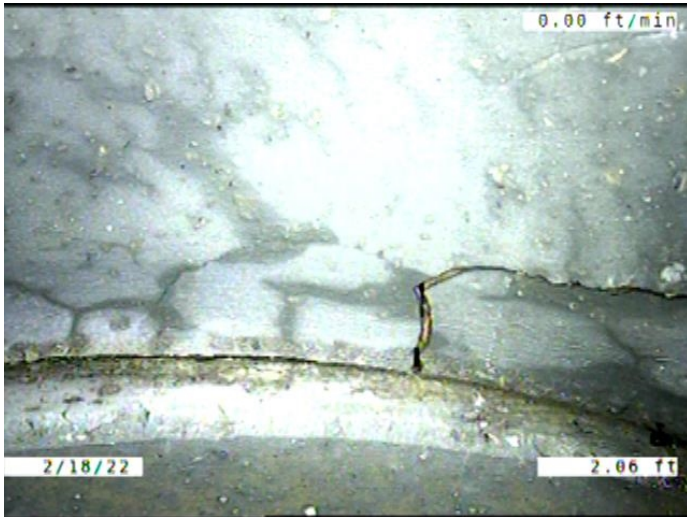
Code: **CM**  
Description: **Crack Multiple**

Distance (ft): **2.1**  
Structural Grade: **3**  
O&M Grade: **0**  
Clock Start/From: **8**  
Clock To: **4**  
1st Value:  
2nd Value:  
Value Percent:  
Continuous Index: **S01**  
Within 8" of Joint: **YES**  
Remarks: **Wandering**

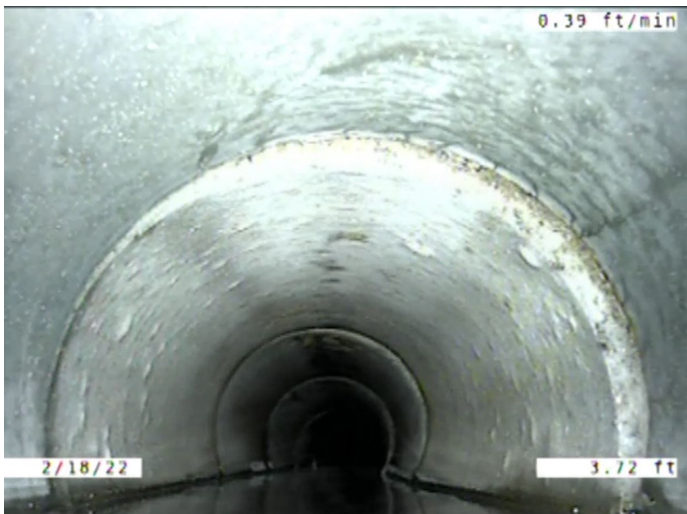
Code: **SZ**  
Description: **Surface Damage Other**

Distance (ft): **3.7**  
Structural Grade: **0**  
O&M Grade: **0**  
Clock Start/From: **8**  
Clock To: **4**  
1st Value:  
2nd Value:  
Value Percent:  
Continuous Index:  
Within 8" of Joint: **NO**  
Remarks: **Indentations, factory defect**

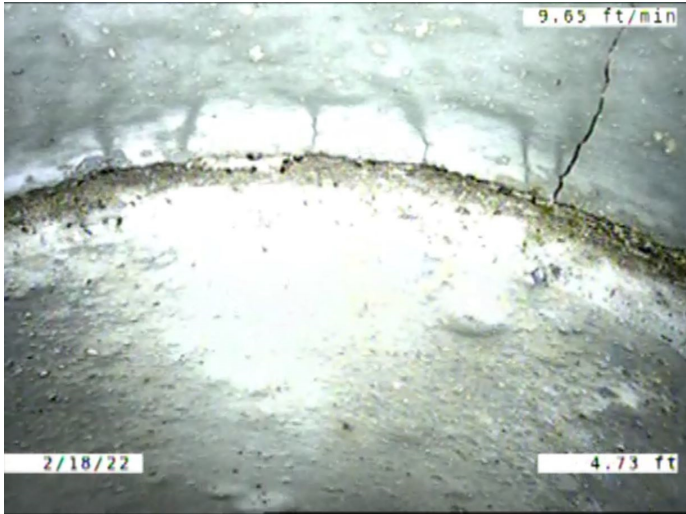
Code: **FL**  
Description: **Fracture Longitudinal**

Distance (ft): **4.7**  
Structural Grade: **3**  
O&M Grade: **0**  
Clock Start/From: **1**  
Clock To:  
1st Value:  
2nd Value:  
Value Percent:  
Continuous Index:  
Within 8" of Joint: **YES**  
Remarks:

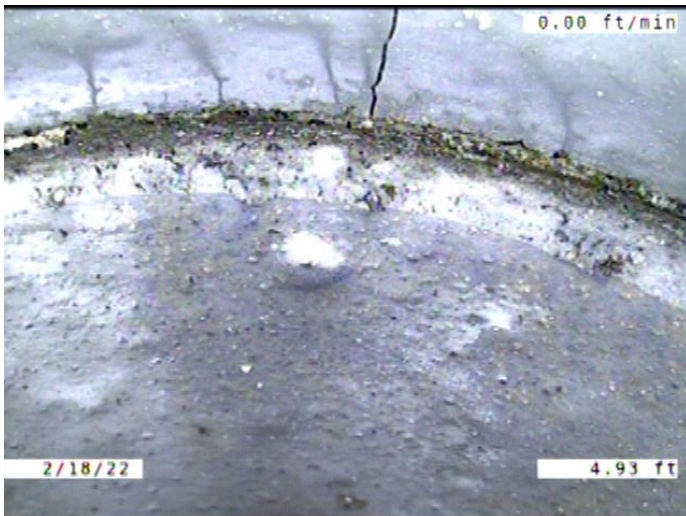
Code: **JOM**  
Description: **Joint Offset Medium**

Distance (ft): **4.9**  
Structural Grade: **3**  
O&M Grade: **0**  
Clock Start/From:  
Clock To:  
1st Value:  
2nd Value:  
Value Percent:  
Continuous Index:  
Within 8" of Joint: **NO**  
Remarks:

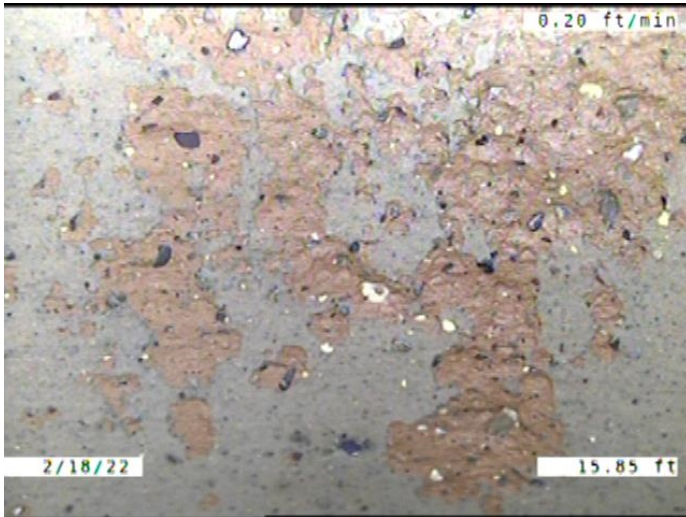
Code: **SSS**  
Description: **Surface Damage Surface Spalling**

Distance (ft): **15.8**  
Structural Grade: **2**  
O&M Grade: **0**  
Clock Start/From: **11**  
Clock To: **1**  
1st Value:  
2nd Value:  
Value Percent:  
Continuous Index:  
Within 8" of Joint: **NO**  
Remarks:

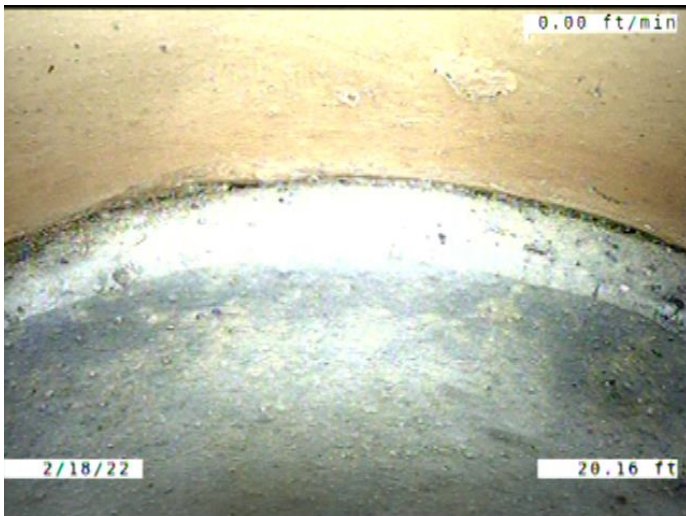
Code: **JOM**  
Description: **Joint Offset Medium**

Distance (ft): **20.2**  
Structural Grade: **3**  
O&M Grade: **0**  
Clock Start/From:  
Clock To:  
1st Value:  
2nd Value:  
Value Percent:  
Continuous Index:  
Within 8" of Joint: **NO**  
Remarks:

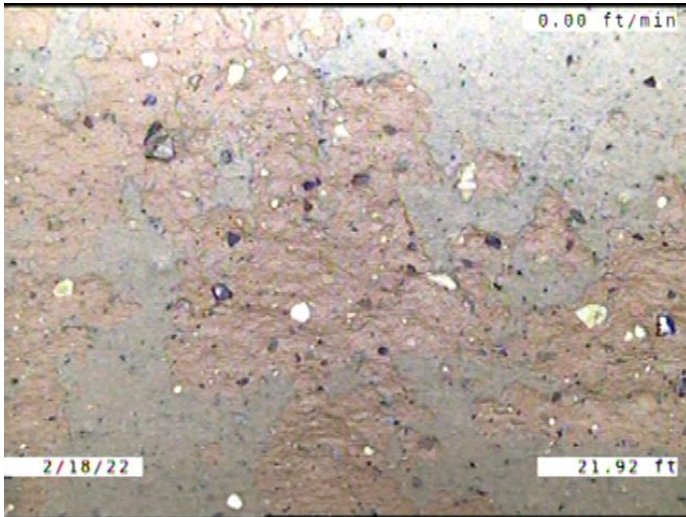
Code: **SSS**  
 Description: **Surface Damage Surface Spalling**

Distance (ft): **21.9**  
 Structural Grade: **2**  
 O&M Grade: **0**  
 Clock Start/From: **11**  
 Clock To: **3**  
 1st Value:  
 2nd Value:  
 Value Percent:  
 Continuous Index:  
 Within 8" of Joint: **NO**  
 Remarks:

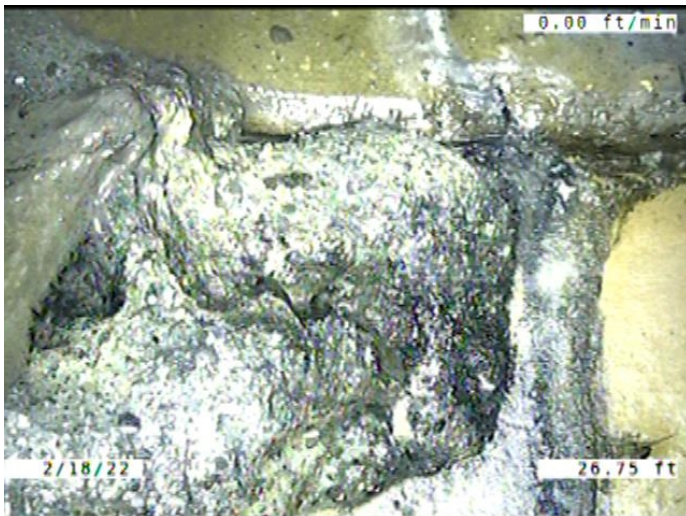
Code: **ISGT**  
 Description: **Intruding Sealing Material Grout**

Distance (ft): **26.7**  
 Structural Grade: **0**  
 O&M Grade: **2**  
 Clock Start/From: **8**  
 Clock To: **9**  
 1st Value:  
 2nd Value:  
 Value Percent: **5.000**  
 Continuous Index:  
 Within 8" of Joint: **NO**  
 Remarks:

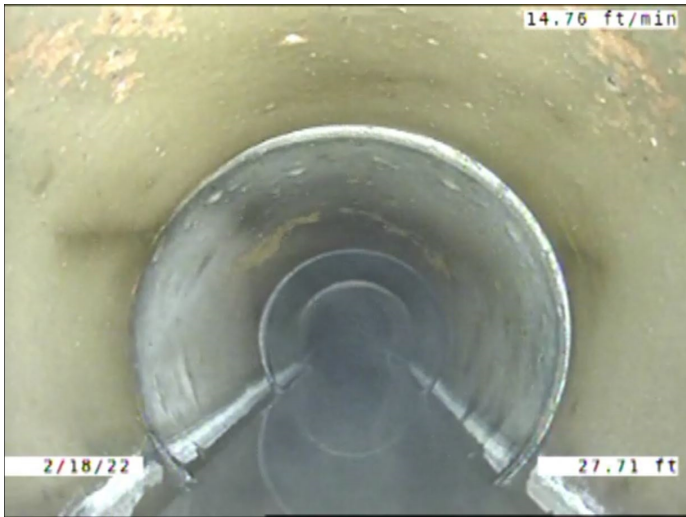
Code: **CM**  
 Description: **Crack Multiple**

Distance (ft): **27.1**  
 Structural Grade: **3**  
 O&M Grade: **0**  
 Clock Start/From: **8**  
 Clock To: **4**  
 1st Value:  
 2nd Value:  
 Value Percent:  
 Continuous Index: **F01**  
 Within 8" of Joint: **YES**  
 Remarks: **Wandering**

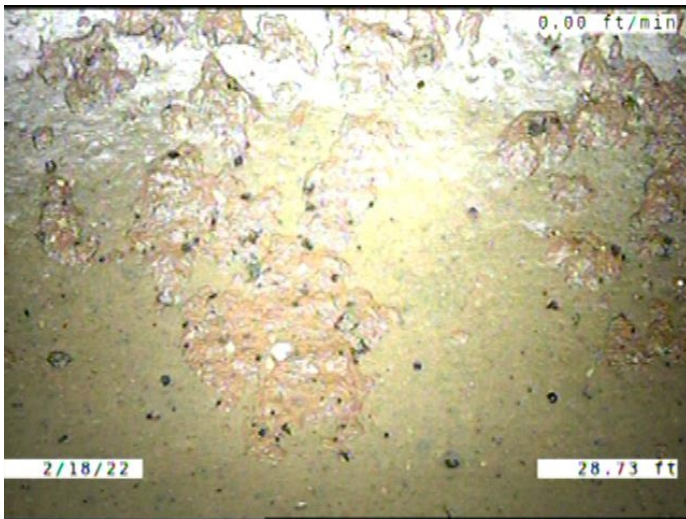
Code: **SSS**  
 Description: **Surface Damage Surface Spalling**

Distance (ft): **28.7**  
 Structural Grade: **2**  
 O&M Grade: **0**  
 Clock Start/From: **10**  
 Clock To: **2**  
 1st Value:  
 2nd Value:  
 Value Percent:  
 Continuous Index:  
 Within 8" of Joint: **NO**  
 Remarks:

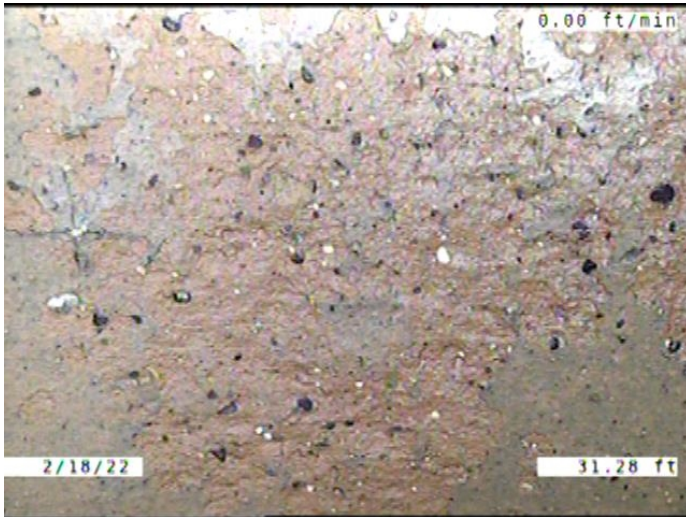
Code:	<b>SSS</b>
Description:	<b>Surface Damage Surface Spalling</b>
Distance (ft):	<b>31.3</b>
Structural Grade:	<b>2</b>
O&M Grade:	<b>0</b>
Clock Start/From:	<b>10</b>
Clock To:	<b>2</b>
1st Value:	
2nd Value:	
Value Percent:	
Continuous Index:	
Within 8" of Joint:	<b>NO</b>
Remarks:

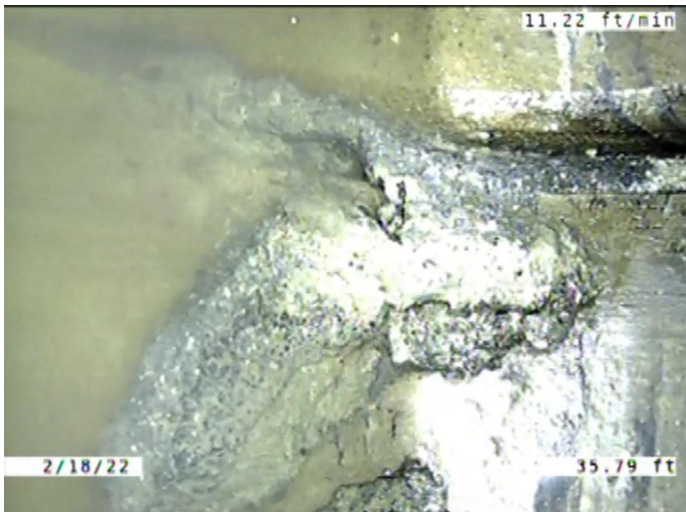
Code:	<b>ISGT</b>
Description:	<b>Intruding Sealing Material Grout</b>
Distance (ft):	<b>35.8</b>
Structural Grade:	<b>0</b>
O&M Grade:	<b>2</b>
Clock Start/From:	<b>4</b>
Clock To:	<b>5</b>
1st Value:	
2nd Value:	
Value Percent:	<b>5.000</b>
Continuous Index:	
Within 8" of Joint:	<b>NO</b>
Remarks:

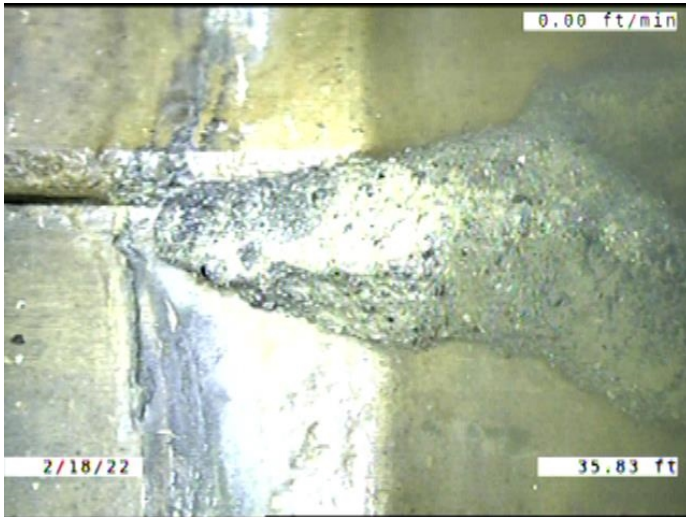
Code: **ISGT**  
 Description: **Intruding Sealing Material Grout**

Distance (ft): **35.8**  
 Structural Grade: **0**  
 O&M Grade: **2**  
 Clock Start/From: **4**  
 Clock To: **8**  
 1st Value:  
 2nd Value:  
 Value Percent: **5.000**  
 Continuous Index:  
 Within 8" of Joint: **NO**  
 Remarks:

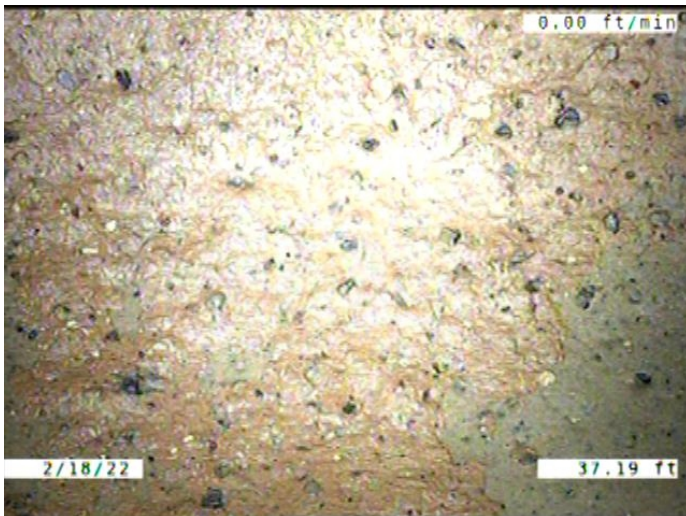
Code: **SSS**  
 Description: **Surface Damage Surface Spalling**

Distance (ft): **37.2**  
 Structural Grade: **2**  
 O&M Grade: **0**  
 Clock Start/From: **11**  
 Clock To: **1**  
 1st Value:  
 2nd Value:  
 Value Percent:  
 Continuous Index:  
 Within 8" of Joint: **NO**  
 Remarks:

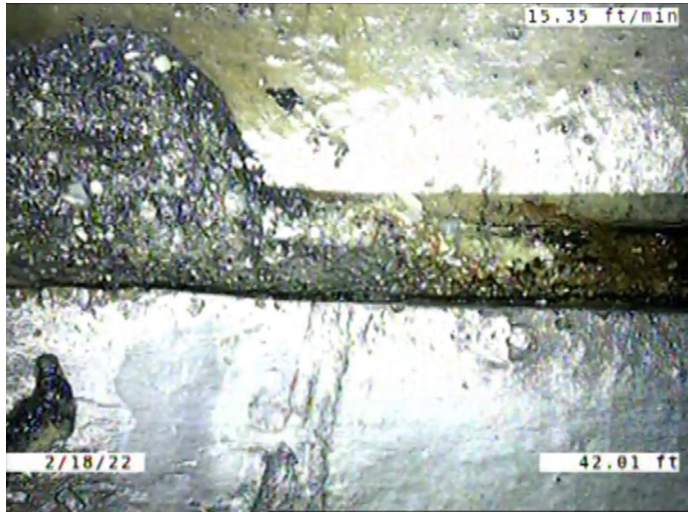
Code: **ISGT**  
Description: **Intruding Sealing Material Grout**

Distance (ft): **42.0**  
Structural Grade: **0**  
O&M Grade: **2**  
Clock Start/From: **4**  
Clock To: **5**  
1st Value:  
2nd Value:  
Value Percent: **5.000**  
Continuous Index:  
Within 8" of Joint: **NO**  
Remarks:

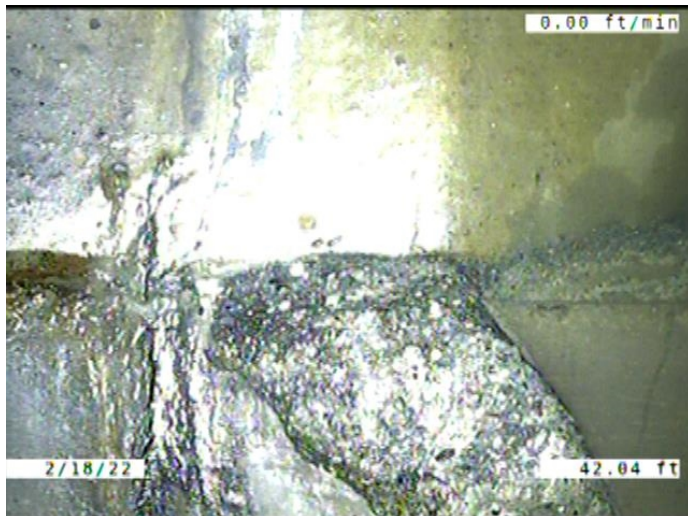
Code: **ISGT**  
Description: **Intruding Sealing Material Grout**

Distance (ft): **42.0**  
Structural Grade: **0**  
O&M Grade: **2**  
Clock Start/From: **8**  
Clock To: **9**  
1st Value:  
2nd Value:  
Value Percent: **5.000**  
Continuous Index:  
Within 8" of Joint: **NO**  
Remarks:

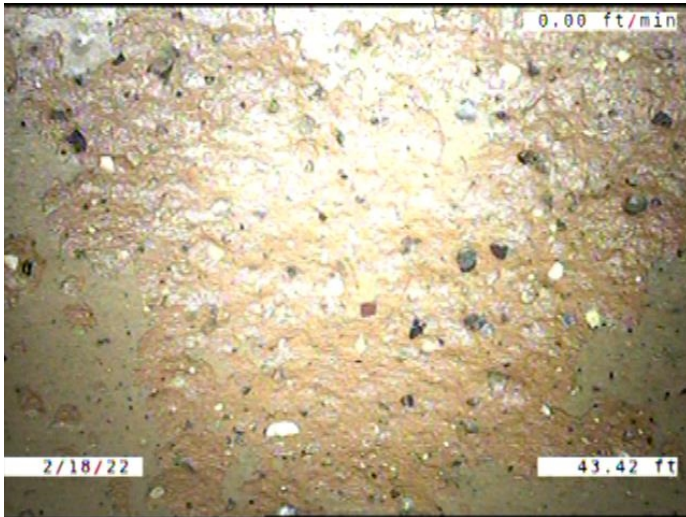
Code: **SSS**  
 Description: **Surface Damage Surface Spalling**

Distance (ft): **43.4**  
 Structural Grade: **2**  
 O&M Grade: **0**  
 Clock Start/From: **10**  
 Clock To: **2**  
 1st Value:  
 2nd Value:  
 Value Percent:  
 Continuous Index:  
 Within 8" of Joint: **NO**  
 Remarks:

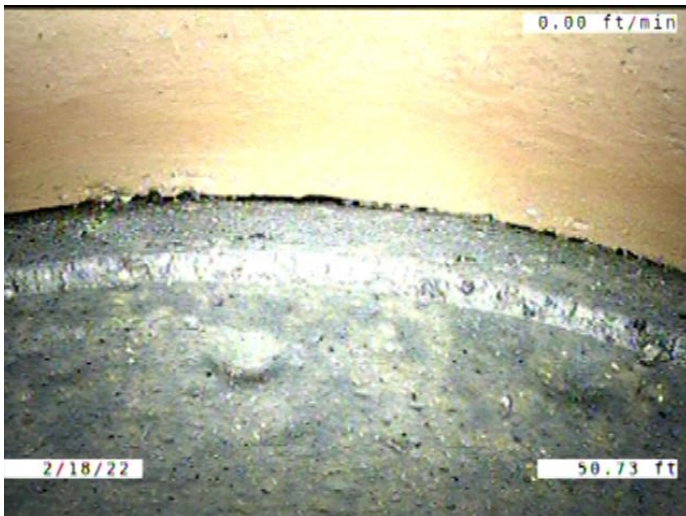
Code: **JOM**  
 Description: **Joint Offset Medium**

Distance (ft): **50.7**  
 Structural Grade: **3**  
 O&M Grade: **0**  
 Clock Start/From:  
 Clock To:  
 1st Value:  
 2nd Value:  
 Value Percent:  
 Continuous Index:  
 Within 8" of Joint: **NO**  
 Remarks:

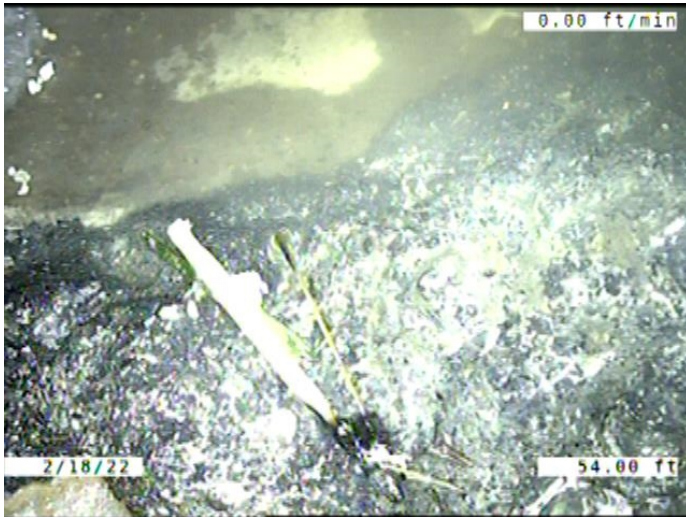
Code:	<b>ISGT</b>
Description:	<b>Intruding Sealing Material Grout</b>
Distance (ft):	<b>54.0</b>
Structural Grade:	<b>0</b>
O&M Grade:	<b>2</b>
Clock Start/From:	<b>4</b>
Clock To:	<b>8</b>
1st Value:	
2nd Value:	
Value Percent:	<b>5.000</b>
Continuous Index:	
Within 8" of Joint:	<b>NO</b>
Remarks:

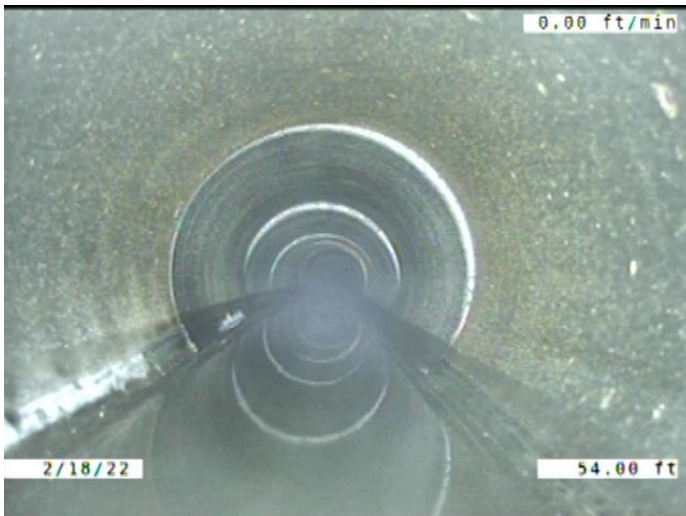
Code:	<b>MWL</b>
Description:	<b>Miscellaneous Water Level</b>
Distance (ft):	<b>54.0</b>
Structural Grade:	<b>0</b>
O&M Grade:	<b>0</b>
Clock Start/From:	
Clock To:	
1st Value:	
2nd Value:	
Value Percent:	<b>10.000</b>
Continuous Index:	
Within 8" of Joint:	<b>NO</b>
Remarks:

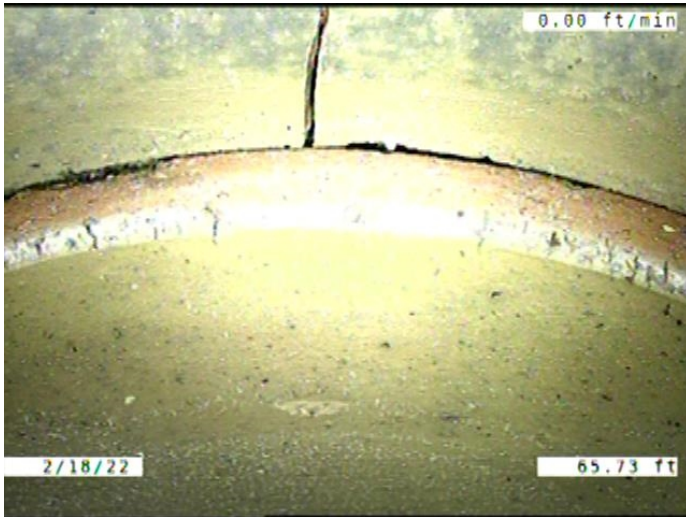
Code: **JOM**  
 Description: **Joint Offset Medium**

Distance (ft): **65.7**  
 Structural Grade: **3**  
 O&M Grade: **0**  
 Clock Start/From:  
 Clock To:  
 1st Value:  
 2nd Value:  
 Value Percent:  
 Continuous Index:  
 Within 8" of Joint: **NO**  
 Remarks:

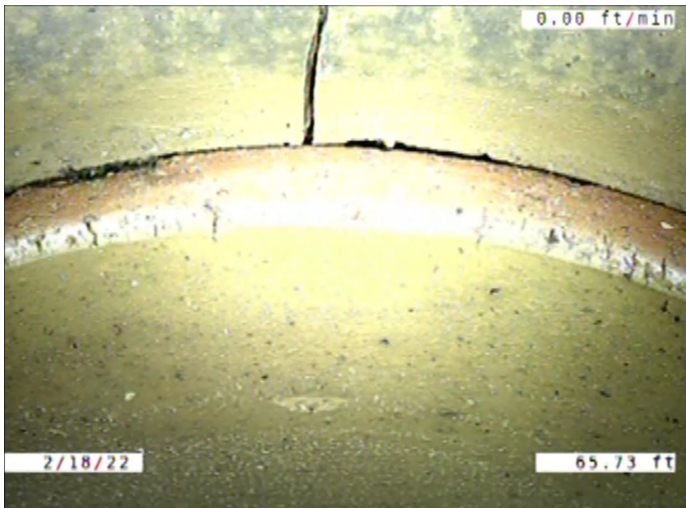
Code: **FL**  
 Description: **Fracture Longitudinal**

Distance (ft): **65.7**  
 Structural Grade: **3**  
 O&M Grade: **0**  
 Clock Start/From: **12**  
 Clock To:  
 1st Value:  
 2nd Value:  
 Value Percent:  
 Continuous Index:  
 Within 8" of Joint: **YES**  
 Remarks:

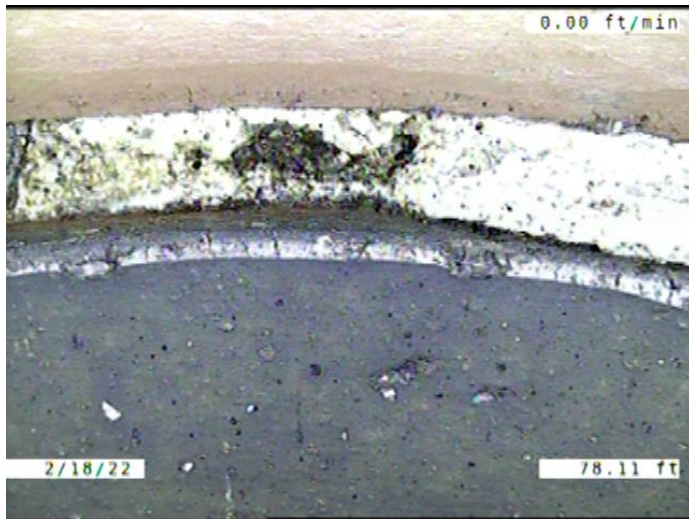
Code: **ISGT**  
 Description: **Intruding Sealing Material Grout**

Distance (ft): **78.1**  
 Structural Grade: **0**  
 O&M Grade: **2**  
 Clock Start/From: **11**  
 Clock To: **1**  
 1st Value:  
 2nd Value:  
 Value Percent: **5.000**  
 Continuous Index:  
 Within 8" of Joint: **NO**  
 Remarks:

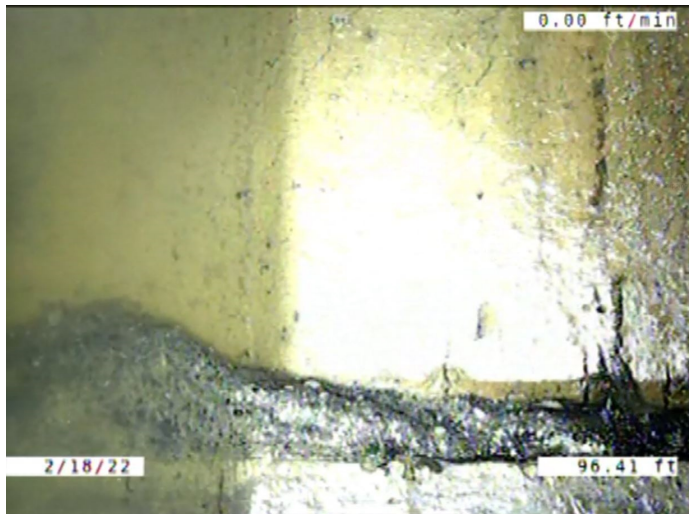
Code: **ISGT**  
 Description: **Intruding Sealing Material Grout**

Distance (ft): **96.4**  
 Structural Grade: **0**  
 O&M Grade: **2**  
 Clock Start/From: **4**  
 Clock To: **5**  
 1st Value:  
 2nd Value:  
 Value Percent: **5.000**  
 Continuous Index:  
 Within 8" of Joint: **NO**  
 Remarks:

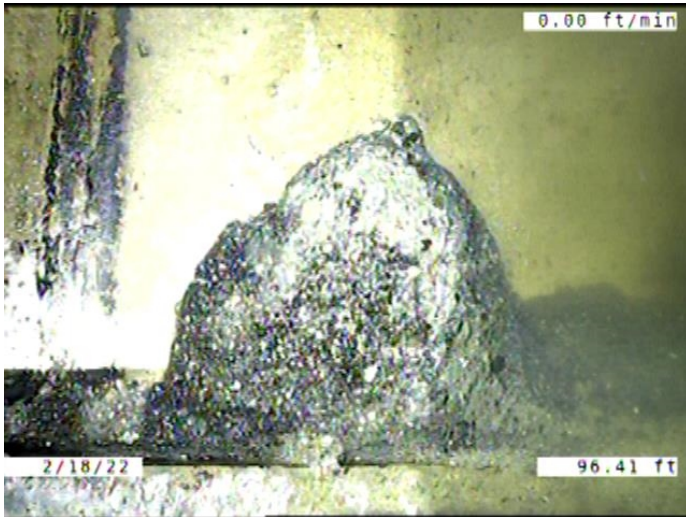
Code: **ISGT**  
Description: **Intruding Sealing Material Grout**

Distance (ft): **96.4**  
Structural Grade: **0**  
O&M Grade: **2**  
Clock Start/From: **8**  
Clock To: **9**  
1st Value:  
2nd Value:  
Value Percent: **5.000**  
Continuous Index:  
Within 8" of Joint: **NO**  
Remarks:

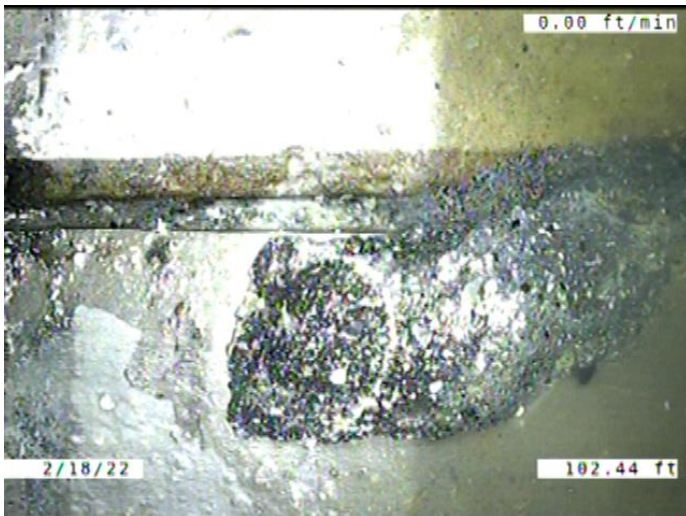
Code: **ISGT**  
Description: **Intruding Sealing Material Grout**

Distance (ft): **102.4**  
Structural Grade: **0**  
O&M Grade: **2**  
Clock Start/From: **4**  
Clock To: **8**  
1st Value:  
2nd Value:  
Value Percent: **5.000**  
Continuous Index:  
Within 8" of Joint: **NO**  
Remarks:

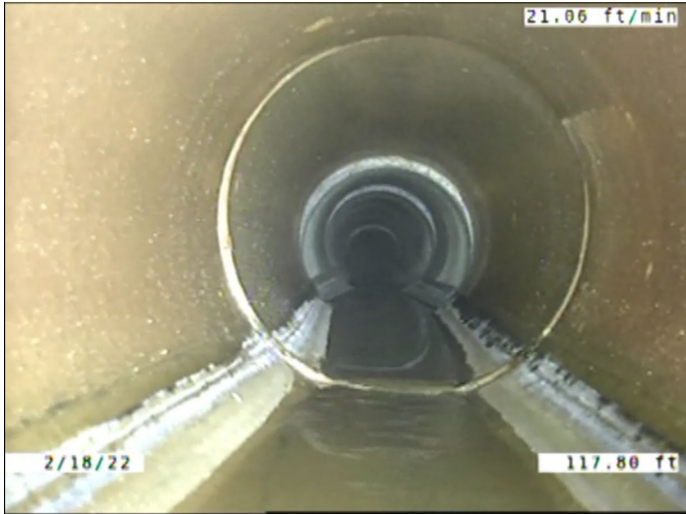
Code: **CL**  
Description: **Crack Longitudinal**

Distance (ft): **117.8**  
Structural Grade: **2**  
O&M Grade: **0**  
Clock Start/From: **2**  
Clock To:  
1st Value:  
2nd Value:  
Value Percent:  
Continuous Index:  
Within 8" of Joint: **YES**  
Remarks:

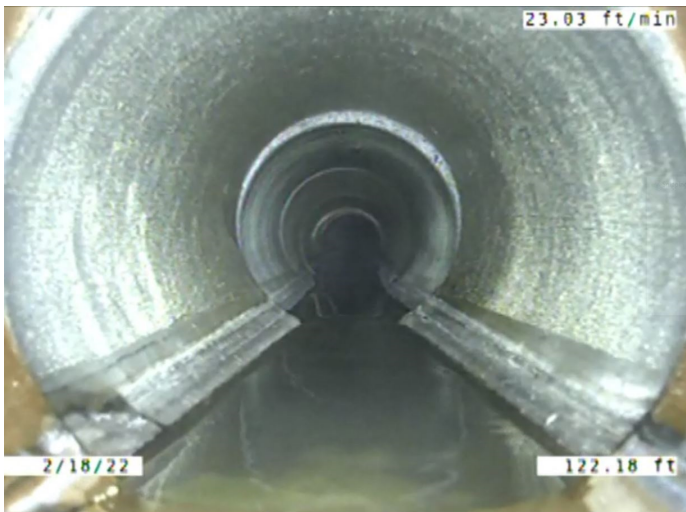
Code: **FL**  
Description: **Fracture Longitudinal**

Distance (ft): **122.2**  
Structural Grade: **3**  
O&M Grade: **0**  
Clock Start/From: **8**  
Clock To:  
1st Value:  
2nd Value:  
Value Percent:  
Continuous Index:  
Within 8" of Joint: **YES**  
Remarks:

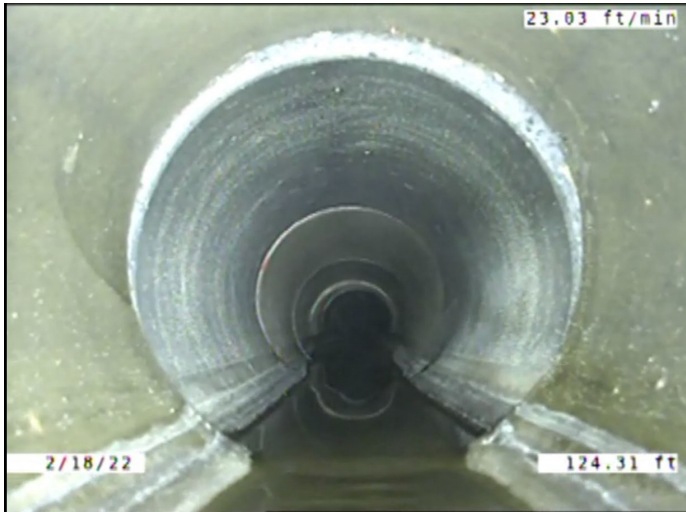
Code: **B**  
Description: **Broken**

Distance (ft): **124.3**  
Structural Grade: **4**  
O&M Grade: **0**  
Clock Start/From: **7**  
Clock To: **10**  
1st Value:  
2nd Value:  
Value Percent:  
Continuous Index:  
Within 8" of Joint: **YES**  
Remarks:

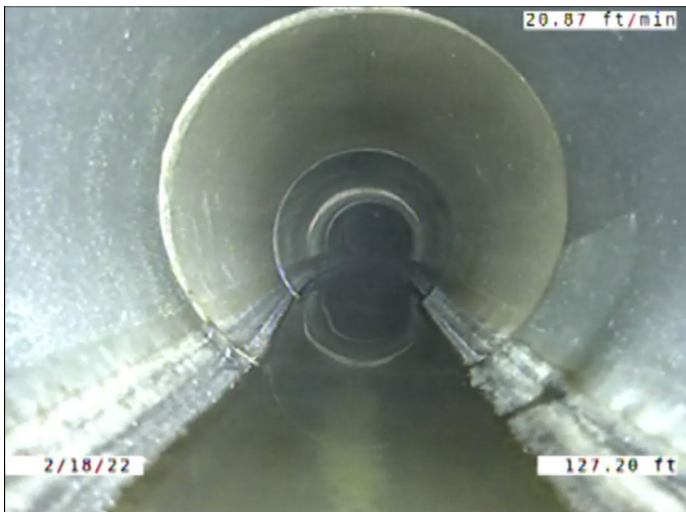
Code: **CL**  
Description: **Crack Longitudinal**

Distance (ft): **127.2**  
Structural Grade: **2**  
O&M Grade: **0**  
Clock Start/From: **3**  
Clock To:  
1st Value:  
2nd Value:  
Value Percent:  
Continuous Index:  
Within 8" of Joint: **YES**  
Remarks:

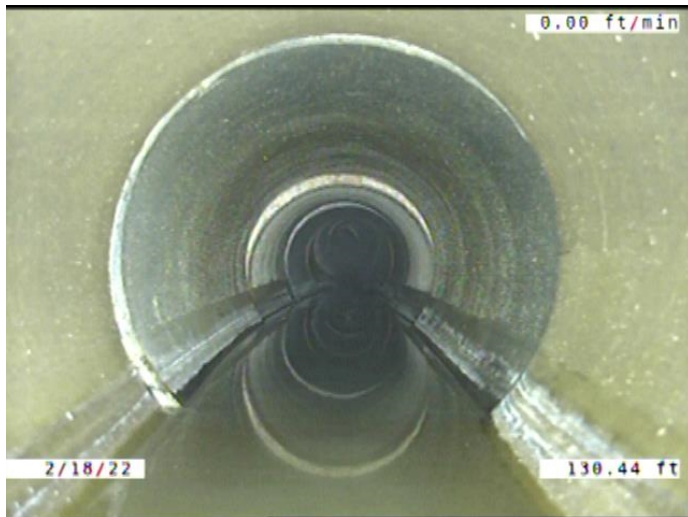
Code: **MWLS**  
 Description: **Miscellaneous Water Level Sag**

Distance (ft): **130.4**  
 Structural Grade: **2**  
 O&M Grade: **0**  
 Clock Start/From:  
 Clock To:  
 1st Value:  
 2nd Value:  
 Value Percent: **10.000**  
 Continuous Index: **S03**  
 Within 8" of Joint: **NO**  
 Remarks:

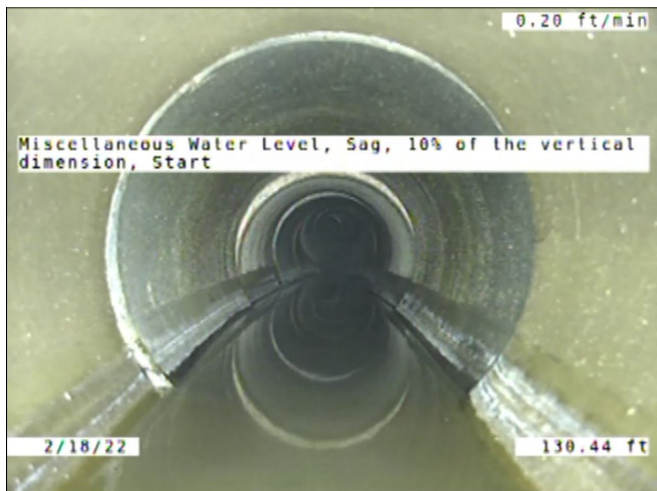
Code: **CL**  
 Description: **Crack Longitudinal**

Distance (ft): **130.4**  
 Structural Grade: **2**  
 O&M Grade: **0**  
 Clock Start/From: **3**  
 Clock To:  
 1st Value:  
 2nd Value:  
 Value Percent:  
 Continuous Index:  
 Within 8" of Joint: **NO**  
 Remarks:

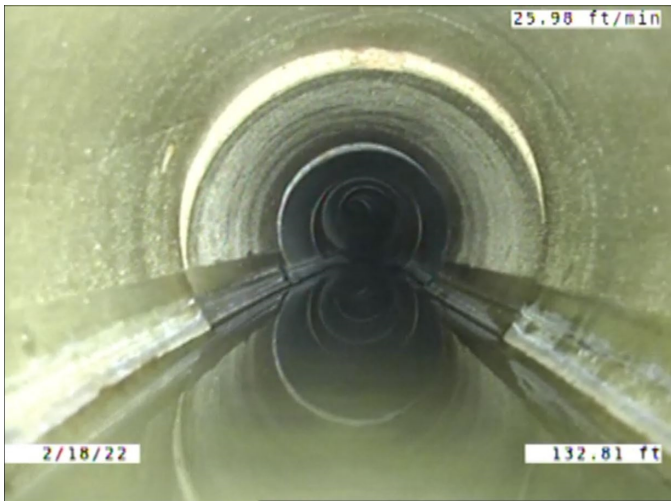
Code: **CS**  
Description: **Crack Spiral**

Distance (ft): **132.8**  
Structural Grade: **2**  
O&M Grade: **0**  
Clock Start/From: **9**  
Clock To: **10**  
1st Value:  
2nd Value:  
Value Percent:  
Continuous Index:  
Within 8" of Joint: **YES**  
Remarks:

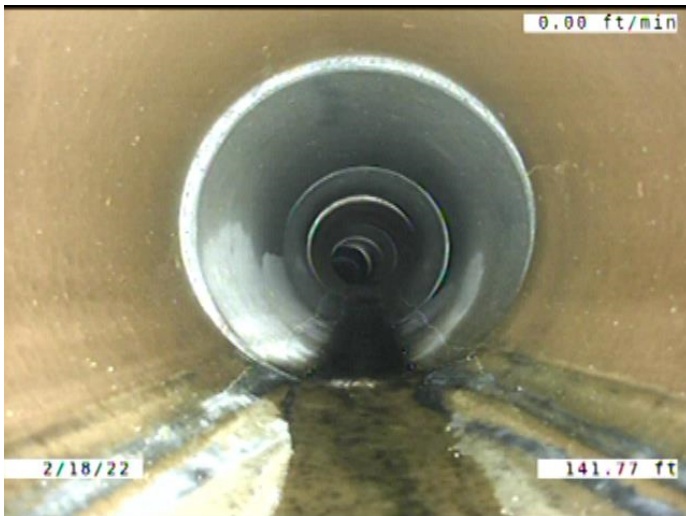
Code: **MWLS**  
Description: **Miscellaneous Water Level Sag**

Distance (ft): **141.8**  
Structural Grade: **2**  
O&M Grade: **0**  
Clock Start/From:  
Clock To:  
1st Value:  
2nd Value:  
Value Percent: **10.000**  
Continuous Index: **F03**  
Within 8" of Joint: **NO**  
Remarks:

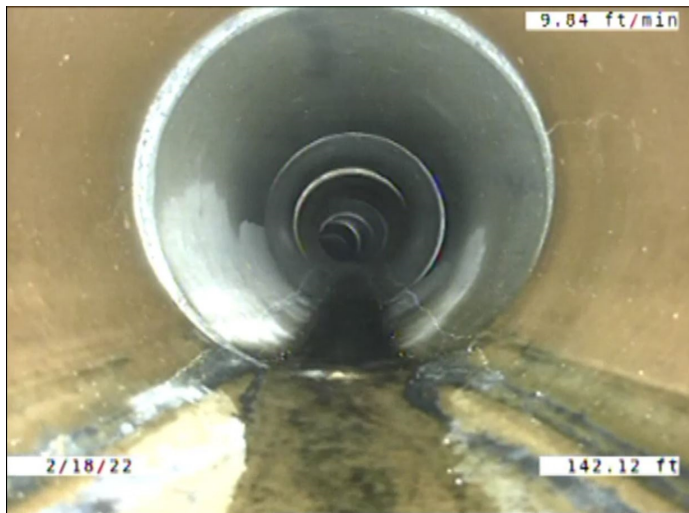
Code: **CL**  
 Description: **Crack Longitudinal**

Distance (ft): **142.1**  
 Structural Grade: **2**  
 O&M Grade: **0**  
 Clock Start/From: **3**  
 Clock To:  
 1st Value:  
 2nd Value:  
 Value Percent:  
 Continuous Index:  
 Within 8" of Joint: **YES**  
 Remarks:

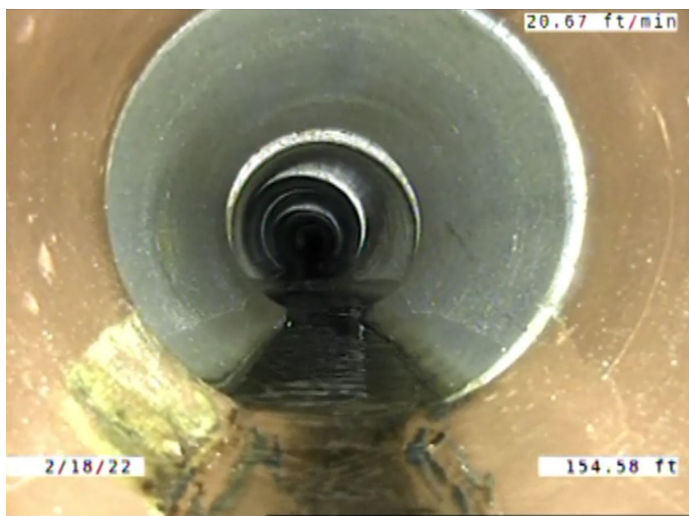
Code: **CM**  
 Description: **Crack Multiple**

Distance (ft): **154.6**  
 Structural Grade: **3**  
 O&M Grade: **0**  
 Clock Start/From: **1**  
 Clock To: **4**  
 1st Value:  
 2nd Value:  
 Value Percent:  
 Continuous Index:  
 Within 8" of Joint: **YES**  
 Remarks:

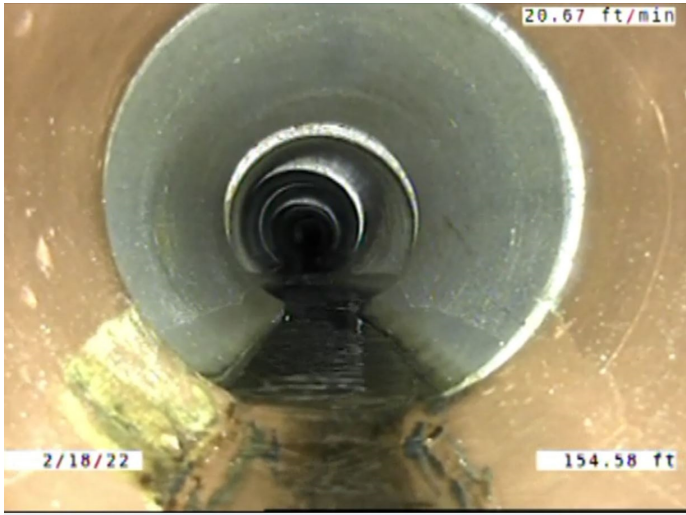
Code: **CL**  
 Description: **Crack Longitudinal**

Distance (ft): **154.6**  
 Structural Grade: **2**  
 O&M Grade: **0**  
 Clock Start/From: **8**  
 Clock To:  
 1st Value:  
 2nd Value:  
 Value Percent:  
 Continuous Index:  
 Within 8" of Joint: **YES**  
 Remarks:

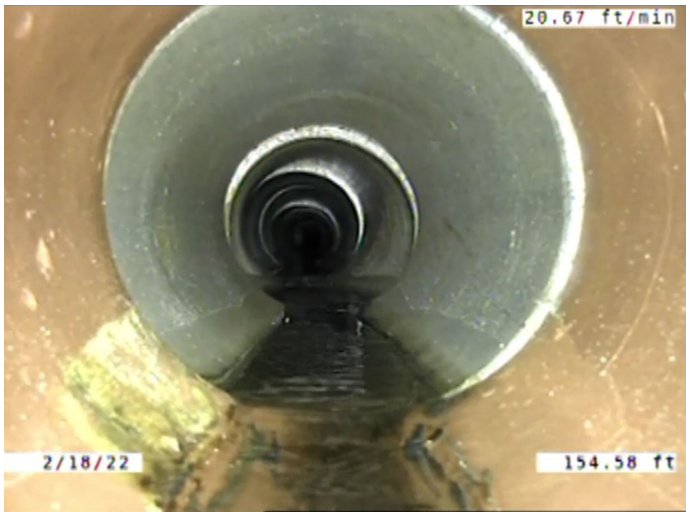
Code: **ISJ**  
 Description: **Infiltration Stain Joint**

Distance (ft): **154.6**  
 Structural Grade: **0**  
 O&M Grade: **1**  
 Clock Start/From: **7**  
 Clock To: **8**  
 1st Value:  
 2nd Value:  
 Value Percent:  
 Continuous Index:  
 Within 8" of Joint: **YES**  
 Remarks:

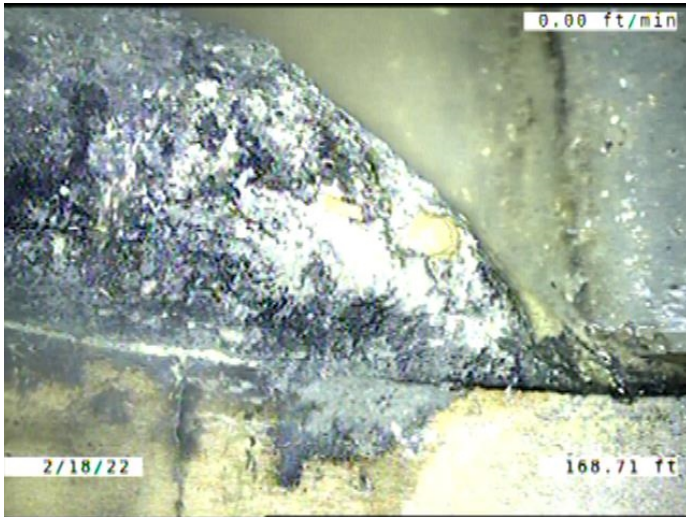
Code:	<b>ISGT</b>
Description:	<b>Intruding Sealing Material Grout</b>
Distance (ft):	<b>168.7</b>
Structural Grade:	<b>0</b>
O&M Grade:	<b>2</b>
Clock Start/From:	<b>4</b>
Clock To:	<b>8</b>
1st Value:	
2nd Value:	
Value Percent:	<b>5.000</b>
Continuous Index:	
Within 8" of Joint:	<b>NO</b>
Remarks:

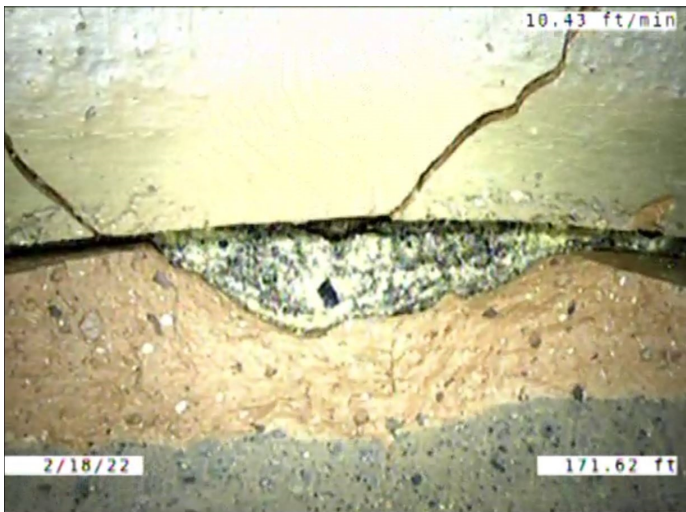
Code:	<b>B</b>
Description:	<b>Broken</b>
Distance (ft):	<b>171.6</b>
Structural Grade:	<b>4</b>
O&M Grade:	<b>0</b>
Clock Start/From:	<b>11</b>
Clock To:	<b>1</b>
1st Value:	
2nd Value:	
Value Percent:	
Continuous Index:	
Within 8" of Joint:	<b>YES</b>
Remarks:

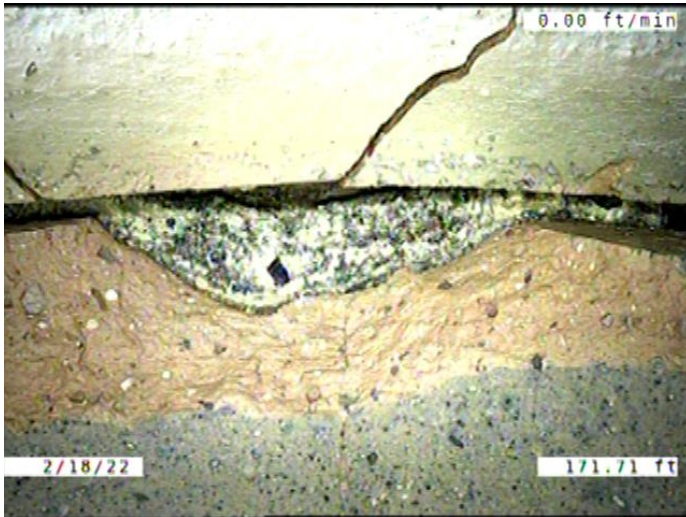
Code: **SZ**  
Description: **Surface Damage Other**

Distance (ft): **171.7**  
Structural Grade: **0**  
O&M Grade: **0**  
Clock Start/From: **9**  
Clock To: **11**  
1st Value:  
2nd Value:  
Value Percent:  
Continuous Index:  
Within 8" of Joint: **YES**  
Remarks: **A PIECE CHIPPED AWAY FROM THE JOINT**

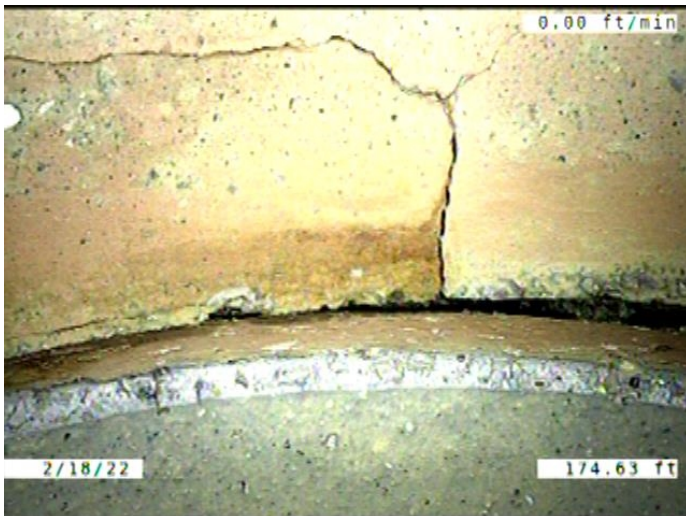
Code: **ISB**  
Description: **Infiltration Stain Barrel**

Distance (ft): **174.6**  
Structural Grade: **0**  
O&M Grade: **1**  
Clock Start/From: **7**  
Clock To: **9**  
1st Value:  
2nd Value:  
Value Percent:  
Continuous Index:  
Within 8" of Joint: **NO**  
Remarks:

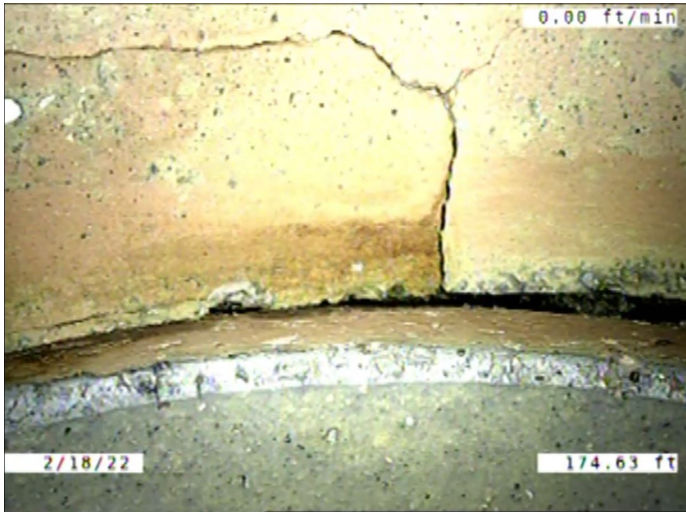
Code: **FM**  
Description: **Fracture Multiple**

Distance (ft): **174.6**  
Structural Grade: **4**  
O&M Grade: **0**  
Clock Start/From: **8**  
Clock To: **4**  
1st Value:  
2nd Value:  
Value Percent:  
Continuous Index:  
Within 8" of Joint: **YES**  
Remarks:

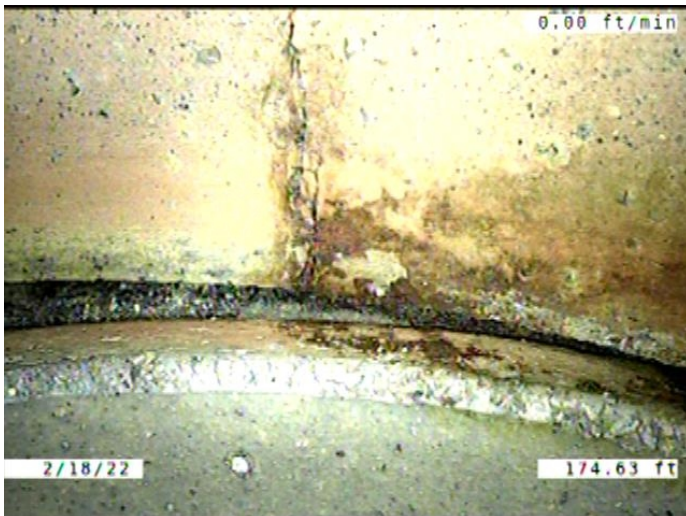
Code: **ISB**  
Description: **Infiltration Stain Barrel**

Distance (ft): **174.6**  
Structural Grade: **0**  
O&M Grade: **1**  
Clock Start/From: **3**  
Clock To: **5**  
1st Value:  
2nd Value:  
Value Percent:  
Continuous Index:  
Within 8" of Joint: **NO**  
Remarks:

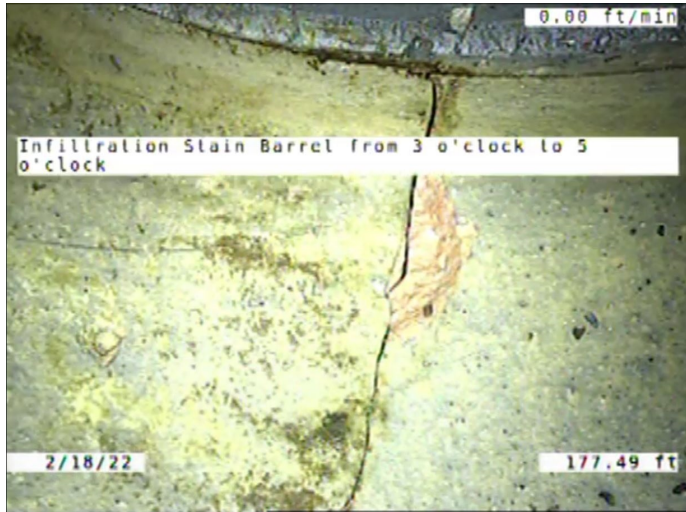
Code: **FM**  
Description: **Fracture Multiple**

Distance (ft): **177.5**  
Structural Grade: **4**  
O&M Grade: **0**  
Clock Start/From: **3**  
Clock To: **9**  
1st Value:  
2nd Value:  
Value Percent:  
Continuous Index:  
Within 8" of Joint: **YES**  
Remarks:

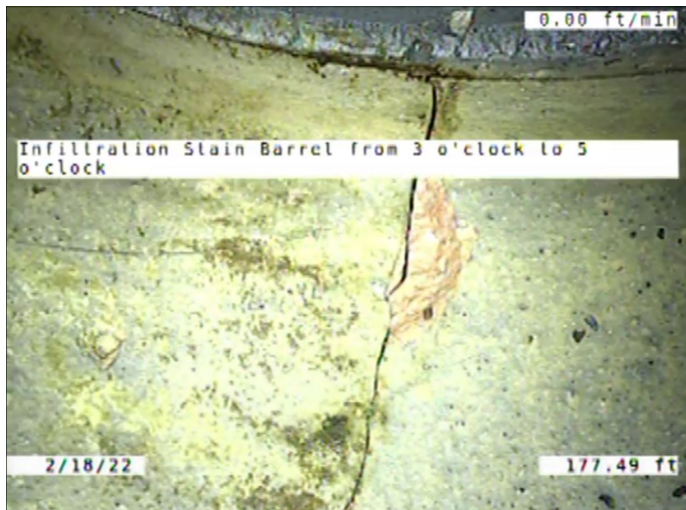
Code: **SSS**  
Description: **Surface Damage Surface Spalling**

Distance (ft): **177.5**  
Structural Grade: **2**  
O&M Grade: **0**  
Clock Start/From: **3**  
Clock To:  
1st Value:  
2nd Value:  
Value Percent:  
Continuous Index:  
Within 8" of Joint: **NO**  
Remarks:

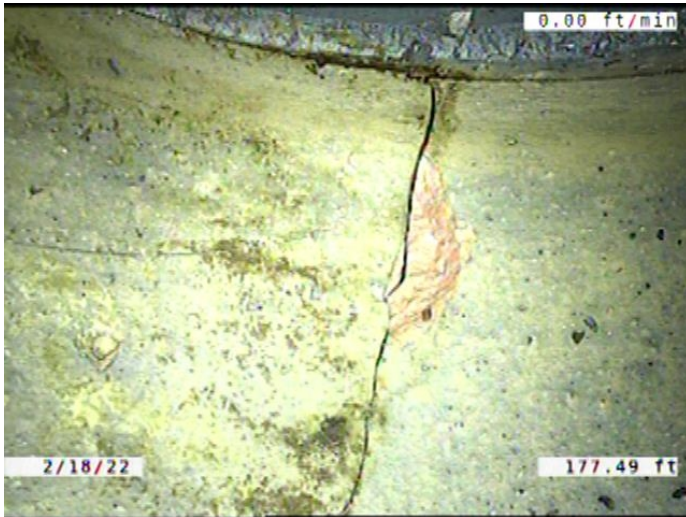
Code: **ISB**  
 Description: **Infiltration Stain Barrel**

Distance (ft): **177.5**  
 Structural Grade: **0**  
 O&M Grade: **1**  
 Clock Start/From: **3**  
 Clock To: **5**  
 1st Value:  
 2nd Value:  
 Value Percent:  
 Continuous Index:  
 Within 8" of Joint: **NO**  
 Remarks:

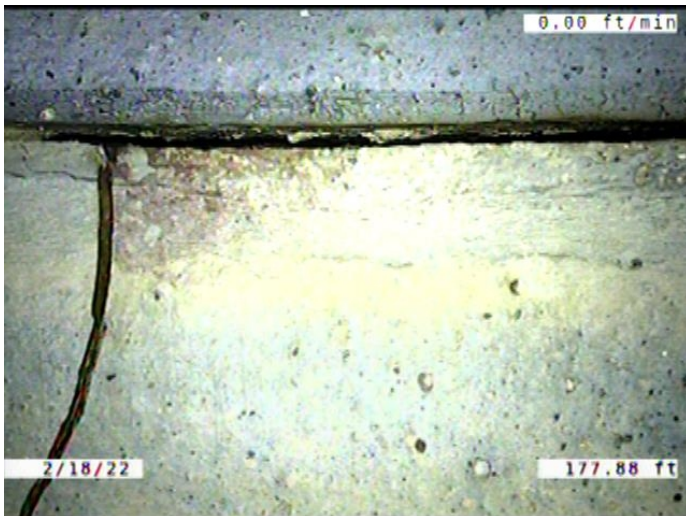
Code: **ISB**  
 Description: **Infiltration Stain Barrel**

Distance (ft): **177.9**  
 Structural Grade: **0**  
 O&M Grade: **1**  
 Clock Start/From: **9**  
 Clock To:  
 1st Value:  
 2nd Value:  
 Value Percent:  
 Continuous Index:  
 Within 8" of Joint: **YES**  
 Remarks:
