# Profile/Photo Observation Report

Date:	02/18/2022	Weather:		Coding:	PACP 7.0
Pipe Length (ft):	390.0	Owner:	City of Hobart	Pre Clean:	Heavy Cleaning
P.O.#:	YES502259	Surveyor:	S. Bucklin	PSR:	P-707-063-039
Customer:	City of Hobart	Clean Date:	02/16/2022	Shape:	C

Street:	East 11th Street	Flow Control:	Not Controlled
City:	Hobart, IN	Year Renewed:	
Location:	Local rural streets with light traffic, t	Tape/Media #:	
Purpose:	Routine Assessment	Dia/Height:	12"
Use:	Sanitary Sewage Pipe	Material:	VCP
Drain Area:		Lining:	None
Category:	NA		
Comment:			
Location Details:		Direction of Survey:	Upstream
US MH:	M-707-039	DS MH:	M-707-063
		Total Length Surveyed (ft):	189.0

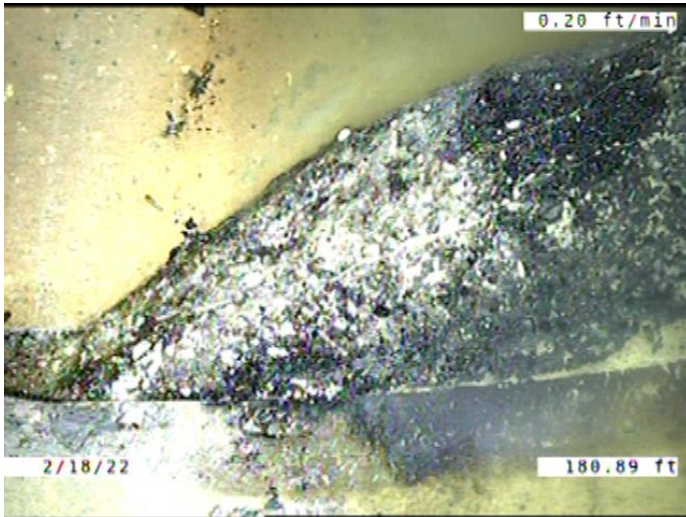
Code: **ISGT**  
 Description: **Intruding Sealing Material Grout**

Distance (ft): **180.9**  
 Structural Grade: **0**  
 O&M Grade: **2**  
 Clock Start/From: **4**  
 Clock To: **8**  
 1st Value:  
 2nd Value:  
 Value Percent: **5.000**  
 Continuous Index:  
 Within 8" of Joint: **NO**  
 Remarks:

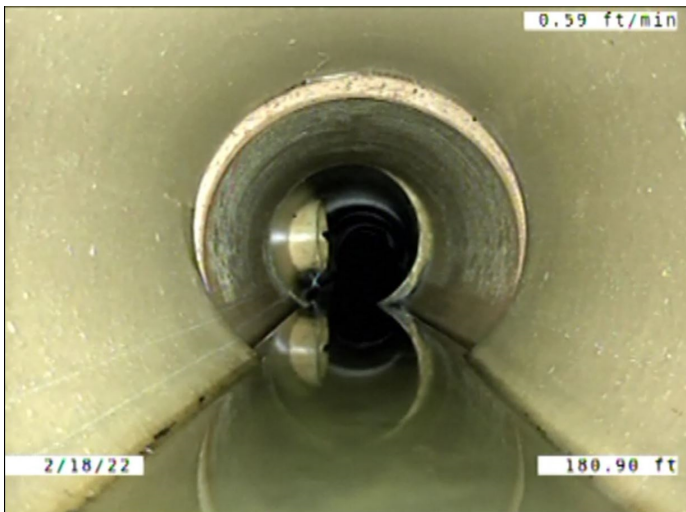
Code: **FM**  
 Description: **Fracture Multiple**

Distance (ft): **180.9**  
 Structural Grade: **4**  
 O&M Grade: **0**  
 Clock Start/From: **9**  
 Clock To: **12**  
 1st Value:  
 2nd Value:  
 Value Percent:  
 Continuous Index:  
 Within 8" of Joint: **YES**  
 Remarks:

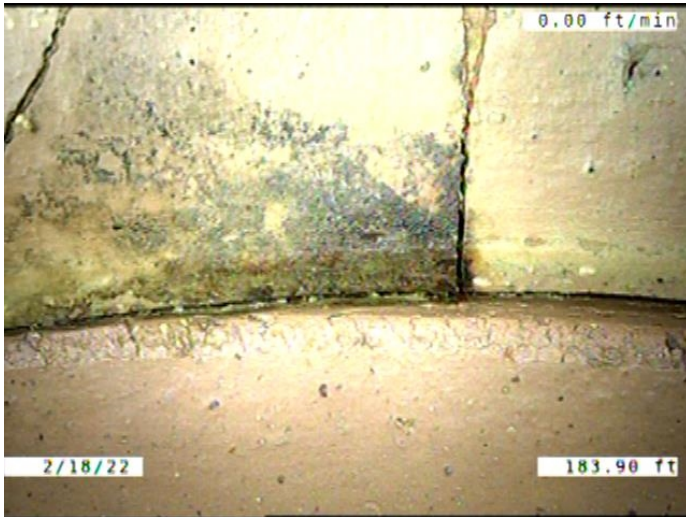
Code: **ISB**  
 Description: **Infiltration Stain Barrel**

Distance (ft): **183.9**  
 Structural Grade: **0**  
 O&M Grade: **1**  
 Clock Start/From: **8**  
 Clock To: **10**  
 1st Value:  
 2nd Value:  
 Value Percent:  
 Continuous Index:  
 Within 8" of Joint: **YES**  
 Remarks:

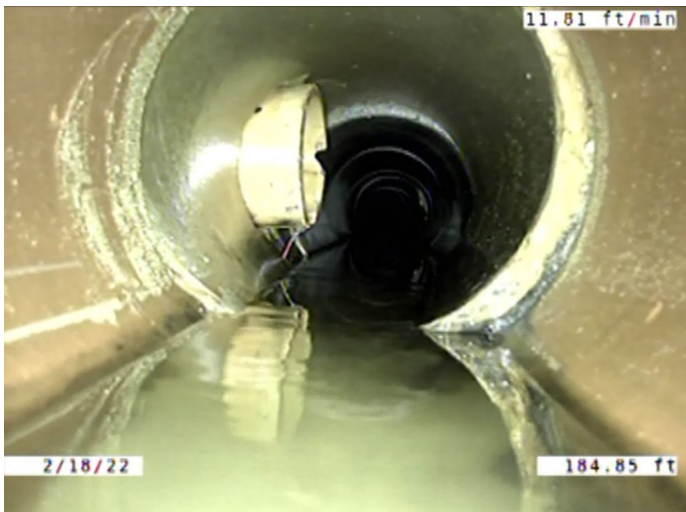
Code: **ISJ**  
 Description: **Infiltration Stain Joint**

Distance (ft): **184.9**  
 Structural Grade: **0**  
 O&M Grade: **1**  
 Clock Start/From: **8**  
 Clock To: **10**  
 1st Value:  
 2nd Value:  
 Value Percent:  
 Continuous Index:  
 Within 8" of Joint: **YES**  
 Remarks:

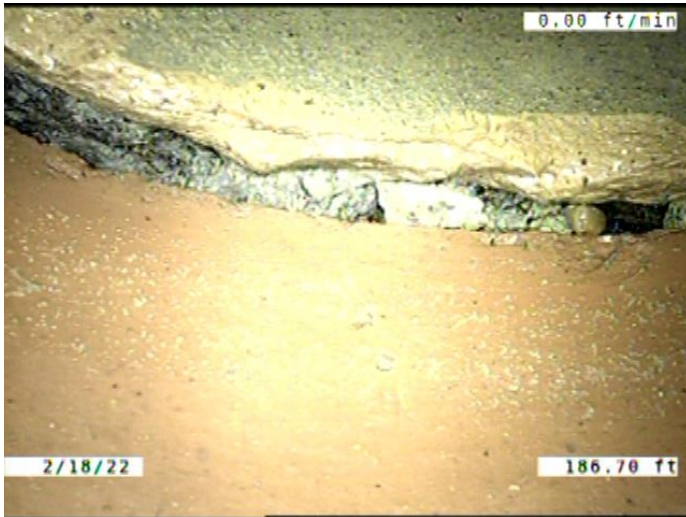
Code: **SSS**  
 Description: **Surface Damage Surface Spalling**

Distance (ft): **186.7**  
 Structural Grade: **2**  
 O&M Grade: **0**  
 Clock Start/From: **1**  
 Clock To: **7**  
 1st Value:  
 2nd Value:  
 Value Percent:  
 Continuous Index:  
 Within 8" of Joint: **YES**  
 Remarks:

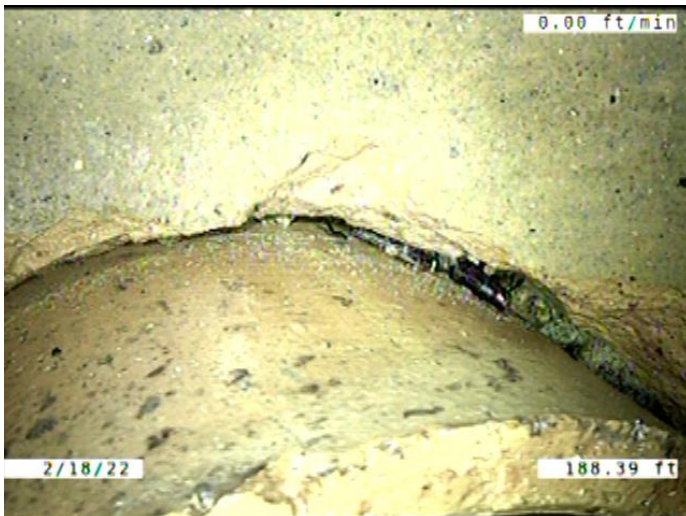
Code: **SSS**  
 Description: **Surface Damage Surface Spalling**

Distance (ft): **188.4**  
 Structural Grade: **2**  
 O&M Grade: **0**  
 Clock Start/From: **8**  
 Clock To: **11**  
 1st Value:  
 2nd Value:  
 Value Percent:  
 Continuous Index:  
 Within 8" of Joint: **NO**  
 Remarks:

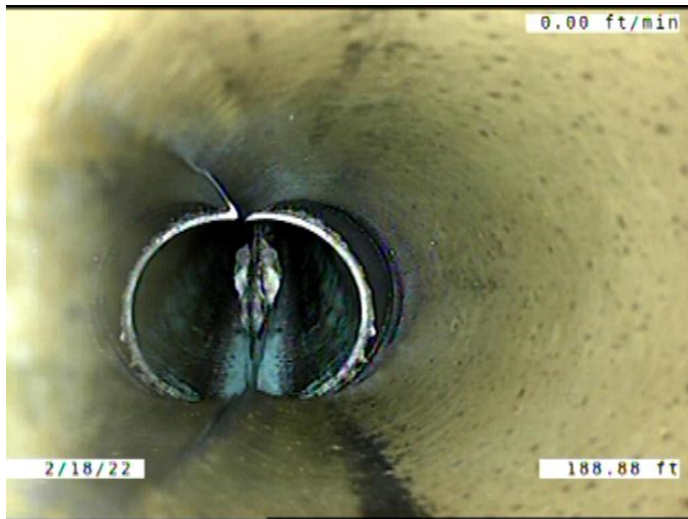
Code: **TBI**  
 Description: **Tap Break-in Intruding**

Distance (ft): **188.9**  
 Structural Grade: **0**  
 O&M Grade: **2**  
 Clock Start/From: **10**  
 Clock To:  
 1st Value: **6.000**  
 2nd Value: **4.000**  
 Value Percent:  
 Continuous Index:  
 Within 8" of Joint: **NO**  
 Remarks: **Active**

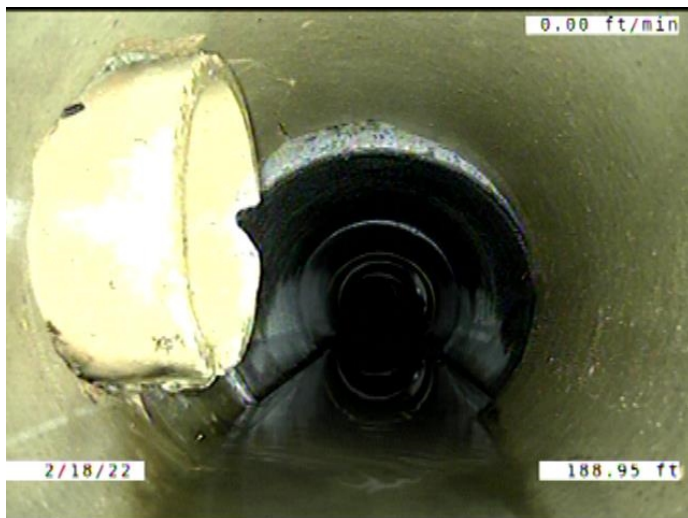
Code: **MSA**  
 Description: **Miscellaneous Survey Abandoned**

Distance (ft): **189.0**  
 Structural Grade: **0**  
 O&M Grade: **0**  
 Clock Start/From:  
 Clock To:  
 1st Value:  
 2nd Value:  
 Value Percent:  
 Continuous Index:  
 Within 8" of Joint: **NO**  
 Remarks: **CAMERA CANT MAKE IT PAST PROTRUDING TAP. MADE IT TO THE**
