## Profile/Photo Observation Report

Street:	<b>Capitol</b>	Flow Control:	<b>Not Controlled</b>
City:	<b>Hobart, IN</b>	Year Renewed:	
Location:	<b>Light Highway</b>	Tape/Media #:	
Purpose:	<b>Maintenance Related</b>	Dia/Height:	<b>12"</b>
Use:	<b>Sanitary</b>	Material:	<b>VCP</b>
Drain Area:	<b>NA</b>	Lining:	<b>Cured in Place</b>
Category:	<b>NA</b>		
Comment:	<b>heavy silt at 2'.</b>

Location Details:		Direction of Survey:	<b>Downstream</b>
US MH:	<b>M-707-040</b>	DS MH:	<b>M-707-039</b>
		Total Length Surveyed (ft):	<b>3.4</b>

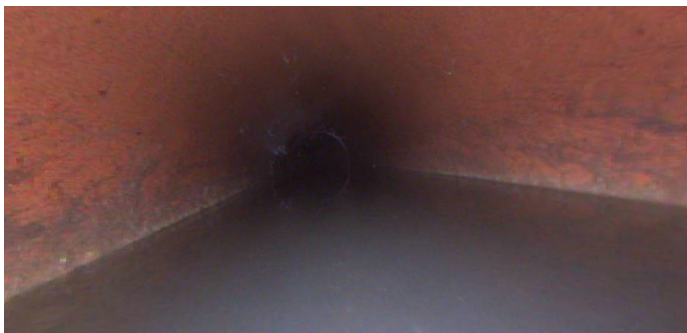
Code: **AMH**  
Description: **Manhole**

Distance (ft): **.0**  
Structural Grade: **0**  
O&M Grade: **0**  
Clock Start/From:  
Clock To:  
1st Value:  
2nd Value:  
Value Percent:  
Continuous Index:  
Within 8" of Joint: **NO**  
Remarks: **M-707-040**

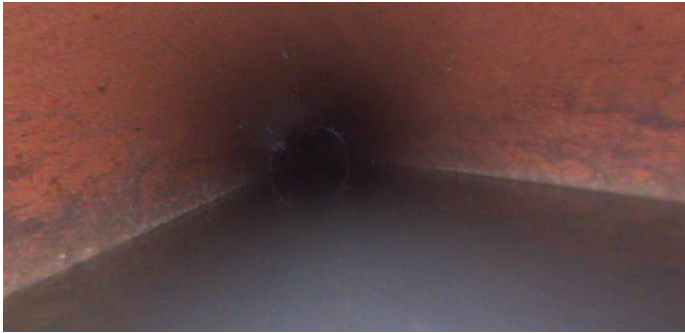
Code:	<b>MWL</b>
Description:	<b>Water Level</b>

Distance (ft):	<b>.0</b>
Structural Grade:	<b>0</b>
O&M Grade:	<b>0</b>
Clock Start/From:	
Clock To:	
1st Value:	
2nd Value:	
Value Percent:	<b>5.000</b>
Continuous Index:	
Within 8" of Joint:	<b>NO</b>
Remarks:
