Profile/Photo Observation Report

Date:	04/15/2018	Weather:		Coding:	PACP 6.0
Pipe Length (ft):	290.3	Owner:	NA	Pre Clean:	Not Known
P.O.#:		Surveyor:	Selasie Honu	PSR:	P-707-040-075
Customer:		Clean Date:	01/01/1900	Shape:	C

Street:	Capitol	Flow Control:	Not Controlled
City:	Hobart, IN	Year Renewed:	
Location:	Light Highway	Tape/Media #:	
Purpose:	Maintenance Related	Dia/Height:	10"
Use:	Sanitary	Material:	VCP
Drain Area:	NA	Lining:	Cured in Place
Category:	NA		
Comment:	12" pipe

Location Details:		Direction of Survey:	Downstream
US MH:	M-707-040	DS MH:	M-707-075
		Total Length Surveyed (ft):	6.5

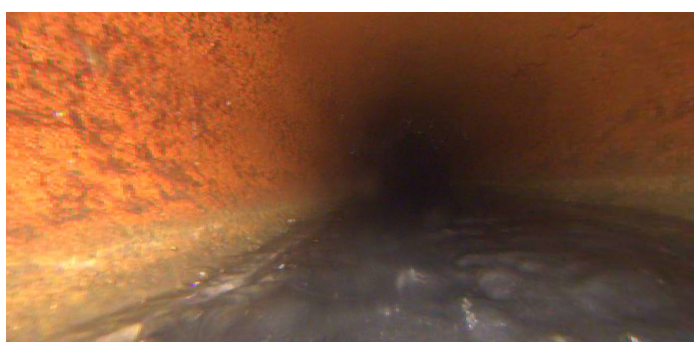
Code: **AMH**
Description: **Manhole**

Distance (ft): **.0**
Structural Grade: **0**
O&M Grade: **0**
Clock Start/From:
Clock To:
1st Value:
2nd Value:
Value Percent:
Continuous Index:
Within 8" of Joint: **NO**
Remarks: **M-707-040**

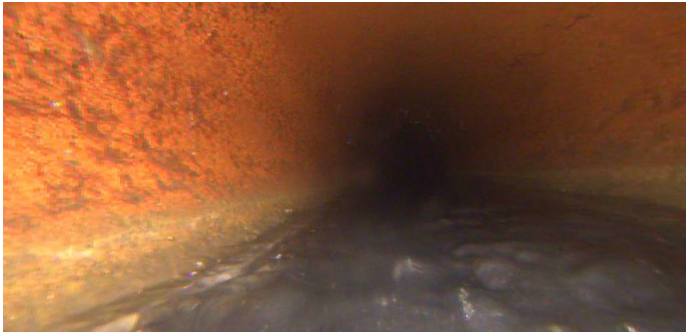
Code:	MWL
Description:	Water Level

Distance (ft):	.0
Structural Grade:	0
O&M Grade:	0
Clock Start/From:	
Clock To:	
1st Value:	
2nd Value:	
Value Percent:	5.000
Continuous Index:	
Within 8" of Joint:	NO
Remarks:

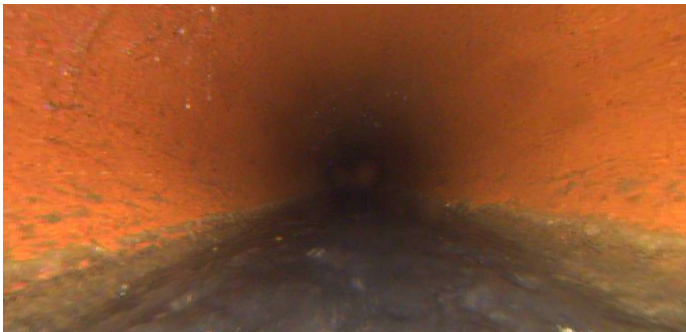
Code:	MSA
Description:	Abandoned Survey

Distance (ft):	6.5
Structural Grade:	0
O&M Grade:	0
Clock Start/From:	
Clock To:	
1st Value:	
2nd Value:	
Value Percent:	
Continuous Index:	
Within 8" of Joint:	NO
Remarks:	camera stopped
