Profile/Photo Observation Report

Date:	02/13/2022	Weather:		Coding:	PACP 7.0
Pipe Length (ft):	96.0	Owner:	City of Hobart	Pre Clean:	Heavy Cleaning
P.O.#:	YES502259	Surveyor:	S. Bucklin	PSR:	P-707-043-042
Customer:	City of Hobart	Clean Date:	02/08/2022	Shape:	C

Street:	East 13th Street	Flow Control:	Not Controlled
City:	Hobart, IN	Year Renewed:	
Location:	Local rural streets with light traffic, t	Tape/Media #:	
Purpose:	Routine Assessment	Dia/Height:	8"
Use:	Sanitary Sewage Pipe	Material:	VCP
Drain Area:		Lining:	None
Category:	NA		
Comment:			
Location Details:		Direction of Survey:	Upstream
US MH:	M-707-042	DS MH:	M-707-043
		Total Length Surveyed (ft):	11.7

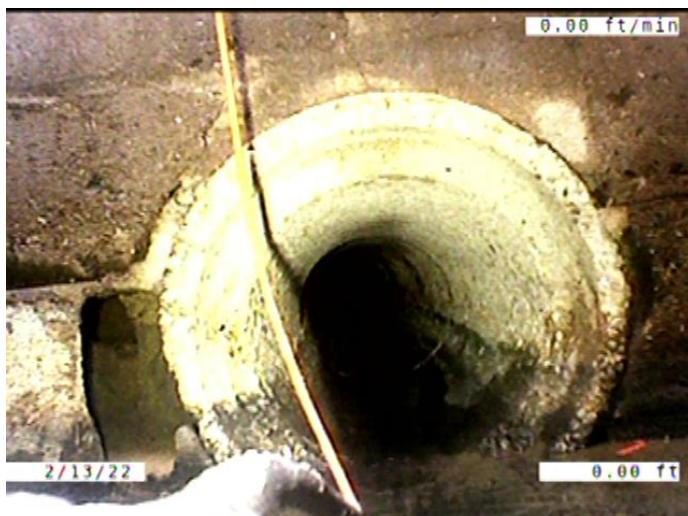
Code: **AMH**
Description: **Manhole**

Distance (ft): **.0**
Structural Grade: **0**
O&M Grade: **0**
Clock Start/From:
Clock To:
1st Value:
2nd Value:
Value Percent:
Continuous Index:
Within 8" of Joint: **NO**
Remarks: **M-707-043**

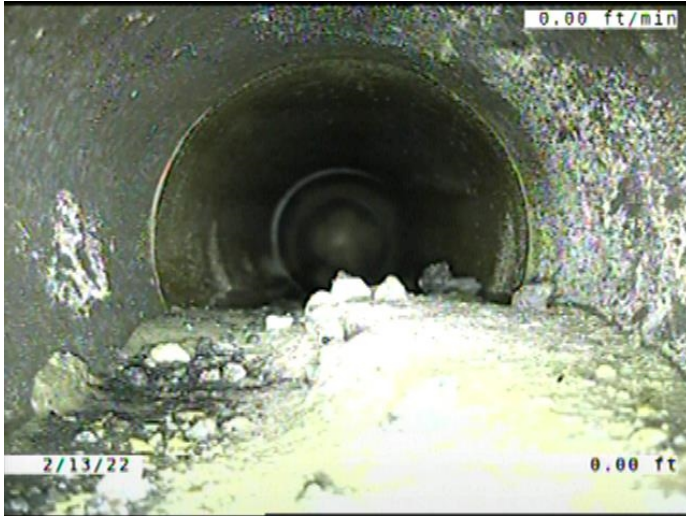
Code: **MWL**
Description: **Miscellaneous Water Level**

Distance (ft): **.0**
Structural Grade: **0**
O&M Grade: **0**
Clock Start/From:
Clock To:
1st Value:
2nd Value:
Value Percent: **5.000**
Continuous Index:
Within 8" of Joint: **NO**
Remarks:

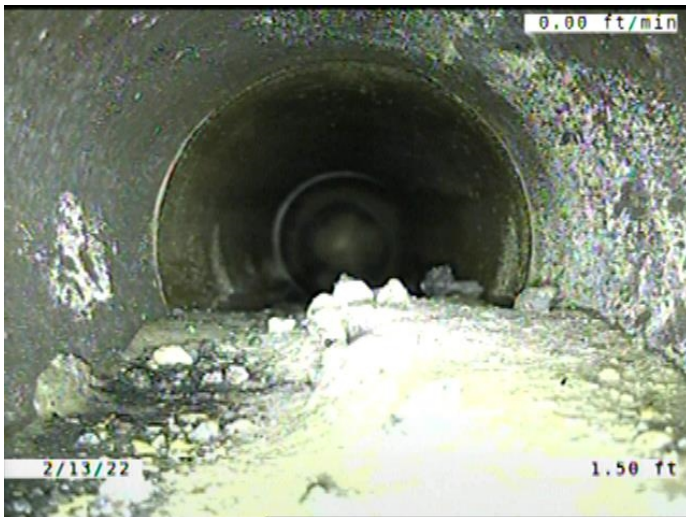
Code: **MGO**
Description: **Miscellaneous General Observation**

Distance (ft): **1.5**
Structural Grade: **0**
O&M Grade: **0**
Clock Start/From:
Clock To:
1st Value:
2nd Value:
Value Percent:
Continuous Index:
Within 8" of Joint: **NO**
Remarks: **DROP INTO THE MANHOLE. HAD TO START IN THE PIPE.**

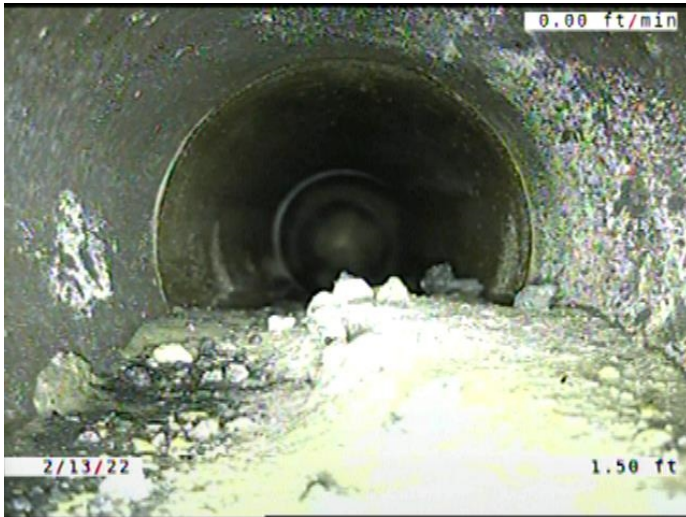
Code: **DSF**
Description: **Deposits Settled Fine**

Distance (ft): **1.5**
Structural Grade: **0**
O&M Grade: **3**
Clock Start/From: **4**
Clock To: **8**
1st Value:
2nd Value:
Value Percent: **20.000**
Continuous Index: **S01**
Within 8" of Joint: **YES**
Remarks:

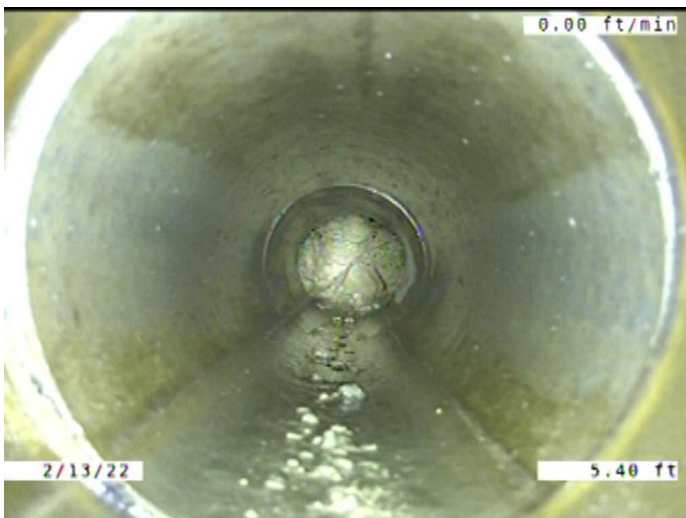
Code: **DSF**
Description: **Deposits Settled Fine**

Distance (ft): **5.4**
Structural Grade: **0**
O&M Grade: **3**
Clock Start/From: **4**
Clock To: **8**
1st Value:
2nd Value:
Value Percent: **20.000**
Continuous Index: **F01**
Within 8" of Joint: **YES**
Remarks:

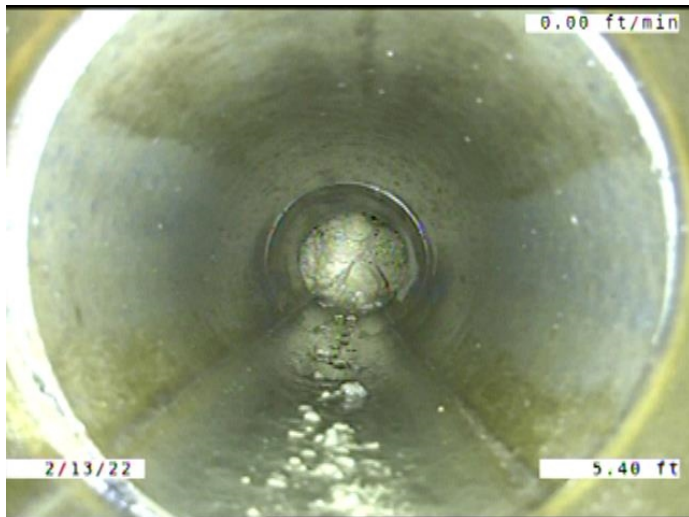
Code: **DSF**
 Description: **Deposits Settled Fine**

Distance (ft): **5.4**
 Structural Grade: **0**
 O&M Grade: **2**
 Clock Start/From: **5**
 Clock To: **7**
 1st Value:
 2nd Value:
 Value Percent: **5.000**
 Continuous Index: **S02**
 Within 8" of Joint: **YES**
 Remarks:

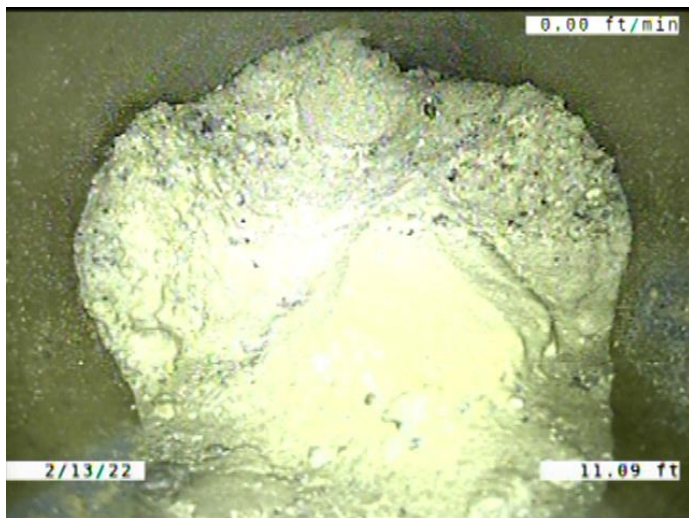
Code: **DSF**
 Description: **Deposits Settled Fine**

Distance (ft): **11.1**
 Structural Grade: **0**
 O&M Grade: **5**
 Clock Start/From: **12**
 Clock To: **12**
 1st Value:
 2nd Value:
 Value Percent: **100.000**
 Continuous Index:
 Within 8" of Joint: **NO**
 Remarks:

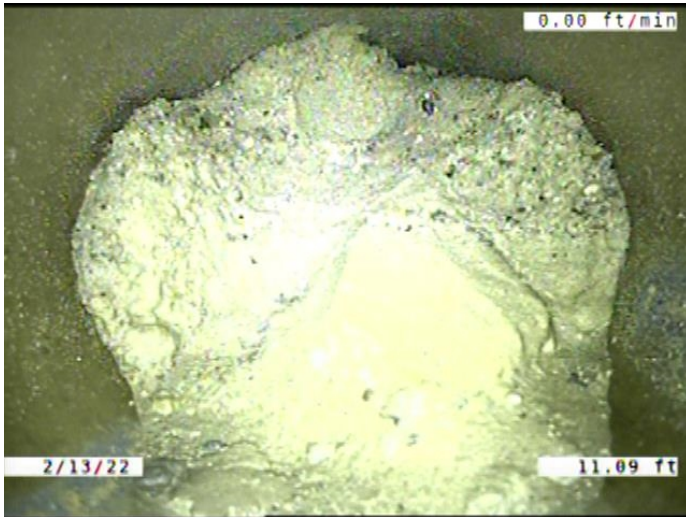
Code:	DSF
Description:	Deposits Settled Fine
Distance (ft):	11.1
Structural Grade:	0
O&M Grade:	2
Clock Start/From:	5
Clock To:	7
1st Value:	
2nd Value:	
Value Percent:	5.000
Continuous Index:	F02
Within 8" of Joint:	YES
Remarks:

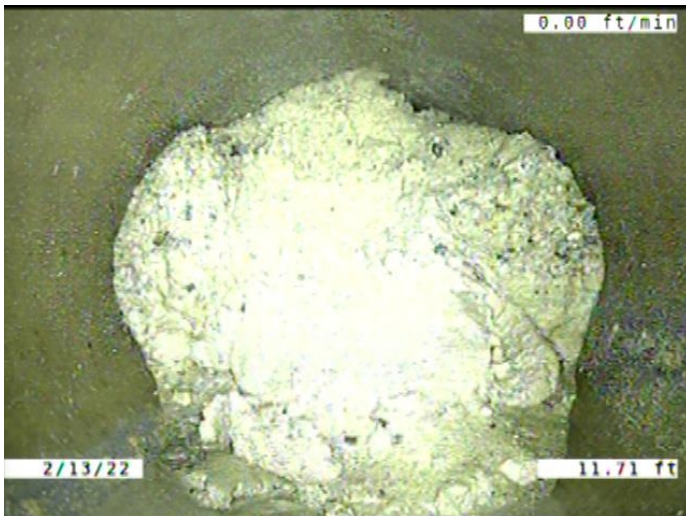
Code:	MSA
Description:	Miscellaneous Survey Abandoned
Distance (ft):	11.7
Structural Grade:	0
O&M Grade:	0
Clock Start/From:	
Clock To:	
1st Value:	
2nd Value:	
Value Percent:	
Continuous Index:	
Within 8" of Joint:	NO
Remarks:	CAMERA CANT MAKE IT PAST DEBRIS.
