## Profile/Photo Observation Report

Date:	<b>02/10/2022</b>	Weather:		Coding:	<b>PACP 7.0</b>
Pipe Length (ft):	<b>34.9</b>	Owner:	<b>City of Hobart</b>	Pre Clean:	<b>Heavy Cleaning</b>
P.O.#:	<b>YES502259</b>	Surveyor:	<b>S. Bucklin</b>	PSR:	<b>P-707-077-042</b>
Customer:	<b>City of Hobart</b>	Clean Date:	<b>02/09/2022</b>	Shape:	<b>C</b>

Street:	<b>East 13th Street</b>	Flow Control:	<b>Not Controlled</b>
City:	<b>Hobart, IN</b>	Year Renewed:	
Location:	<b>Easement/Right of Way</b>	Tape/Media #:	
Purpose:	<b>Routine Assessment</b>	Dia/Height:	<b>8"</b>
Use:	<b>Sanitary Sewage Pipe</b>	Material:	<b>VCP</b>
Drain Area:		Lining:	<b>None</b>
Category:	<b>NA</b>		
Comment:			
Location Details:		Direction of Survey:	<b>Downstream</b>
US MH:	<b>M-707-042</b>	DS MH:	<b>M-707-077</b>
		Total Length Surveyed (ft):	<b>34.9</b>

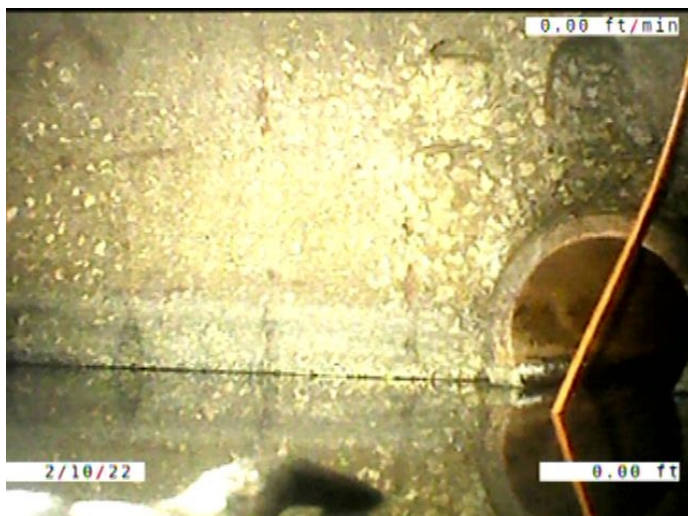
Code: **AMH**  
 Description: **Manhole**

Distance (ft): **.0**  
 Structural Grade: **0**  
 O&M Grade: **0**  
 Clock Start/From:  
 Clock To:  
 1st Value:  
 2nd Value:  
 Value Percent:  
 Continuous Index:  
 Within 8" of Joint: **NO**  
 Remarks: **M-707-042**

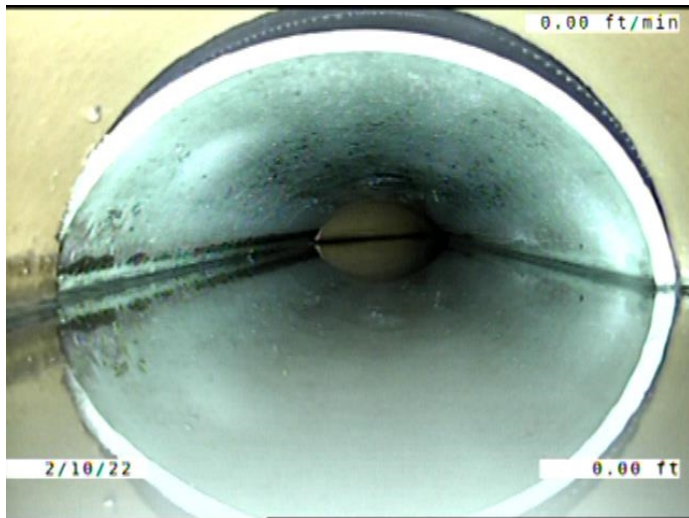
Code: **MWL**  
Description: **Miscellaneous Water Level**

Distance (ft): **.0**  
Structural Grade: **0**  
O&M Grade: **0**  
Clock Start/From:  
Clock To:  
1st Value:  
2nd Value:  
Value Percent: **60.000**  
Continuous Index:  
Within 8" of Joint: **NO**  
Remarks:

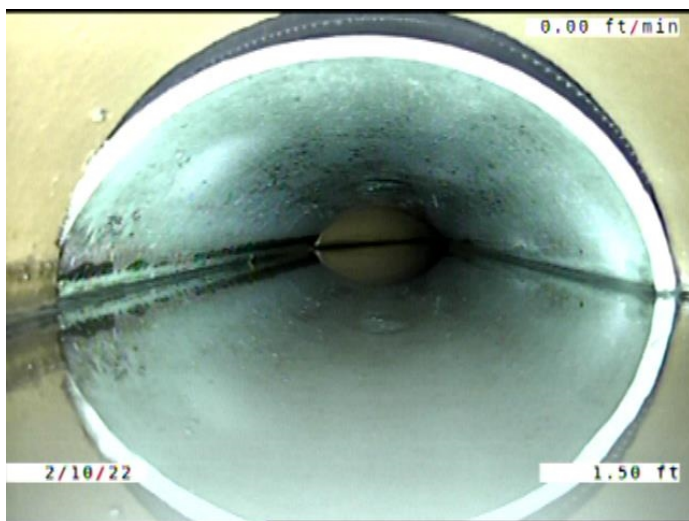
Code: **MGO**  
Description: **Miscellaneous General Observation**

Distance (ft): **1.5**  
Structural Grade: **0**  
O&M Grade: **0**  
Clock Start/From:  
Clock To:  
1st Value:  
2nd Value:  
Value Percent:  
Continuous Index:  
Within 8" of Joint: **NO**  
Remarks: **DROP INTO THE MANHOLE. HAD TO START IN THE PIPE.**

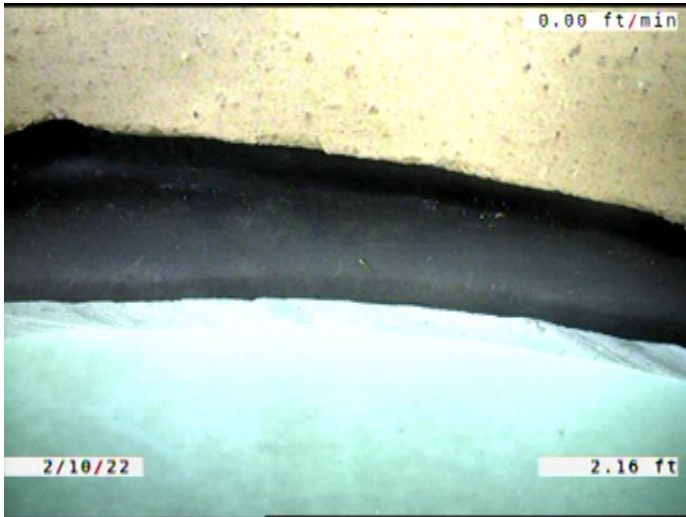
Code: **JOM**  
 Description: **Joint Offset Medium**

Distance (ft): **2.1**  
 Structural Grade: **3**  
 O&M Grade: **0**  
 Clock Start/From:  
 Clock To:  
 1st Value: **1.000**  
 2nd Value:  
 Value Percent:  
 Continuous Index:  
 Within 8" of Joint: **NO**  
 Remarks:

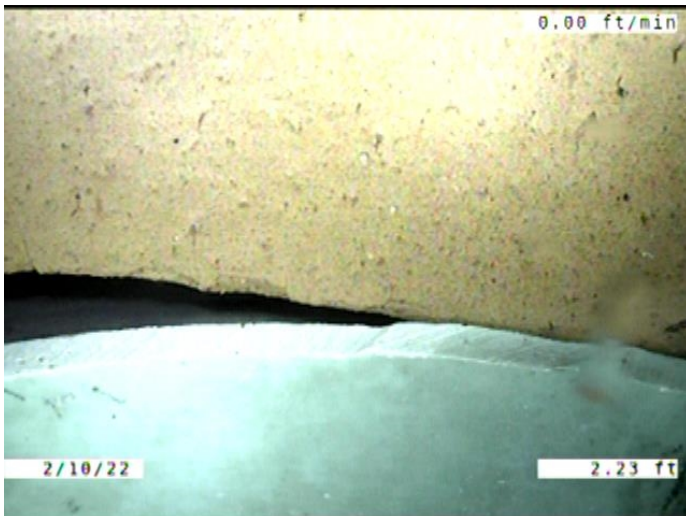
Code: **MMC**  
 Description: **Miscellaneous Material Change**

Distance (ft): **2.2**  
 Structural Grade: **0**  
 O&M Grade: **0**  
 Clock Start/From:  
 Clock To:  
 1st Value:  
 2nd Value:  
 Value Percent:  
 Continuous Index:  
 Within 8" of Joint: **NO**  
 Remarks: **VCP TO PVC**

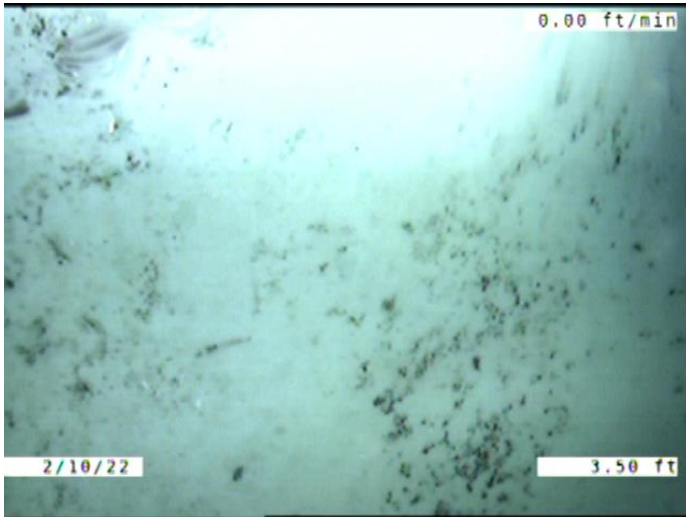
Code: **MCU**  
Description: **Miscellaneous Camera Underwater**

Distance (ft): **3.5**  
Structural Grade: **0**  
O&M Grade: **4**  
Clock Start/From:  
Clock To:  
1st Value:  
2nd Value:  
Value Percent:  
Continuous Index: **S01**  
Within 8" of Joint: **NO**  
Remarks:

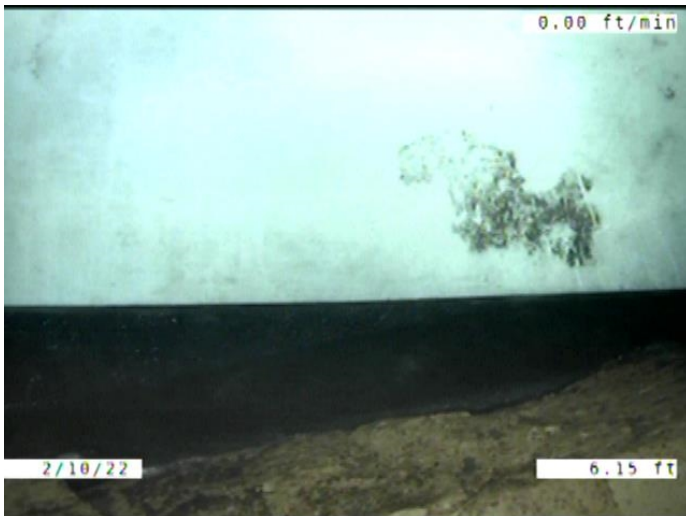
Code: **MMC**  
Description: **Miscellaneous Material Change**

Distance (ft): **6.2**  
Structural Grade: **0**  
O&M Grade: **0**  
Clock Start/From:  
Clock To:  
1st Value:  
2nd Value:  
Value Percent:  
Continuous Index:  
Within 8" of Joint: **NO**  
Remarks: **PVC TO VCP**

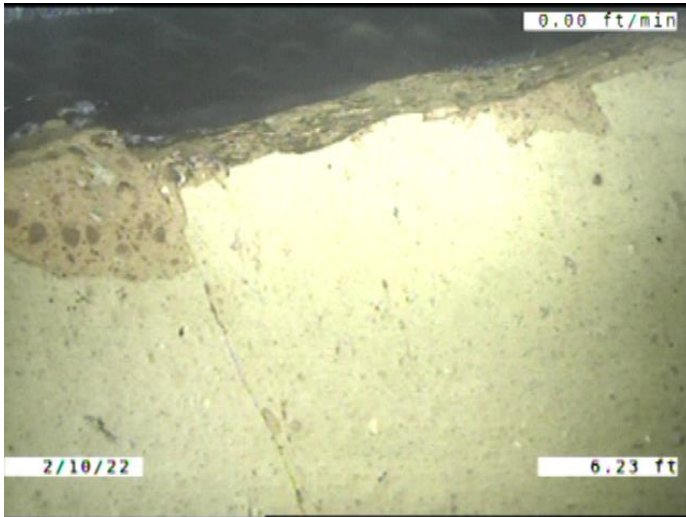
Code: **CL**  
 Description: **Crack Longitudinal**

Distance (ft): **6.2**  
 Structural Grade: **2**  
 O&M Grade: **0**  
 Clock Start/From: **12**  
 Clock To:  
 1st Value:  
 2nd Value:  
 Value Percent:  
 Continuous Index:  
 Within 8" of Joint: **YES**  
 Remarks:

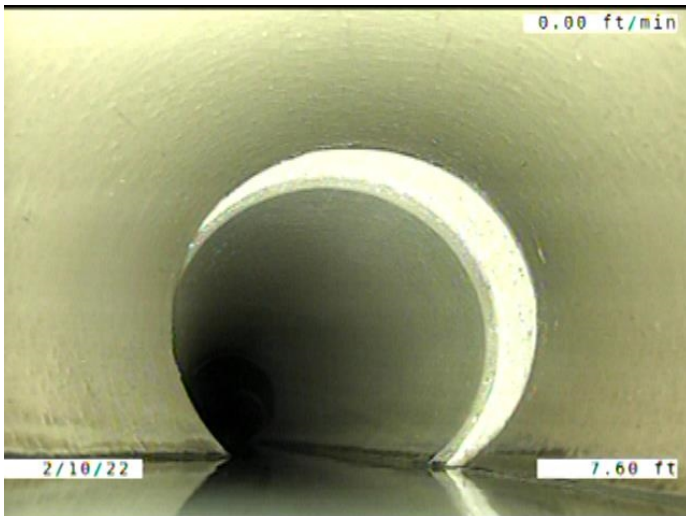
Code: **MWL**  
 Description: **Miscellaneous Water Level**

Distance (ft): **7.6**  
 Structural Grade: **0**  
 O&M Grade: **0**  
 Clock Start/From:  
 Clock To:  
 1st Value:  
 2nd Value:  
 Value Percent: **15.000**  
 Continuous Index:  
 Within 8" of Joint: **NO**  
 Remarks:

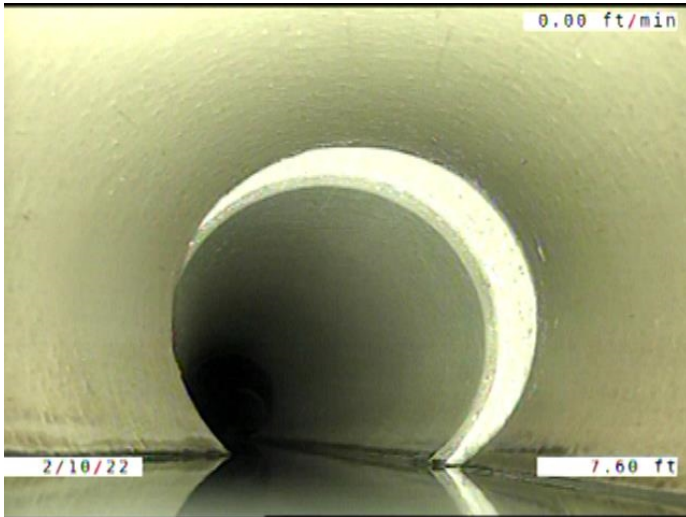
Code: **MCU**  
Description: **Miscellaneous Camera Underwater**

Distance (ft): **7.6**  
Structural Grade: **0**  
O&M Grade: **4**  
Clock Start/From:  
Clock To:  
1st Value:  
2nd Value:  
Value Percent:  
Continuous Index: **F01**  
Within 8" of Joint: **NO**  
Remarks:

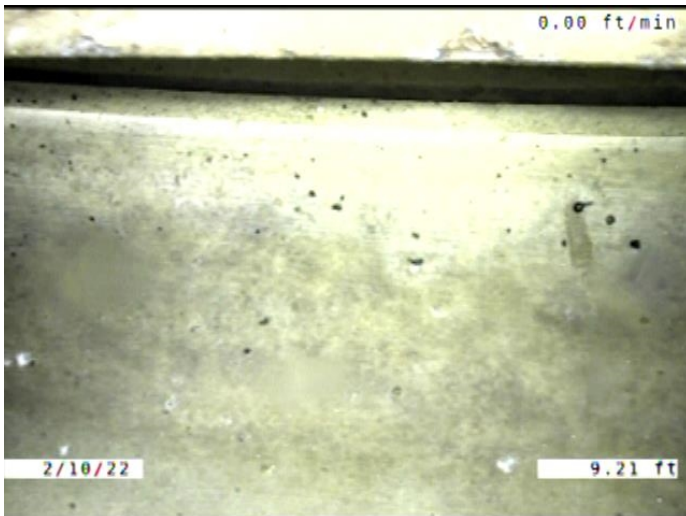
Code: **JAL**  
Description: **Joint Angular Large**

Distance (ft): **9.2**  
Structural Grade: **4**  
O&M Grade: **0**  
Clock Start/From:  
Clock To:  
1st Value:  
2nd Value:  
Value Percent:  
Continuous Index:  
Within 8" of Joint: **NO**  
Remarks:

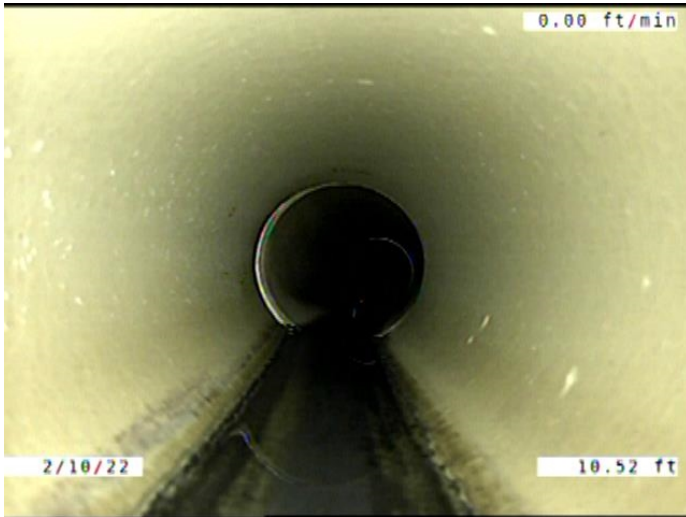
Code: **MWL**  
Description: **Miscellaneous Water Level**

Distance (ft): **10.5**  
Structural Grade: **0**  
O&M Grade: **0**  
Clock Start/From:  
Clock To:  
1st Value:  
2nd Value:  
Value Percent: **5.000**  
Continuous Index:  
Within 8" of Joint: **NO**  
Remarks:

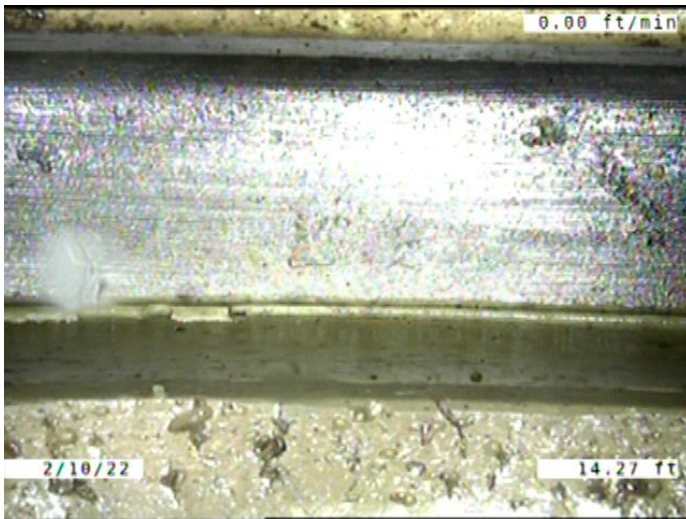
Code: **JAM**  
Description: **Joint Angular Medium**

Distance (ft): **14.3**  
Structural Grade: **3**  
O&M Grade: **0**  
Clock Start/From:  
Clock To:  
1st Value:  
2nd Value:  
Value Percent:  
Continuous Index:  
Within 8" of Joint: **NO**  
Remarks:

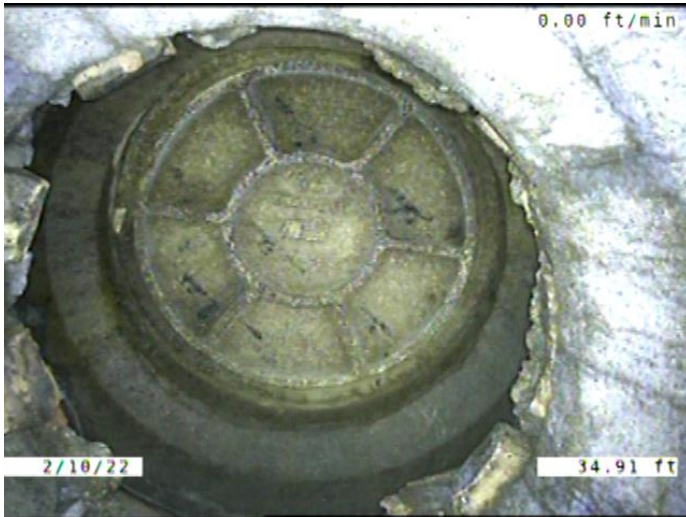
Code:	AMH
Description:	Manhole
Distance (ft):	34.9
Structural Grade:	0
O&M Grade:	0
Clock Start/From:	
Clock To:	
1st Value:	
2nd Value:	
Value Percent:	
Continuous Index:	
Within 8" of Joint:	NO
Remarks:	M-707-077
