Profile/Photo Observation Report

| P.O.#: | YES502259 | Surveyor: | S. Bucklin | PSR: | P-707-044-043 |

| Street: | East 13th Street | Flow Control: | Not Controlled |
| US MH: | M-707-043 | DS MH: | M-707-044 |

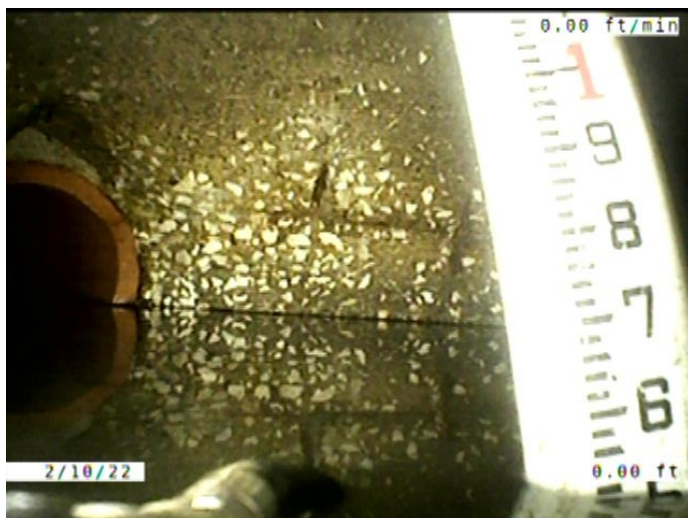
Code: **AMH**
 Description: **Manhole**

Distance (ft): **.0**
 Structural Grade: **0**
 O&M Grade: **0**
 Clock Start/From:
 Clock To:
 1st Value:
 2nd Value:
 Value Percent:
 Continuous Index:
 Within 8" of Joint: **NO**
 Remarks: **M-707-044**

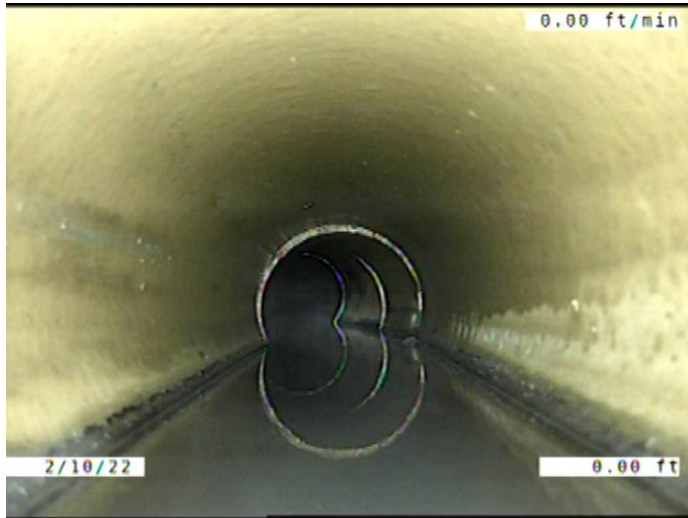
Code: **MWL**
 Description: **Miscellaneous Water Level**

Distance (ft): **.0**
 Structural Grade: **0**
 O&M Grade: **0**
 Clock Start/From:
 Clock To:
 1st Value:
 2nd Value:
 Value Percent: **10.000**
 Continuous Index:
 Within 8" of Joint: **NO**
 Remarks:

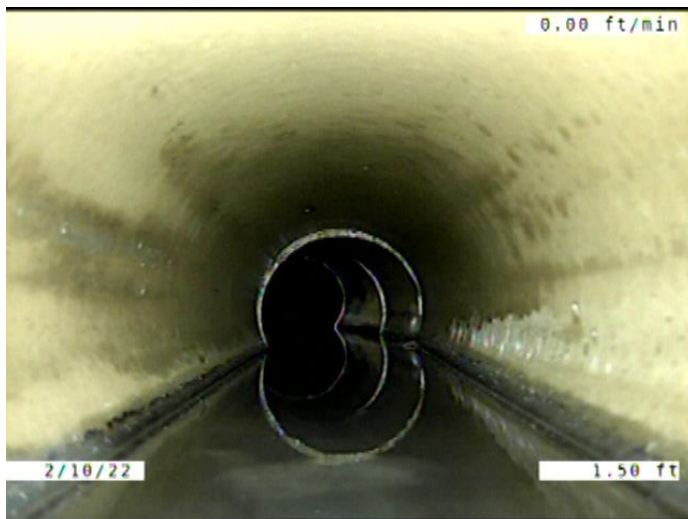
Code: **MGO**
 Description: **Miscellaneous General Observation**

Distance (ft): **1.5**
 Structural Grade: **0**
 O&M Grade: **0**
 Clock Start/From:
 Clock To:
 1st Value:
 2nd Value:
 Value Percent:
 Continuous Index:
 Within 8" of Joint: **NO**
 Remarks: **DROP INTO THE MANHOLE. HAD TO START IN THE PIPE.**

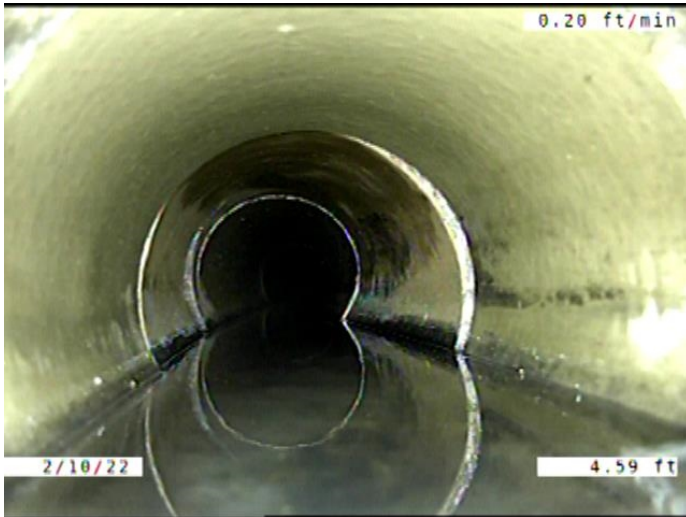
Code: **LL**
 Description: **Line Left**

Distance (ft): **4.6**
 Structural Grade: **0**
 O&M Grade: **1**
 Clock Start/From:
 Clock To:
 1st Value:
 2nd Value:
 Value Percent: **5.000**
 Continuous Index:
 Within 8" of Joint: **NO**
 Remarks:

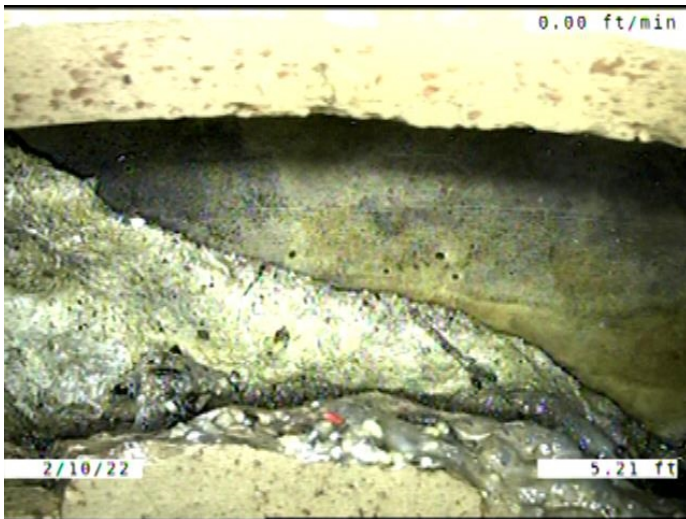
Code: **JSL**
 Description: **Joint Separated Large**

Distance (ft): **5.2**
 Structural Grade: **4**
 O&M Grade: **0**
 Clock Start/From:
 Clock To:
 1st Value:
 2nd Value:
 Value Percent:
 Continuous Index:
 Within 8" of Joint: **NO**
 Remarks:

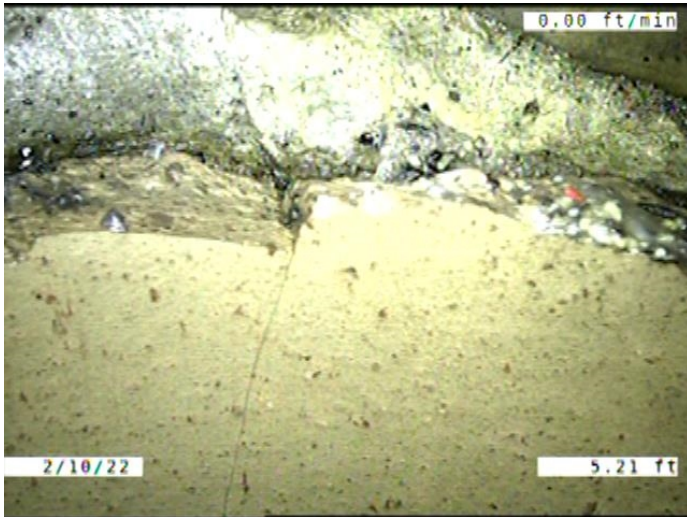
Code: **CL**
 Description: **Crack Longitudinal**

Distance (ft): **5.2**
 Structural Grade: **2**
 O&M Grade: **0**
 Clock Start/From: **1**
 Clock To:
 1st Value:
 2nd Value:
 Value Percent:
 Continuous Index:
 Within 8" of Joint: **YES**
 Remarks:

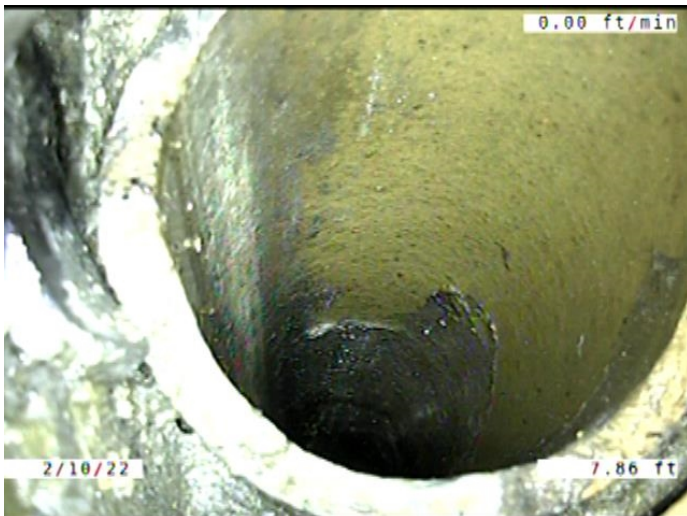
Code: **TF**
 Description: **Tap Factory**

Distance (ft): **7.9**
 Structural Grade: **0**
 O&M Grade: **0**
 Clock Start/From: **9**
 Clock To:
 1st Value: **6.000**
 2nd Value:
 Value Percent:
 Continuous Index:
 Within 8" of Joint: **YES**
 Remarks: **SERVICE LINE BROKEN SEPERATED AND OFFSET FROM THE MAIN**

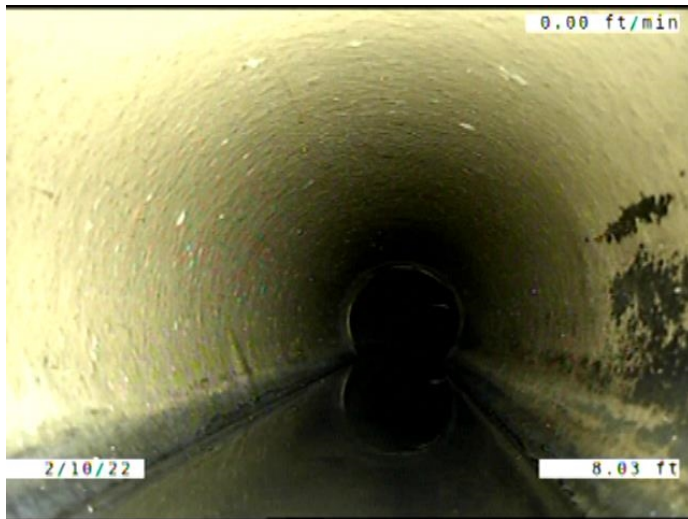
Code: **LR**
Description: **Line Right**

Distance (ft): **8.0**
Structural Grade: **0**
O&M Grade: **1**
Clock Start/From:
Clock To:
1st Value:
2nd Value:
Value Percent: **5.000**
Continuous Index:
Within 8" of Joint: **NO**
Remarks:

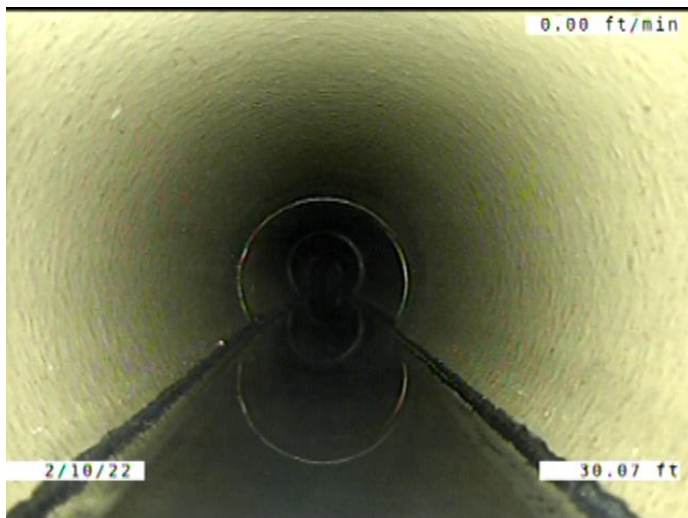
Code: **MWLS**
Description: **Miscellaneous Water Level Sag**

Distance (ft): **30.1**
Structural Grade: **2**
O&M Grade: **0**
Clock Start/From:
Clock To:
1st Value:
2nd Value:
Value Percent: **10.000**
Continuous Index: **S01**
Within 8" of Joint: **NO**
Remarks:

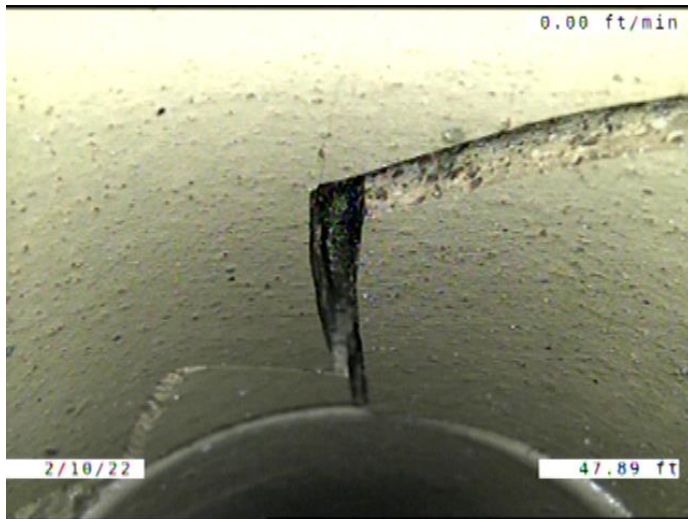
Code: **BSV**
 Description: **Broken Soil Visible**

Distance (ft): **47.9**
 Structural Grade: **5**
 O&M Grade: **0**
 Clock Start/From: **10**
 Clock To: **7**
 1st Value:
 2nd Value:
 Value Percent:
 Continuous Index:
 Within 8" of Joint: **YES**
 Remarks:

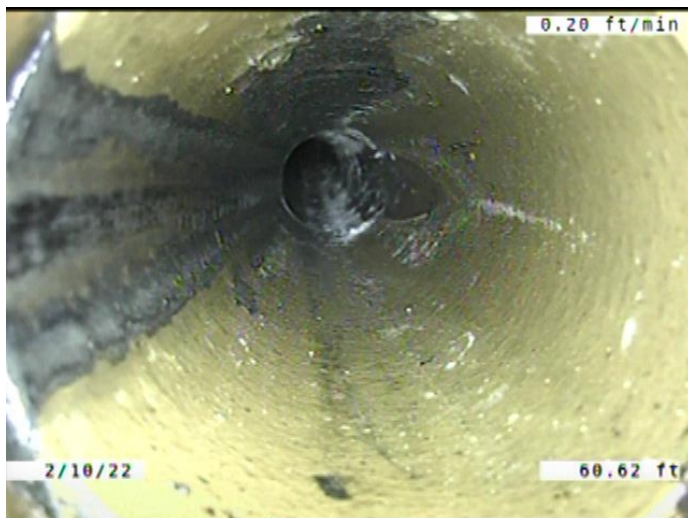
Code: **TF**
 Description: **Tap Factory**

Distance (ft): **60.6**
 Structural Grade: **0**
 O&M Grade: **0**
 Clock Start/From: **9**
 Clock To:
 1st Value: **6.000**
 2nd Value:
 Value Percent:
 Continuous Index:
 Within 8" of Joint: **YES**
 Remarks:

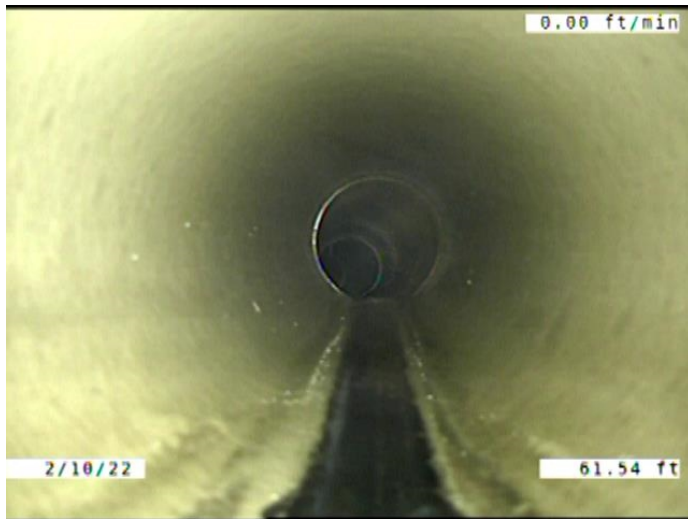
Code: **LU**
Description: **Line Up**

Distance (ft): **61.5**
Structural Grade: **0**
O&M Grade: **1**
Clock Start/From:
Clock To:
1st Value:
2nd Value:
Value Percent: **5.000**
Continuous Index:
Within 8" of Joint: **NO**
Remarks:

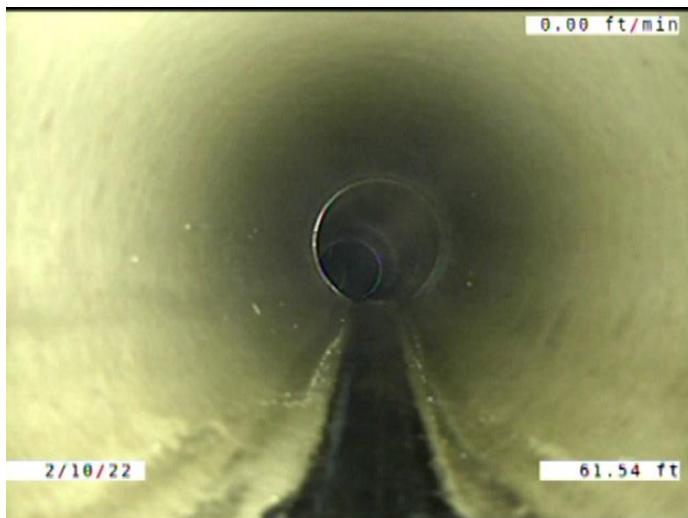
Code: **MWLS**
Description: **Miscellaneous Water Level Sag**

Distance (ft): **61.5**
Structural Grade: **2**
O&M Grade: **0**
Clock Start/From:
Clock To:
1st Value:
2nd Value:
Value Percent: **10.000**
Continuous Index: **F01**
Within 8" of Joint: **NO**
Remarks:

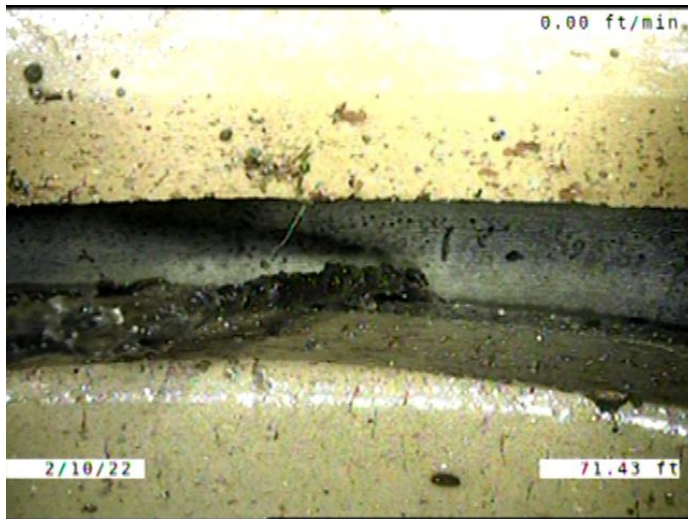
Code: **RFJ**
 Description: **Roots Fine Joint**

Distance (ft): **71.4**
 Structural Grade: **0**
 O&M Grade: **1**
 Clock Start/From: **11**
 Clock To:
 1st Value:
 2nd Value:
 Value Percent:
 Continuous Index:
 Within 8" of Joint: **YES**
 Remarks:

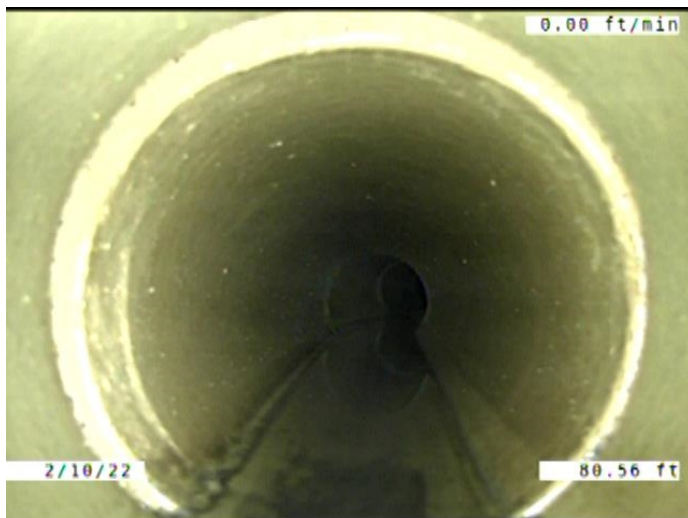
Code: **MWLS**
 Description: **Miscellaneous Water Level Sag**

Distance (ft): **80.6**
 Structural Grade: **2**
 O&M Grade: **0**
 Clock Start/From:
 Clock To:
 1st Value:
 2nd Value:
 Value Percent: **5.000**
 Continuous Index: **S02**
 Within 8" of Joint: **NO**
 Remarks:

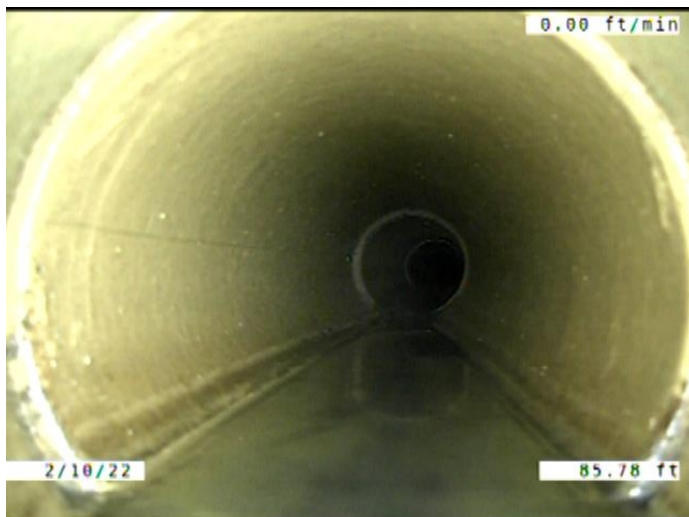
Code: **LR**
Description: **Line Right**

Distance (ft): **85.8**
Structural Grade: **0**
O&M Grade: **1**
Clock Start/From:
Clock To:
1st Value:
2nd Value:
Value Percent: **10.000**
Continuous Index:
Within 8" of Joint: **NO**
Remarks:

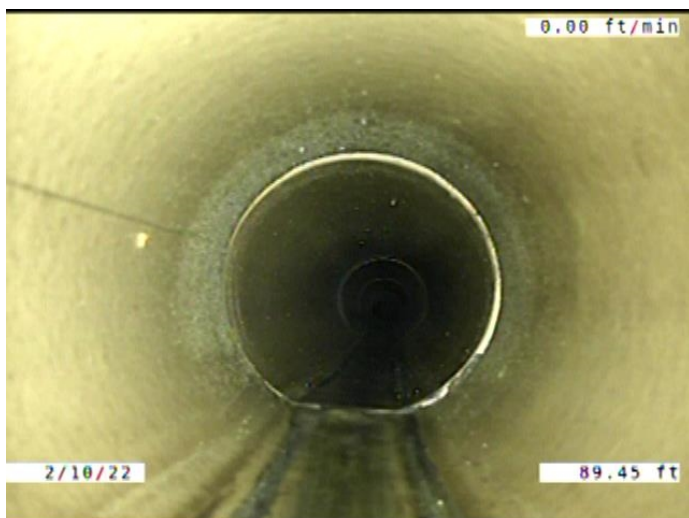
Code: **MWLS**
Description: **Miscellaneous Water Level Sag**

Distance (ft): **89.4**
Structural Grade: **2**
O&M Grade: **0**
Clock Start/From:
Clock To:
1st Value:
2nd Value:
Value Percent: **5.000**
Continuous Index: **F02**
Within 8" of Joint: **NO**
Remarks:

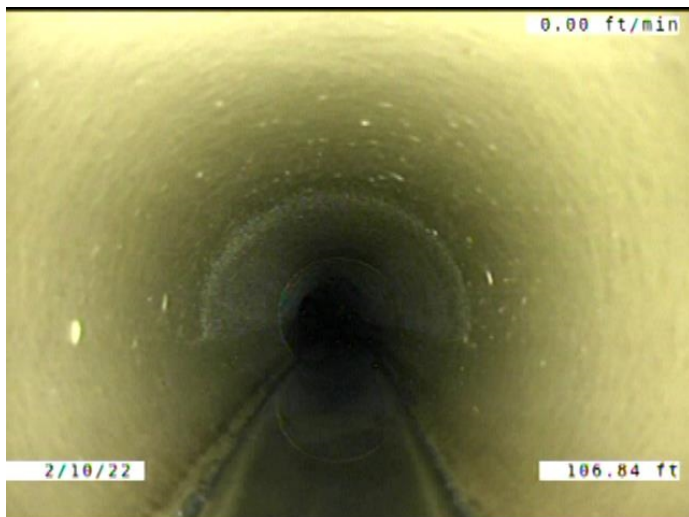
Code: **MWLS**
 Description: **Miscellaneous Water Level Sag**

Distance (ft): **106.8**
 Structural Grade: **2**
 O&M Grade: **0**
 Clock Start/From:
 Clock To:
 1st Value:
 2nd Value:
 Value Percent: **10.000**
 Continuous Index: **S03**
 Within 8" of Joint: **NO**
 Remarks:

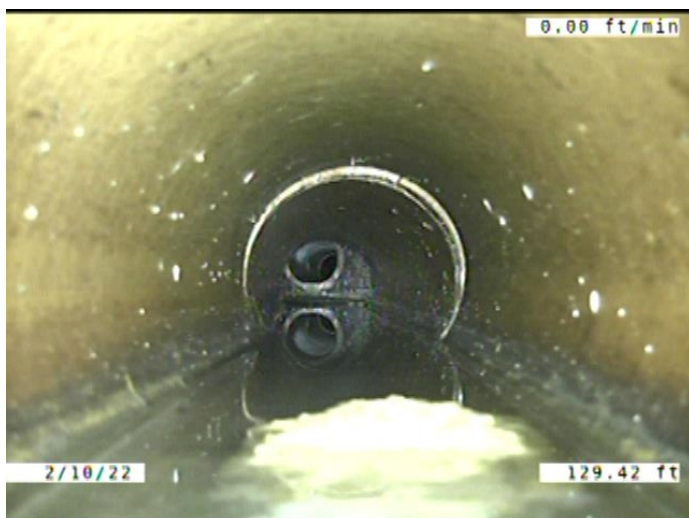
Code: **DSF**
 Description: **Deposits Settled Fine**

Distance (ft): **129.4**
 Structural Grade: **0**
 O&M Grade: **2**
 Clock Start/From: **5**
 Clock To: **7**
 1st Value:
 2nd Value:
 Value Percent: **5.000**
 Continuous Index:
 Within 8" of Joint: **YES**
 Remarks: **ALSO TP**

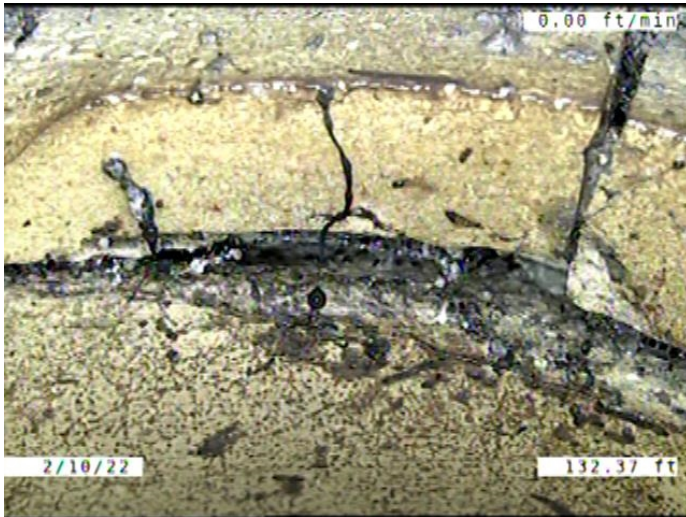
Code: **B**
 Description: **Broken**

Distance (ft): **132.4**
 Structural Grade: **4**
 O&M Grade: **0**
 Clock Start/From: **9**
 Clock To: **4**
 1st Value:
 2nd Value:
 Value Percent:
 Continuous Index:
 Within 8" of Joint: **YES**
 Remarks:

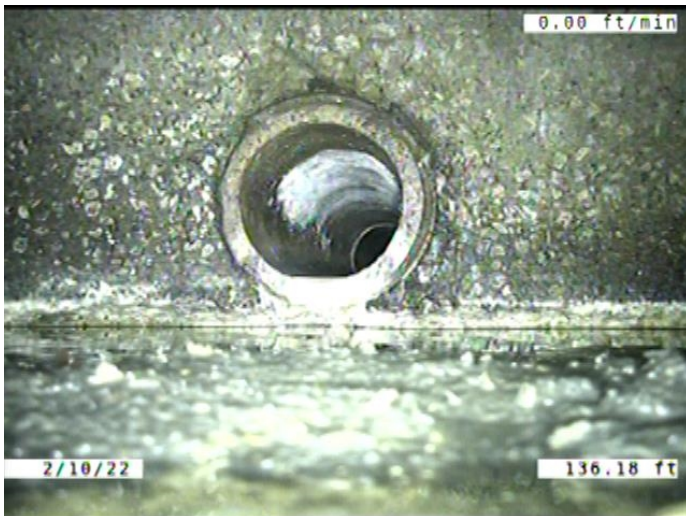
Code: **MWLS**
 Description: **Miscellaneous Water Level Sag**

Distance (ft): **136.1**
 Structural Grade: **2**
 O&M Grade: **0**
 Clock Start/From:
 Clock To:
 1st Value:
 2nd Value:
 Value Percent: **10.000**
 Continuous Index: **F03**
 Within 8" of Joint: **NO**
 Remarks:

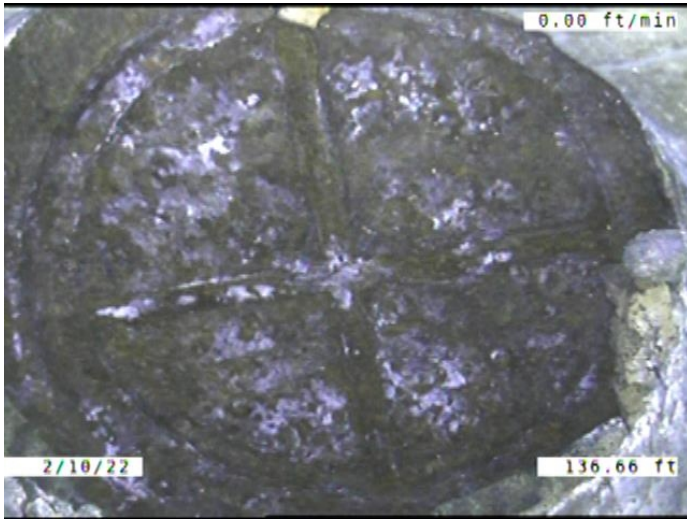
| Code: | AMH |
| Description: | Manhole |
| Distance (ft): | 136.7 |
| Remarks: | M-707-043 |
