## Profile/Photo Observation Report

Street:	<b>13th</b>	Flow Control:	<b>Not Controlled</b>
City:	<b>Hobart, IN</b>	Year Renewed:	
Location:	<b>Light Highway</b>	Tape/Media #:	
Purpose:	<b>Maintenance Related</b>	Dia/Height:	<b>8"</b>
Use:	<b>Sanitary</b>	Material:	<b>PVC</b>
Drain Area:	<b>NA</b>	Lining:	<b>Cured in Place</b>
Category:	<b>NA</b>		
Comment:

Location Details:		Direction of Survey:	<b>Downstream</b>
US MH:	<b>M-707-047</b>	DS MH:	<b>M-707-048</b>
		Total Length Surveyed (ft):	<b>247.7</b>

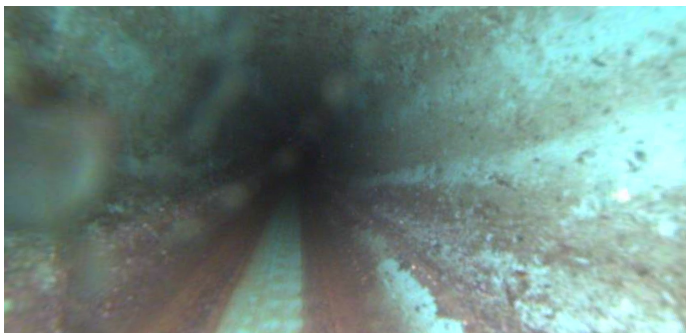
Code: **AMH**  
Description: **Manhole**

Distance (ft): **.0**  
Structural Grade: **0**  
O&M Grade: **0**  
Clock Start/From:  
Clock To:  
1st Value:  
2nd Value:  
Value Percent:  
Continuous Index:  
Within 8" of Joint: **NO**  
Remarks: **M-707-047**

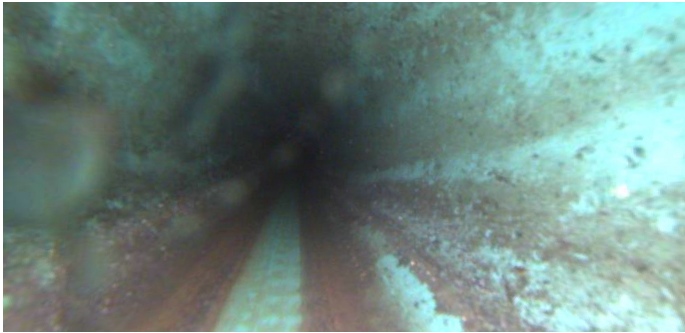
Code:	<b>MWL</b>
Description:	<b>Water Level</b>

Distance (ft):	<b>.0</b>
Structural Grade:	<b>0</b>
O&M Grade:	<b>0</b>
Clock Start/From:	
Clock To:	
1st Value:	
2nd Value:	
Value Percent:	<b>5.000</b>
Continuous Index:	
Within 8" of Joint:	<b>NO</b>
Remarks:

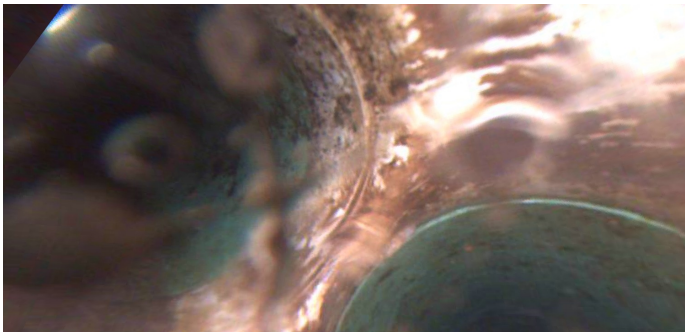
Code:	<b>TF</b>
Description:	<b>Tap Factory</b>

Distance (ft):	<b>40.5</b>
Structural Grade:	<b>0</b>
O&M Grade:	<b>0</b>
Clock Start/From:	<b>10</b>
Clock To:	
1st Value:	<b>4.000</b>
2nd Value:	
Value Percent:	
Continuous Index:	
Within 8" of Joint:	
Remarks:

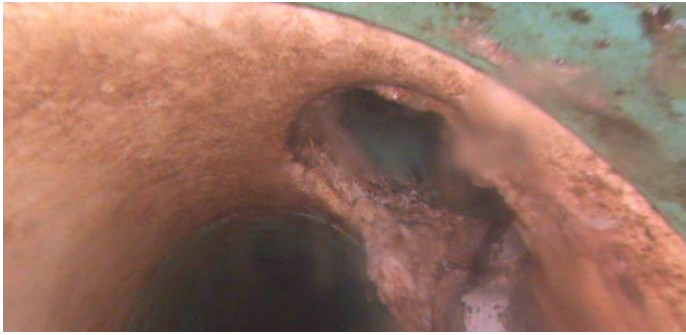
Code: **TFD**  
Description: **Tap Factory Defective**

Distance (ft): **126.0**  
Structural Grade: **0**  
O&M Grade: **2**  
Clock Start/From: **10**  
Clock To:  
1st Value: **4.000**  
2nd Value:  
Value Percent:  
Continuous Index:  
Within 8" of Joint:  
Remarks: **DAGS**

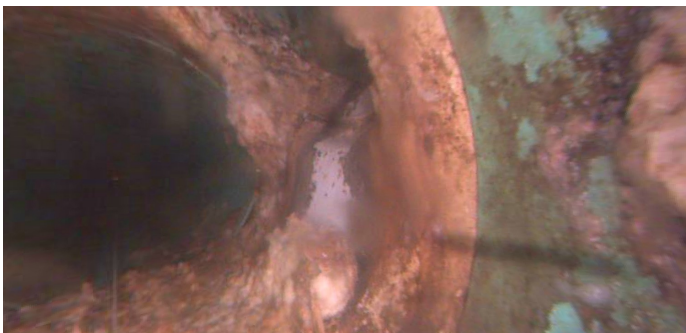
Code: **DAGS**  
Description: **Deposits Attached Grease**

Distance (ft): **126.0**  
Structural Grade: **0**  
O&M Grade: **2**  
Clock Start/From: **8**  
Clock To: **10**  
1st Value:  
2nd Value:  
Value Percent: **5.000**  
Continuous Index:  
Within 8" of Joint: **NO**  
Remarks:

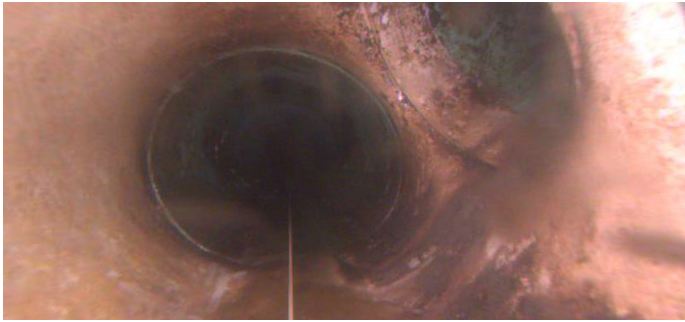
Code: **TF**  
Description: **Tap Factory**

Distance (ft): **222.2**  
Structural Grade: **0**  
O&M Grade: **0**  
Clock Start/From: **10**  
Clock To:  
1st Value: **4.000**  
2nd Value:  
Value Percent:  
Continuous Index:  
Within 8" of Joint:  
Remarks:

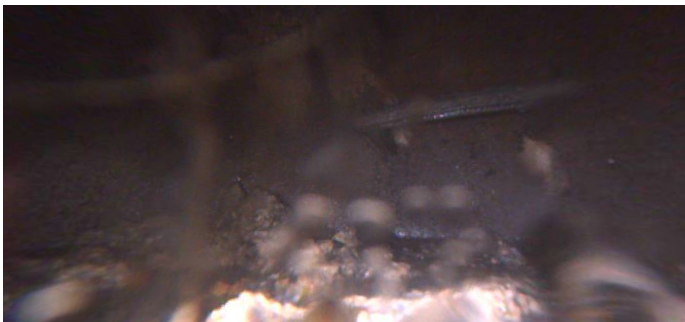
Code: **AMH**  
Description: **Manhole**

Distance (ft): **247.7**  
Structural Grade: **0**  
O&M Grade: **0**  
Clock Start/From:  
Clock To:  
1st Value:  
2nd Value:  
Value Percent:  
Continuous Index:  
Within 8" of Joint: **NO**  
Remarks: **M-707-048**
