Profile/Photo Observation Report

| Street: | FLEMING ST | Flow Control: | Not Controlled |
| City: | Hobart, IN | Year Renewed: | |

| US MH: | M-707-049 | DS MH: | M-707-047 |

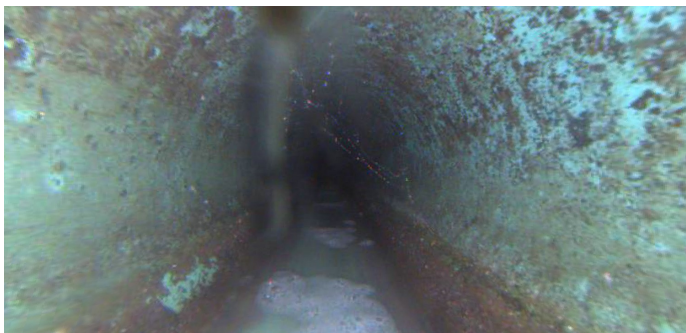
Code: **AMH**
Description: **Manhole**

Distance (ft): **.0**
Structural Grade: **0**
O&M Grade: **0**
Clock Start/From:
Clock To:
1st Value:
2nd Value:
Value Percent:
Continuous Index:
Within 8" of Joint: **NO**
Remarks: **M-707-049**

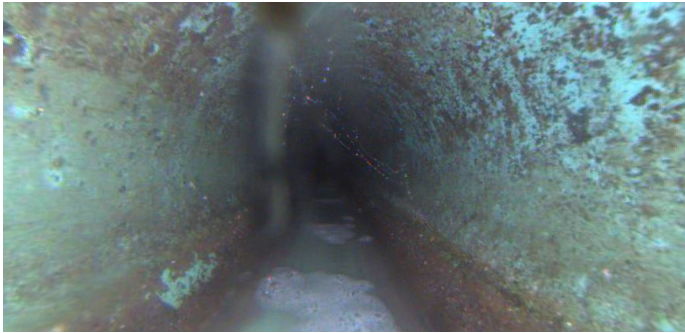
| Code: | MWL |
| Description: | Water Level |

| Value Percent: | 5.000 |

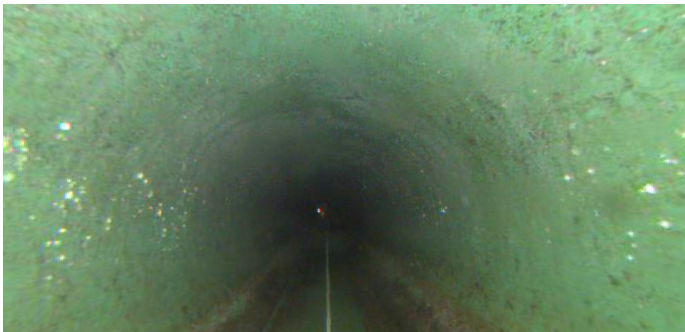
| Code: | MGO |
| Description: | General Observation |

| Remarks: | REAR CAMERA |

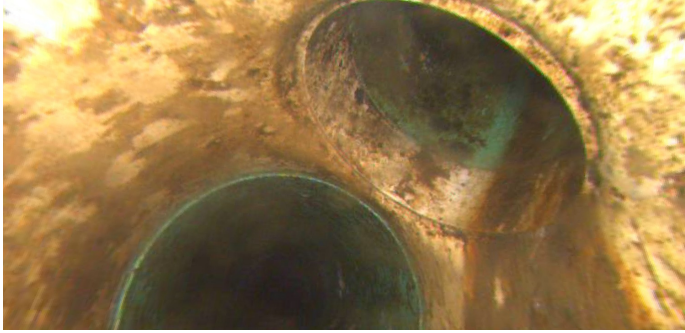
Code: **TF**
Description: **Tap Factory**

Distance (ft): **63.2**
Structural Grade: **0**
O&M Grade: **0**
Clock Start/From: **11**
Clock To:
1st Value: **4.000**
2nd Value:
Value Percent:
Continuous Index:
Within 8" of Joint:
Remarks:

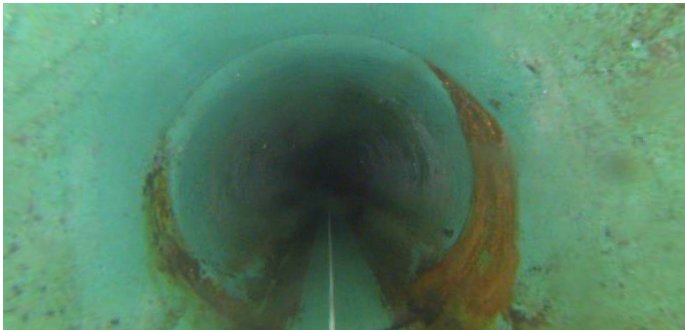
| | Position | Code | Observation | Video (sec) | Grade |
|--|---|---|---|---|---|
| | 114.0 | IW | Infil Weeper | 286 | M 2 |

Code: **IW**
Description: **Infil Weeper**

Distance (ft): **114.0**
Structural Grade: **0**
O&M Grade: **2**
Clock Start/From: **8**
Clock To: **4**
1st Value:
2nd Value:
Value Percent:
Continuous Index:
Within 8" of Joint: **YES**
Remarks:

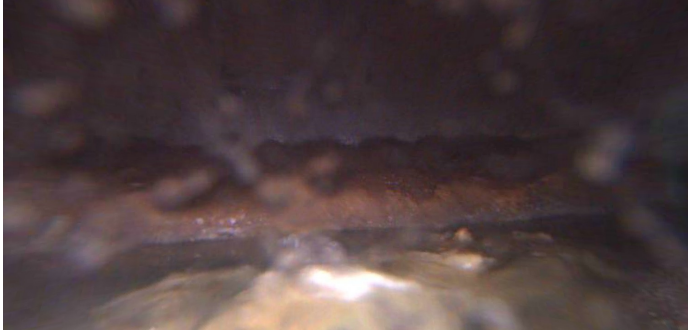
| Code: | AMH |
| Description: | Manhole |
| Distance (ft): | 147.8 |
| Remarks: | M-707-047 |
