## Profile/Photo Observation Report

Street:	<b>FLEMING ST</b>	Flow Control:	<b>Not Controlled</b>
City:	<b>Hobart, IN</b>	Year Renewed:	
Location:	<b>Light Highway</b>	Tape/Media #:	
Purpose:	<b>Maintenance Related</b>	Dia/Height:	<b>8"</b>
Use:	<b>Sanitary</b>	Material:	<b>PVC</b>
Drain Area:	<b>NA</b>	Lining:	<b>Cured in Place</b>
Category:	<b>NA</b>		
Comment:

Location Details:		Direction of Survey:	<b>Downstream</b>
US MH:	<b>M-707-049</b>	DS MH:	<b>M-707-050</b>
		Total Length Surveyed (ft):	<b>11.7</b>

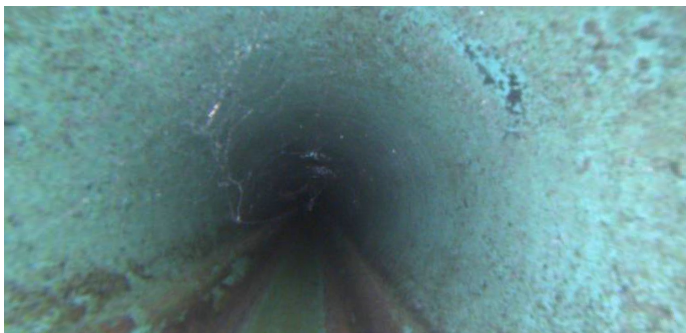
Code: **AMH**  
Description: **Manhole**

Distance (ft): **.0**  
Structural Grade: **0**  
O&M Grade: **0**  
Clock Start/From:  
Clock To:  
1st Value:  
2nd Value:  
Value Percent:  
Continuous Index:  
Within 8" of Joint: **NO**  
Remarks: **M-707-049**

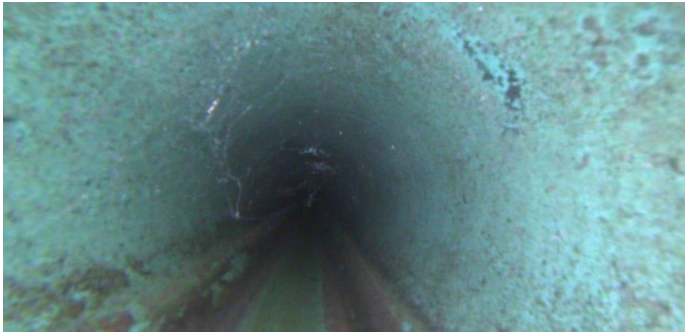
Code:	<b>MWL</b>
Description:	<b>Water Level</b>

Distance (ft):	<b>.0</b>
Structural Grade:	<b>0</b>
O&M Grade:	<b>0</b>
Clock Start/From:	
Clock To:	
1st Value:	
2nd Value:	
Value Percent:	<b>5.000</b>
Continuous Index:	
Within 8" of Joint:	<b>NO</b>
Remarks:

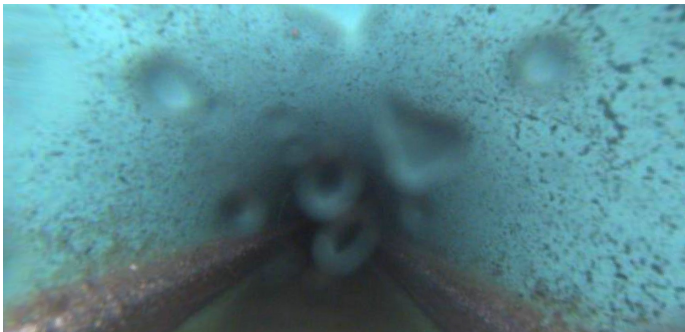
Code:	<b>MSA</b>
Description:	<b>Abandoned Survey</b>

Distance (ft):	<b>11.7</b>
Structural Grade:	<b>0</b>
O&M Grade:	<b>0</b>
Clock Start/From:	
Clock To:	
1st Value:	
2nd Value:	
Value Percent:	
Continuous Index:	
Within 8" of Joint:	<b>NO</b>
Remarks:	<b>debris under water</b>
