## Profile/Photo Observation Report

Street:	<b>Fleming</b>	Flow Control:	<b>Not Controlled</b>
City:	<b>Hobart, IN</b>	Year Renewed:	
Location:	<b>Light Highway</b>	Tape/Media #:	
Purpose:	<b>Maintenance Related</b>	Dia/Height:	<b>8"</b>
Use:	<b>Sanitary</b>	Material:	<b>PVC</b>
Drain Area:	<b>NA</b>	Lining:	<b>Cured in Place</b>
Category:	<b>NA</b>		
Comment:

Location Details:		Direction of Survey:	<b>Downstream</b>
US MH:	<b>M-707-049</b>	DS MH:	<b>M-707-050</b>
		Total Length Surveyed (ft):	<b>11.7</b>

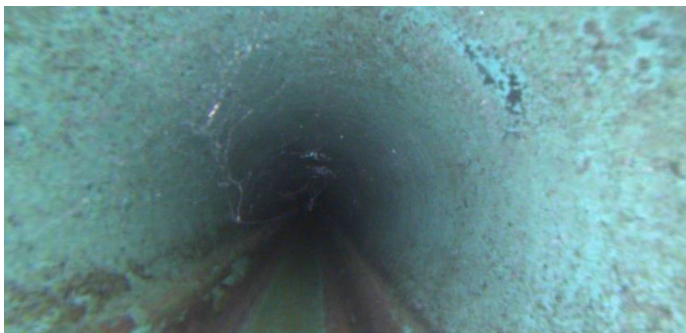
Code: **AMH**  
Description: **Manhole**

Distance (ft): **.0**  
Structural Grade: **0**  
O&M Grade: **0**  
Clock Start/From:  
Clock To:  
1st Value:  
2nd Value:  
Value Percent:  
Continuous Index:  
Within 8" of Joint: **NO**  
Remarks: **M-707-049**

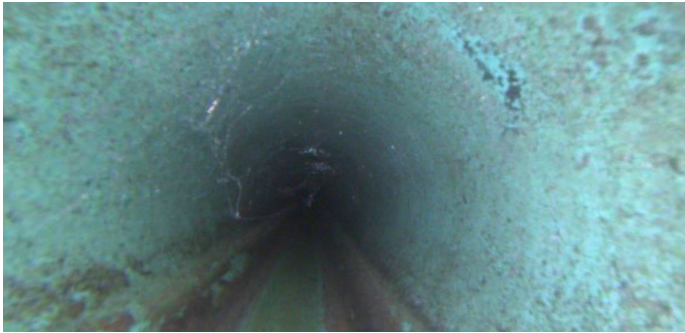
Code:	<b>MWL</b>
Description:	<b>Water Level</b>

Distance (ft):	<b>.0</b>
Structural Grade:	<b>0</b>
O&M Grade:	<b>0</b>
Clock Start/From:	
Clock To:	
1st Value:	
2nd Value:	
Value Percent:	<b>5.000</b>
Continuous Index:	
Within 8" of Joint:	<b>NO</b>
Remarks:

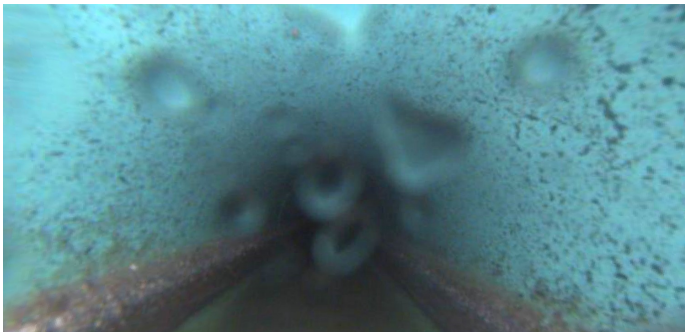
Code:	<b>MSA</b>
Description:	<b>Abandoned Survey</b>

Distance (ft):	<b>11.7</b>
Structural Grade:	<b>0</b>
O&M Grade:	<b>0</b>
Clock Start/From:	
Clock To:	
1st Value:	
2nd Value:	
Value Percent:	
Continuous Index:	
Within 8" of Joint:	<b>NO</b>
Remarks:	<b>debris under water</b>
