Profile/Photo Observation Report

Date:	04/07/2018	Weather:		Coding:	PACP 6.0
Pipe Length (ft):	262.8	Owner:	NA	Pre Clean:	Not Known
P.O.#:		Surveyor:	Jen Costello	PSR:	P-707-050-051
Customer:		Clean Date:	01/01/1900	Shape:	C

Street:	ALLEY BETWEEN E 13TH ST & E 13TH	Flow Control:	Not Controlled
City:	Hobart, IN	Year Renewed:	
Location:	Easement/Right of Way	Tape/Media #:	
Purpose:	Maintenance Related	Dia/Height:	8"
Use:	Sanitary	Material:	PVC
Drain Area:	NA	Lining:	Cured in Place
Category:	NA		
Comment:

Location Details:		Direction of Survey:	Upstream
US MH:	M-707-050	DS MH:	M-707-051
		Total Length Surveyed (ft):	256.7

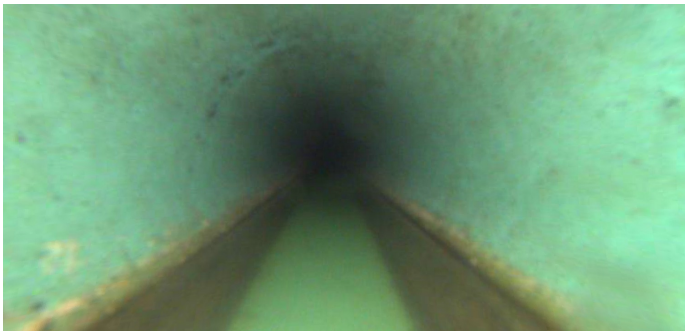
Code: **AMH**
Description: **Manhole**

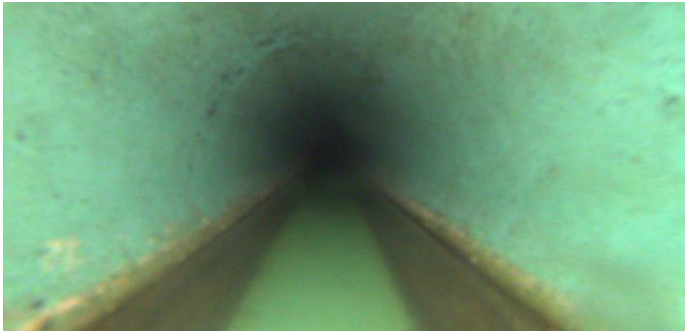
Code:	MWL
Description:	Water Level

Distance (ft):	.0
Structural Grade:	0
O&M Grade:	0
Clock Start/From:	
Clock To:	
1st Value:	
2nd Value:	
Value Percent:	10.000
Continuous Index:	
Within 8" of Joint:	NO
Remarks:

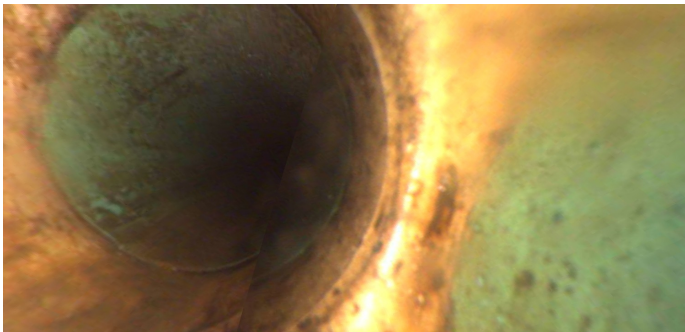
Code:	TF
Description:	Tap Factory

Distance (ft):	53.4
Structural Grade:	0
O&M Grade:	0
Clock Start/From:	10
Clock To:	
1st Value:	4.000
2nd Value:	
Value Percent:	
Continuous Index:	
Within 8" of Joint:	
Remarks:

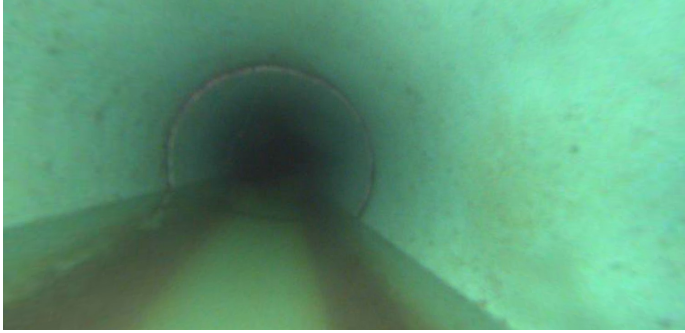
Code: **MWL**
Description: **Water Level**

Distance (ft): **65.0**
Structural Grade: **0**
O&M Grade: **0**
Clock Start/From:
Clock To:
1st Value:
2nd Value:
Value Percent: **40.000**
Continuous Index:
Within 8" of Joint: **NO**
Remarks:

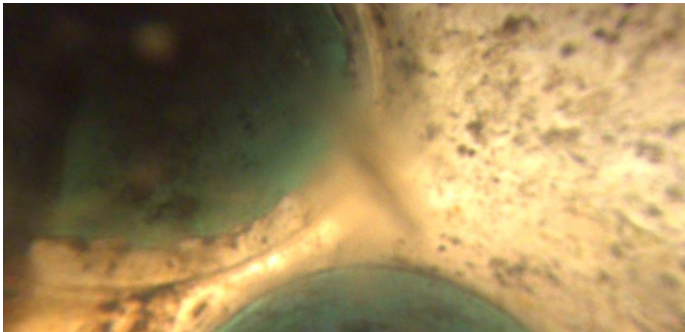
Code: **TF**
Description: **Tap Factory**

Distance (ft): **140.3**
Structural Grade: **0**
O&M Grade: **0**
Clock Start/From: **11**
Clock To:
1st Value: **4.000**
2nd Value:
Value Percent:
Continuous Index:
Within 8" of Joint:
Remarks:

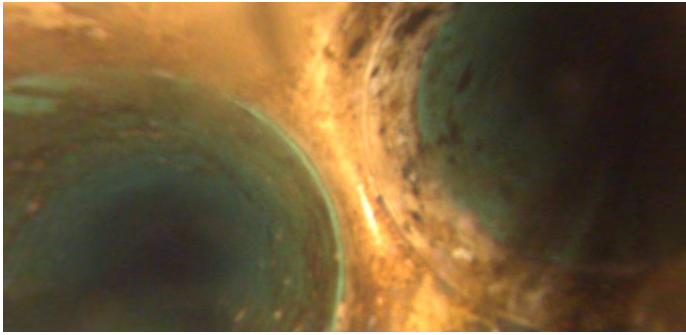
Code: **TF**
Description: **Tap Factory**

Distance (ft): **155.4**
Structural Grade: **0**
O&M Grade: **0**
Clock Start/From: **2**
Clock To:
1st Value: **4.000**
2nd Value:
Value Percent:
Continuous Index:
Within 8" of Joint:
Remarks:

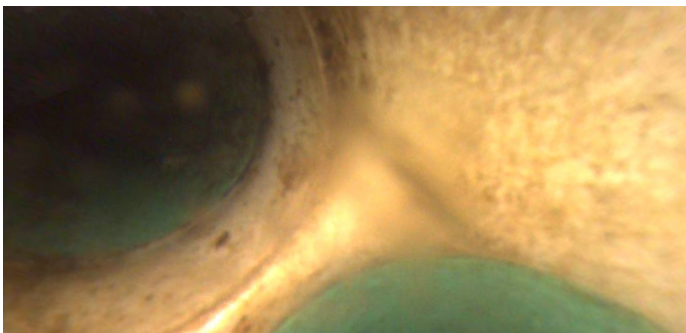
Code: **TF**
Description: **Tap Factory**

Distance (ft): **197.0**
Structural Grade: **0**
O&M Grade: **0**
Clock Start/From: **10**
Clock To:
1st Value: **4.000**
2nd Value:
Value Percent:
Continuous Index:
Within 8" of Joint:
Remarks:

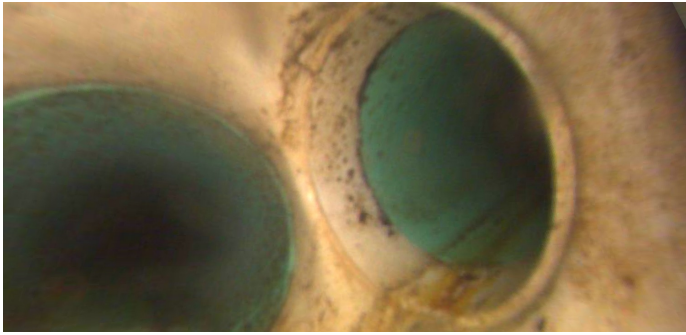
Code: **TF**
Description: **Tap Factory**

Distance (ft): **215.8**
Structural Grade: **0**
O&M Grade: **0**
Clock Start/From: **3**
Clock To:
1st Value: **4.000**
2nd Value:
Value Percent:
Continuous Index:
Within 8" of Joint:
Remarks:

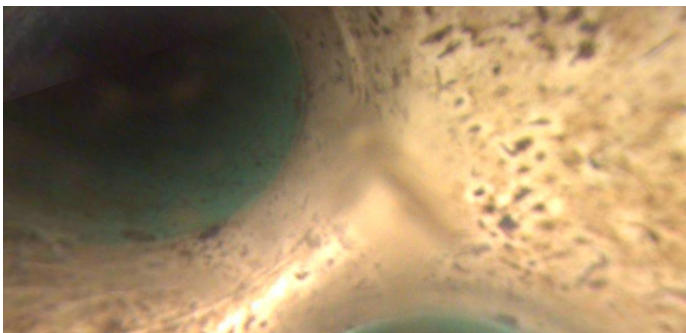
Code: **TF**
Description: **Tap Factory**

Distance (ft): **252.8**
Structural Grade: **0**
O&M Grade: **0**
Clock Start/From: **10**
Clock To:
1st Value: **4.000**
2nd Value:
Value Percent:
Continuous Index:
Within 8" of Joint:
Remarks:

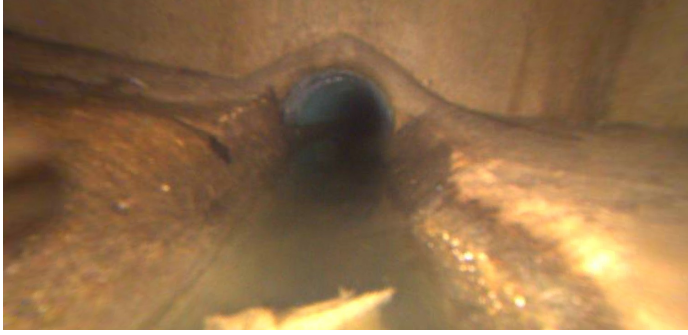
Code:	AMH
Description:	Manhole
Distance (ft):	256.7
Structural Grade:	0
O&M Grade:	0
Clock Start/From:	
Clock To:	
1st Value:	
2nd Value:	
Value Percent:	
Continuous Index:	
Within 8" of Joint:	NO
Remarks:	M-707-050
