Profile/Photo Observation Report

Street:	E 13TH PL	Flow Control:	Not Controlled
City:	Hobart, IN	Year Renewed:	
Location:	Easement/Right of Way	Tape/Media #:	
Purpose:	Maintenance Related	Dia/Height:	8"
Use:	Sanitary	Material:	PVC
Drain Area:	NA	Lining:	Cured in Place
Category:	NA		
Comment:	Flow direction wrong.

Location Details:		Direction of Survey:	Downstream
US MH:	M-707-051	DS MH:	M-707-070
		Total Length Surveyed (ft):	141.2

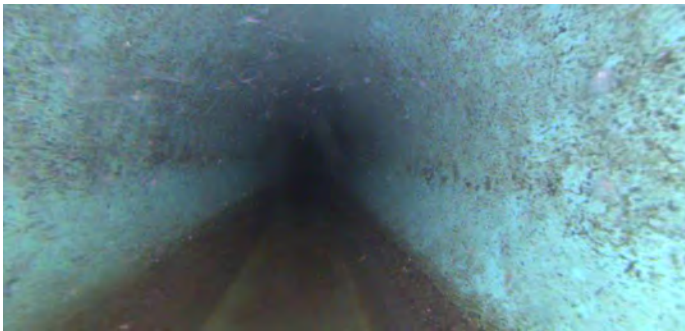
Code: **AMH**
Description: **Manhole**

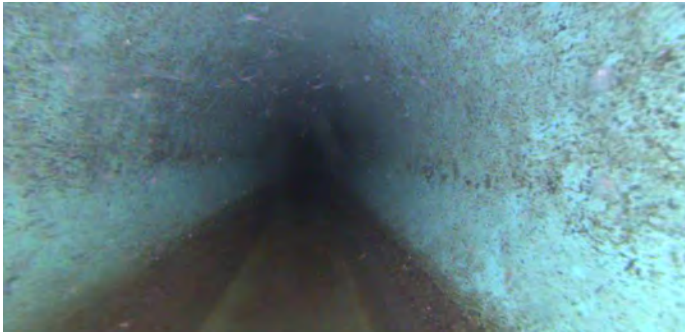
Code:	MWL
Description:	Water Level

Distance (ft):	.0
Structural Grade:	0
O&M Grade:	0
Clock Start/From:	
Clock To:	
1st Value:	
2nd Value:	
Value Percent:	5.000
Continuous Index:	
Within 8" of Joint:	NO
Remarks:

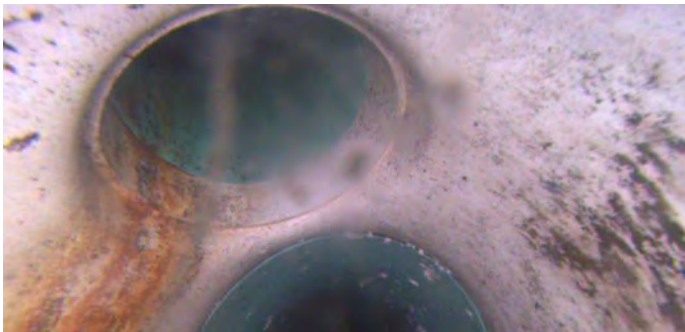
Code:	TF
Description:	Tap Factory

Distance (ft):	36.5
Structural Grade:	0
O&M Grade:	0
Clock Start/From:	12
Clock To:	
1st Value:	4.000
2nd Value:	
Value Percent:	
Continuous Index:	
Within 8" of Joint:	
Remarks:

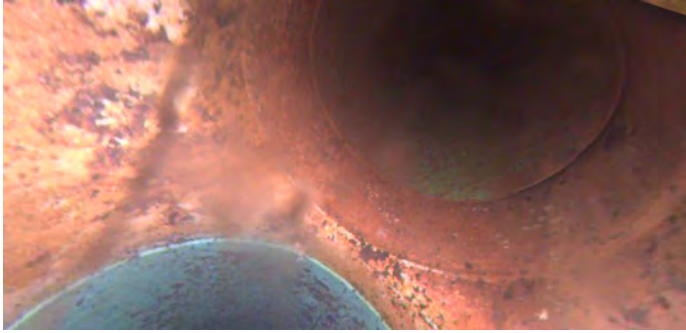
Code: **TF**
Description: **Tap Factory**

Distance (ft): **90.1**
Structural Grade: **0**
O&M Grade: **0**
Clock Start/From: **1**
Clock To:
1st Value: **4.000**
2nd Value:
Value Percent:
Continuous Index:
Within 8" of Joint:
Remarks:

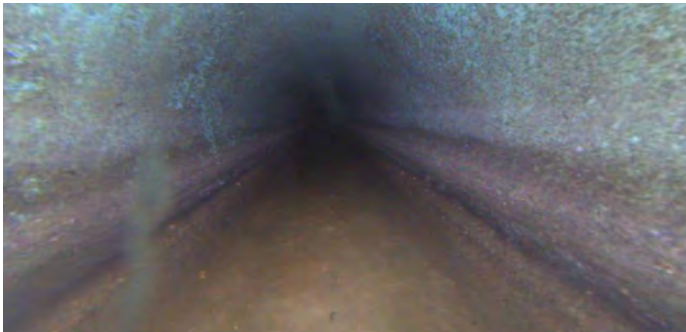
Code: **MWL**
Description: **Water Level**

Distance (ft): **129.1**
Structural Grade: **0**
O&M Grade: **0**
Clock Start/From:
Clock To:
1st Value:
2nd Value:
Value Percent: **10.000**
Continuous Index:
Within 8" of Joint: **NO**
Remarks:

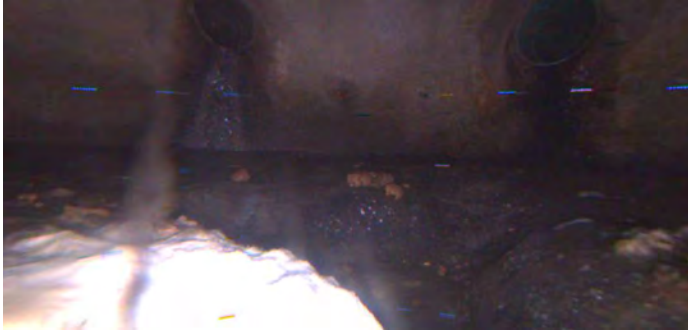
Code:	AMH
Description:	Manhole
Distance (ft):	141.2
Structural Grade:	0
O&M Grade:	0
Clock Start/From:	
Clock To:	
1st Value:	
2nd Value:	
Value Percent:	
Continuous Index:	
Within 8" of Joint:	NO
Remarks:	M-707-070
