Profile/Ph	oto Observatio	n Report			RedZone R 0 B 0 T I C S
Date: Pipe Length (ft P.O.#: Customer:	04/04/2018 :): 144.4	Weather: Owner: Surveyor: Clean Date:	NA Jen Costello 01/01/1900	Coding: Pre Clean: PSR: Shape:	PACP 6.0 No Pre-Cleaning P-707-052-053 C
Street:	S LAKE PARK AVE	& E 13TH ST	Flow Control:	Not Controlled	I
City:	Hobart, IN		Year Renewed:		
Location:	Yard		Tape/Media #:		
Purpose:	Routine Assessme	ent	Dia/Height:	8"	
Use:	Sanitary		Material:	PVC	
Drain Area:	NA		Lining:		
Category:	NA				
Comment:	Flow direction is	marked wrong.			
Location Detai	ls:		Direction of Survey	: Upstream	
US MH:	M-707-053	DS MH: N	1-707-052	Total Length Surveyed (ft	): <b>92.5</b>
0&M Index:	2.50	O&M Quick:	3121	O&M Rating:	5.00
Structural Index:	0.00	Structural Quic	k: 0000	Structural Rating:	0.00
Overall Index:	2.50	Overall Quick:	3121	Overall Rating:	5.00

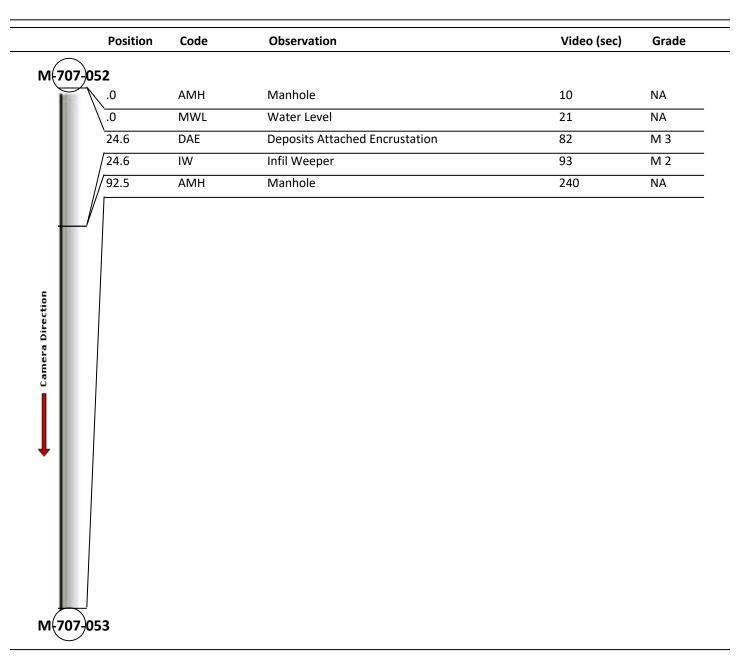
Code:	DAE
Description:	Deposits Attached Encrustation

Distance (ft):	24.6
Structural Grade:	0
O&M Grade:	3
Clock Start/From:	8
Clock To:	4
1st Value:	
2nd Value:	
Value Percent:	20.000
Continuous Index:	
Within 8" of Joint:	YES
Remarks:

Code:	IW
Description:	Infil Weeper

Distance (ft):	24.6
Structural Grade:	0
O&M Grade:	2
Clock Start/From:	8
Clock To:	4
1st Value:	
2nd Value:	
Value Percent:	
Continuous Index:	
Within 8" of Joint:	YES
Remarks:
