Profile/Photo Observation Report

Street:	13th	Flow Control:	Not Controlled
City:	Hobart, IN	Year Renewed:	
Location:	Light Highway	Tape/Media #:	
Purpose:	Maintenance Related	Dia/Height:	12"
Use:	Sanitary	Material:	PVC
Drain Area:	NA	Lining:	Cured in Place
Category:	NA		
Comment:

Location Details:		Direction of Survey:	Downstream
US MH:	M-707-055	DS MH:	M-707-049
		Total Length Surveyed (ft):	149.7

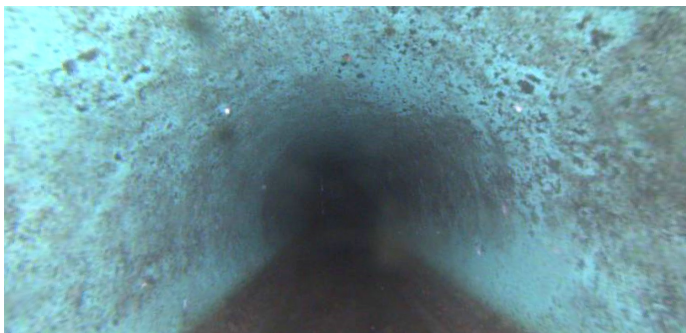
Code: **AMH**
Description: **Manhole**

Distance (ft): **.0**
Structural Grade: **0**
O&M Grade: **0**
Clock Start/From:
Clock To:
1st Value:
2nd Value:
Value Percent:
Continuous Index:
Within 8" of Joint: **NO**
Remarks: **M-707-055**

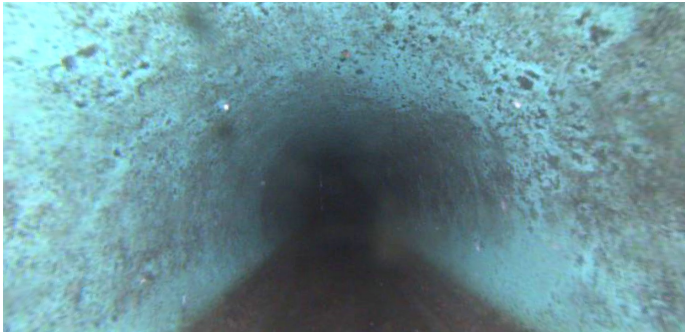
Code:	MWL
Description:	Water Level

Distance (ft):	.0
Structural Grade:	0
O&M Grade:	0
Clock Start/From:	
Clock To:	
1st Value:	
2nd Value:	
Value Percent:	5.000
Continuous Index:	
Within 8" of Joint:	NO
Remarks:

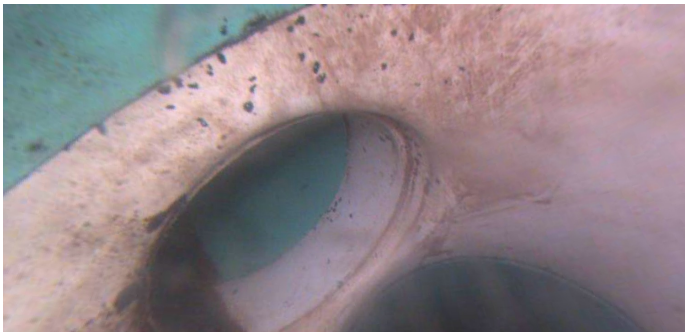
Code:	TF
Description:	Tap Factory

Distance (ft):	105.8
Structural Grade:	0
O&M Grade:	0
Clock Start/From:	2
Clock To:	
1st Value:	4.000
2nd Value:	
Value Percent:	
Continuous Index:	
Within 8" of Joint:	
Remarks:

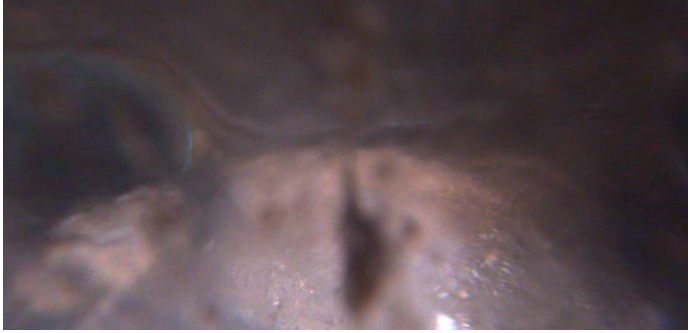
Code: **AMH**
Description: **Manhole**

Distance (ft): **149.7**
Structural Grade: **0**
O&M Grade: **0**
Clock Start/From:
Clock To:
1st Value:
2nd Value:
Value Percent:
Continuous Index:
Within 8" of Joint: **NO**
Remarks: **M-707-049**
